## Appendix G

### EIS Resource Technical Appendix

# Guam and CNMI Military Relocation EIS

## Volume 9: EIS Resource Technical Appendix

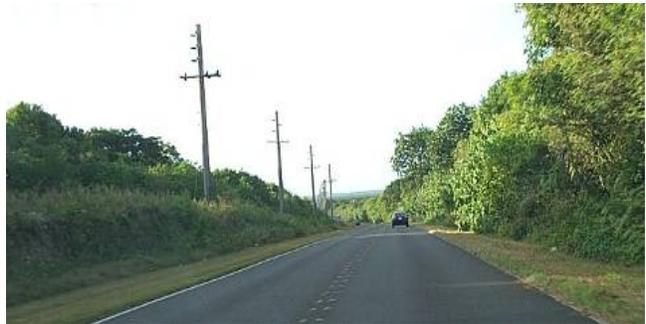
*Figure 4 North Guam Typical Roadway Cross-Section*

**Surface Drainage:** The surface in North Guam is relatively flat and heavy precipitation generally flows by sheets into swales, then into depressions/retention basins (sinks), where it percolates into the ground. The subsoil is composed of highly porous limestone covered with a soil layer generally less than 2 feet thick. Percolation rates are high, generally from 8 to 24 feet per day. Typical roadway drainage throughout the north area is shown on

Figure 4. Roadway runoff generally sheet flows through grass strips located along the edge of pavement. In some of the more urban locations (such as along Route 1 on the western side of the island), the road cross-section is curbed with roadway runoff conveyed through a storm drain system that outlets into the sinks or existing infiltration basins. There are numerous infiltration basins owned and maintained by the Guam Department of Public Works (see Appendix B) which are currently being used as outlets for the routed roadways in North Guam. Table 4 provides a summary of the routed roads to be improved as part of the GRN and the respective infiltration basins currently being used as outlets for the roadway drainage systems.

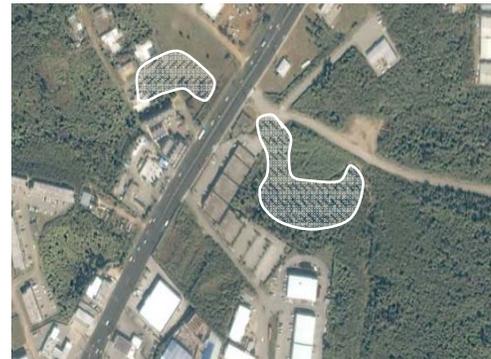
*Figure 5 Harmon Sink at Rte 1*

**Flood Zones:** The Federal Emergency Management Agency (FEMA) has mapped flood hazard areas throughout the island for the National Flood Insurance Program (NFIP) and has designated the areas on Flood Insurance Rate Maps (FIRMs). These maps are provided in Appendix D. As shown in FIRM Map 6600010125D, various depressions are located throughout the area and have been designated as Flood Hazard Zone X (areas of less than 1 ft depth or areas with less than 1 sq mile of contributing drainage area). The largest depression within the north area is referred to as the Harmon Sink.

This sink has been mapped as a Flood Hazard Zone AE by FEMA and crosses under Route 1 with a high water elevation of 93 feet above mean sea level. In general, the sink acts as an outlet for much of the local storm water runoff in the area including street drainage (see

Figure 5 where the sink is located adjacent to Route 1). South of Route 3, the drainage along Route 1 is conveyed to the Harmon Sink via a storm drain network.

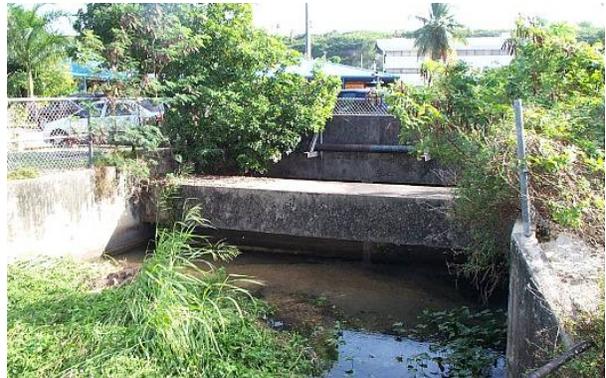
*Figure 6 Tamuning Drainageway Outlet*

**Flood Zones:** GRN Projects located within the south area are primarily on the west side of the island where the area is traversed by streams that are short with steep gradients and drainage areas of less than three square miles each. Route 1 is located very close to the mouths of several of these streams which outlet into several bays connected to the Philippine Sea or Apra Harbor. These include: 1) the Tamuning Drainageway, Agana River and Fonte River outleting to Agana Bay, 2) the Asan River with two tributaries, each of which outlet to Asan Bay, 3) the Matgue, Taguag and Masso Rivers, each outleting into Piti Bay, 4) the Sasa, Laguas and Aguada Rivers, each outleting into the Sasa Bay Marine Preserve and 5) the Atantano River that outlets into the Apra Inner Harbor. The Tamuning Drainageway and the Agana, Fonte, Asan and Masso Rivers are designated as floodways by FEMA (see Appendix D). Other rivers are designated as Flood Hazard Zone X areas with minimal flooding potential. Route 1 parallels the coastline from Apra Harbor, northward to Agana Bay. Along this section of roadway, several locations are designated within FEMA Flood Hazard Zone V or VE which is defined as a coastal flood zone with velocity hazard due to wave action. The Sasa Bay Marine Preserve which is the outlet for the Sasa, Laguas and Aguada Rivers is located along the shoreline of Apra Harbor. The Atantano River flows into the Inner Harbor. FEMA Floodplain Mapping indicates that much of the Harbor is within FEMA Flood Zone A. Route 11 is the main entry to Apra Harbor which is also shown to be within the flood zone.

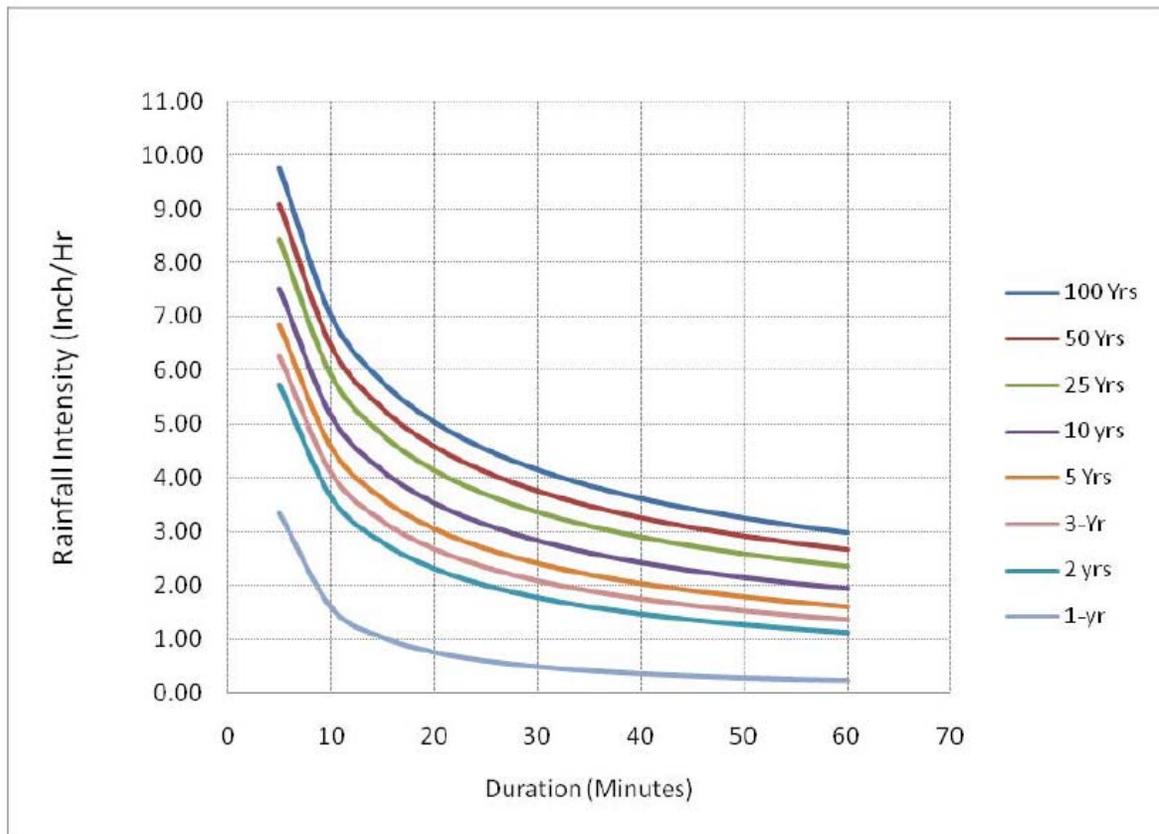
Figure 7 – Guam TSDM Intensity Duration Frequency Curves

**Water Quality Flow:** The water quality flow (WQF) corresponds to the design flow used for flow-based stormwater treatment BMPs that are usually filtration type BMPs such as grass swales and buffer strips. For the project area, the WQF is calculated using the Rational Method and a precipitation intensity equal to 56% and 72% of the 2 yr - 1 hr storm intensity for moderate and high water quality classification areas, respectively. See Figure 7 which shows that the 2 yr – 1 hr storm intensity equate to 1.1 inches per hour.

**Sizing Criteria** - Water quality volumes used for volume-based treatment facility sizing and recharge augmentation facility sizing will be calculated using procedures described in the 2006 Manual and the TSDM. Water quality flows used for flow-based treatment facilities (e.g. for bioswales and biostrips) will be calculated using rainfall intensities for the 80<sup>th</sup> and 90<sup>th</sup> percentile storms for areas designated with moderate and high water quality classifications, respectively. These intensities have been statistically approximated at 56% and 72% of a 2-year storm event (1 hour duration), per the TSDM (see Figure 7).

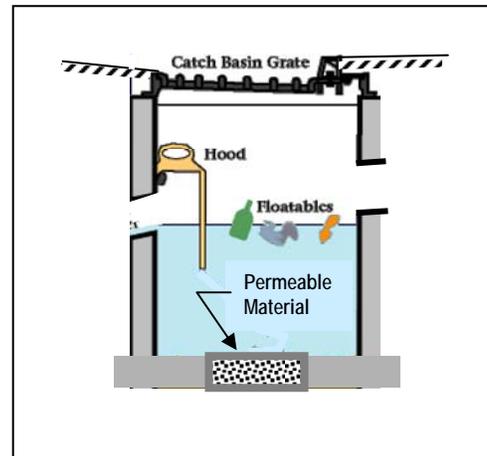
Figure 8: Sample Catch Basin Retrofit

**Catch Basin Retrofits:** Within urban areas where the on-site roadway drainage systems include catch basins connected to conveyance pipelines, there are often no areas available for

downstream treatment BMPs. In these areas, it is recommended that the catch basins be retrofitted to accommodate removal of litter and debris (commonly referred to as gross solids). The retrofit can be accomplished in various ways. A simple retrofit option of catch basins is to ensure that all catch basins have a hooded outlet to prevent floatable materials, such as trash and debris, from entering the storm drain system. An opening filled with pervious material placed in the bottom of the catch basin will enable a small amount of runoff to infiltrate, preventing standing water in the bottom of the structure (see Figure 8). A second option is to incorporate a reverse 90 degree bend in the outlet structure. The outlet can also be equipped with a filtering plate such as a plastic or metal wire mesh with 0.5 mm openings in order to filter out some of the larger suspended solids. Note that both of these options will require continued maintenance for trash and debris removal as specified in separate DPW guidelines.

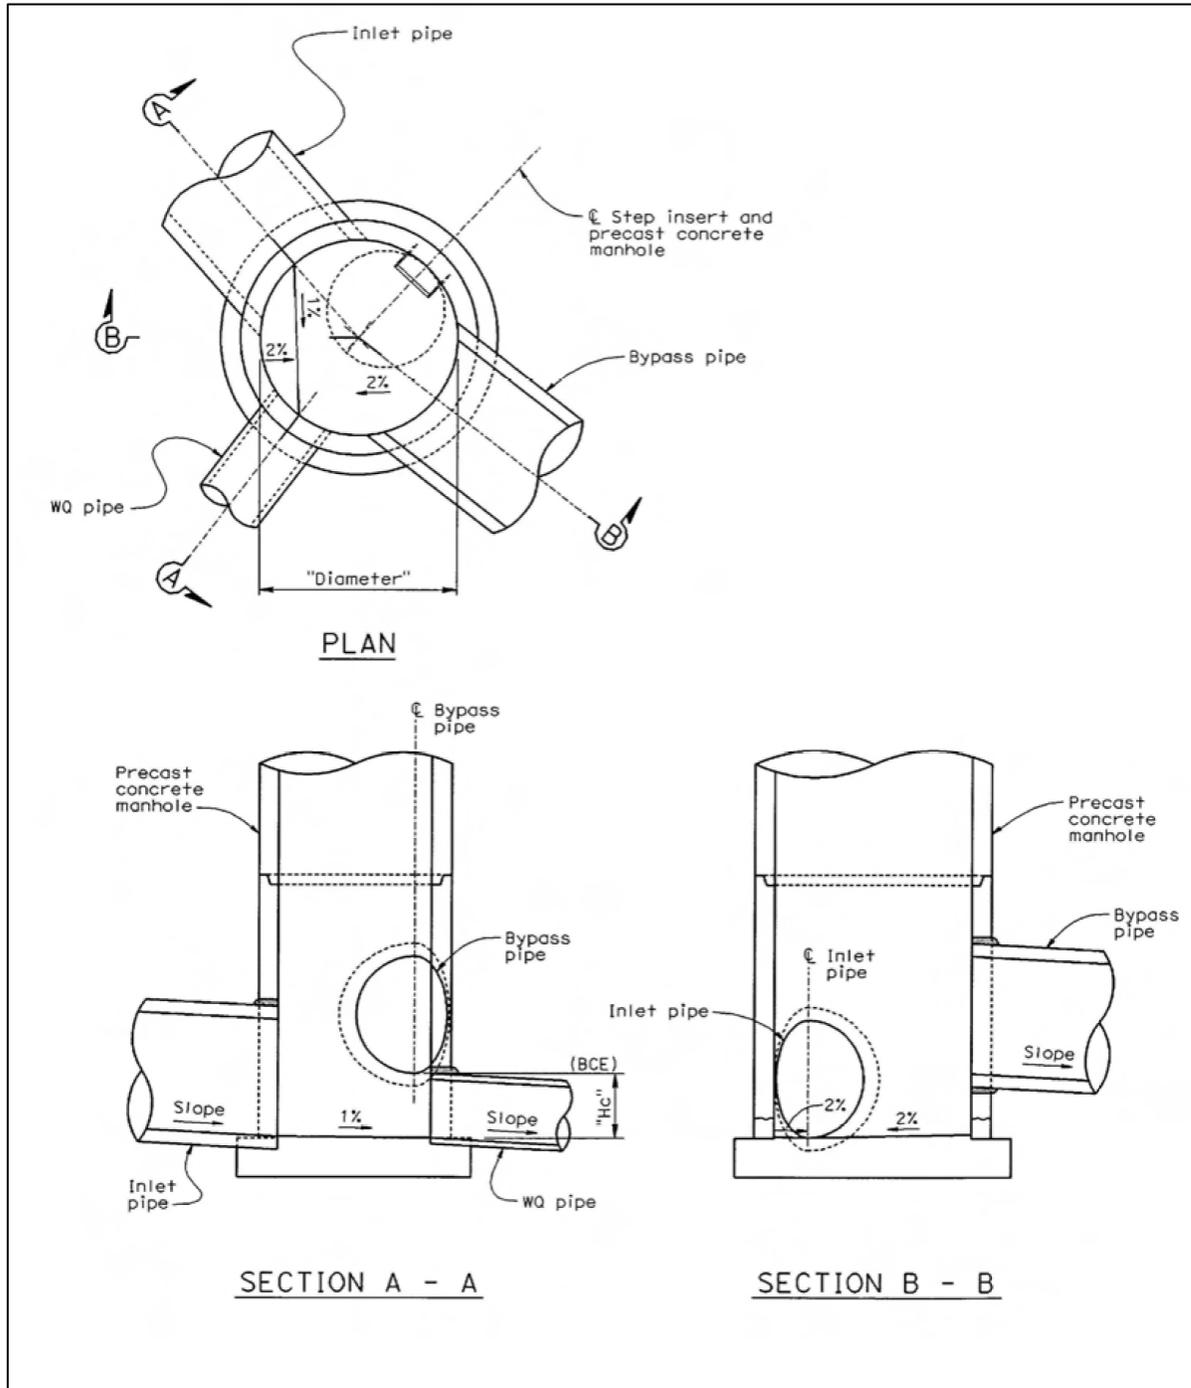
Figure 9: Sample Flow Splitter Design

**Flow Splitters:** The purpose of the flow splitter is to direct water quality flows (WQF) to the BMPs for stormwater treatment, while allowing peak flows to remain in their original watershed/discharge location (mimicking pre-project conditions). The splitter design shown in Figure 9 represents a typical vaulted flow splitter. Alternative designs may be evaluated in the final design phase for projects requiring these devices.

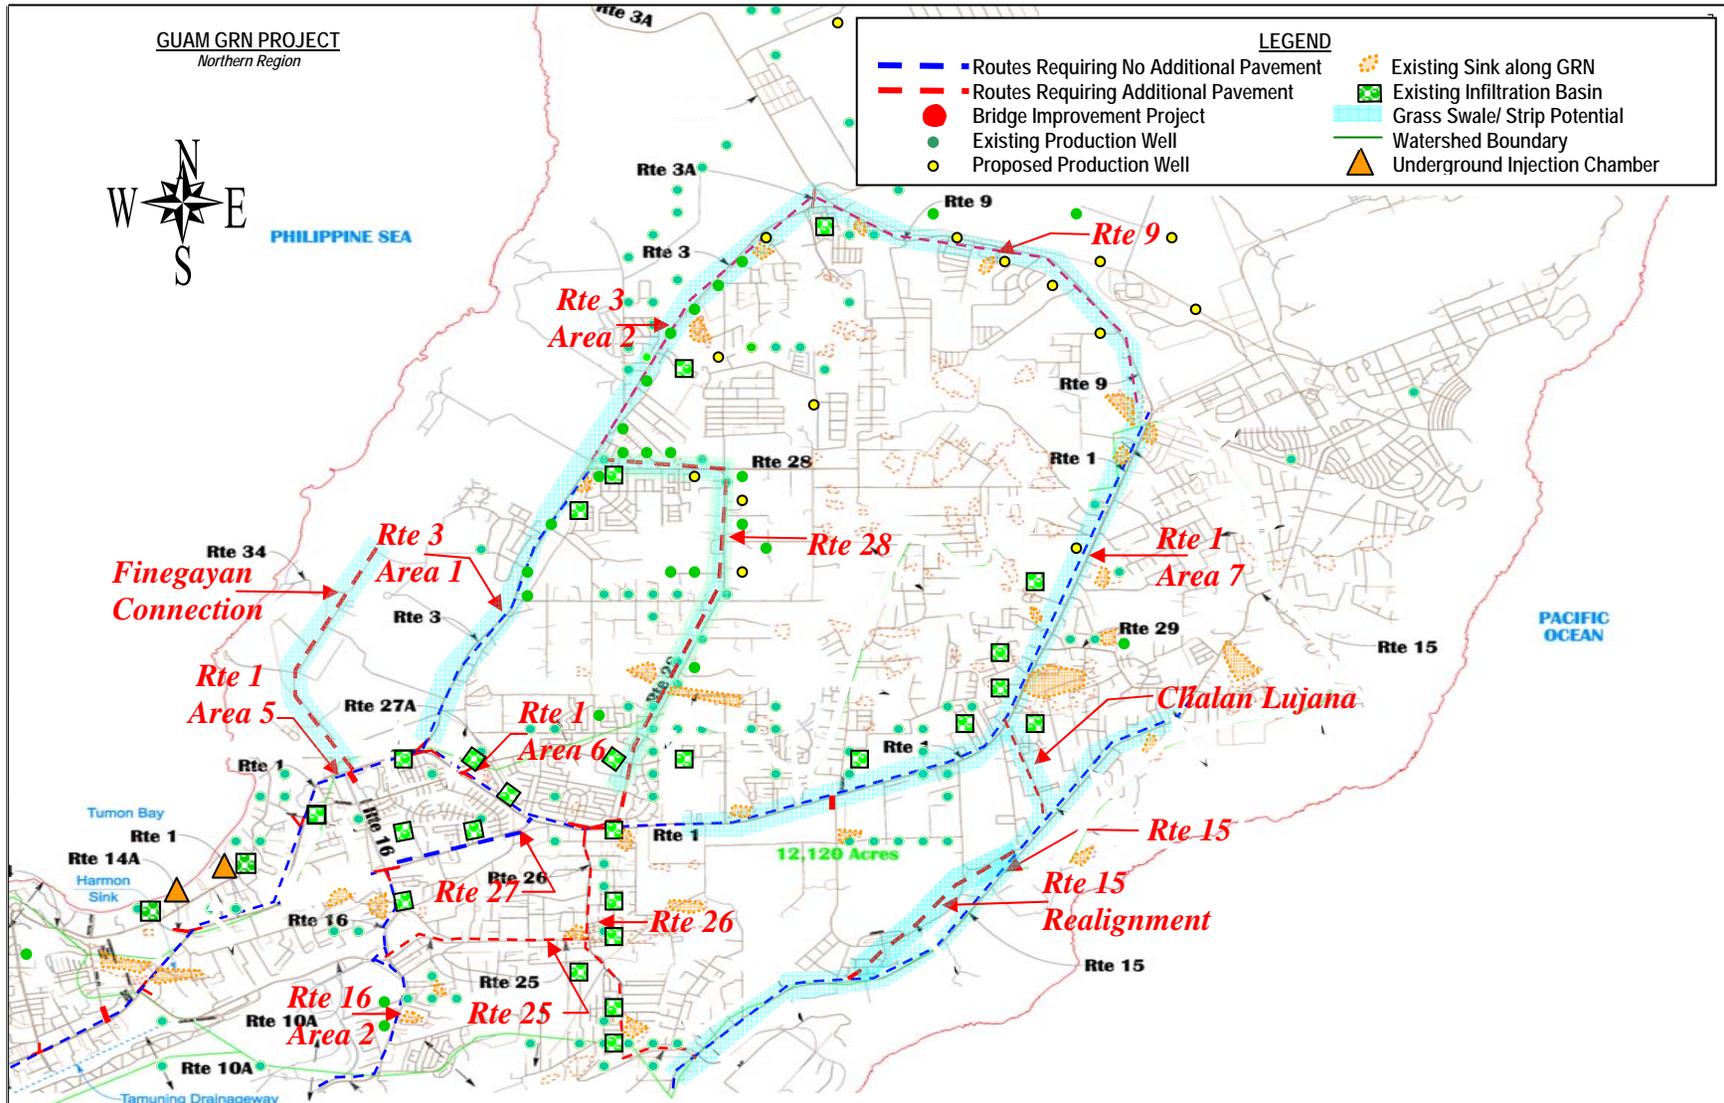
Figure11 North Guam Road Network Corridor Identification

**Rural Areas** - The corridors highlighted in blue in Figure 11 display road sections generally located in the more rural areas that have existing grass shoulders and/or swales generally of sufficient size to act as treatment BMPs for water pollution control of on-site drainage. GRN project designs for these areas should include road cross-sections that incorporate these existing features with grass shoulders designed to accommodate sheet flow (not concentrated flow) from the pavement as described in Section 4.4 (Biofiltration Strips). The existing sinks will act as outlets for the drainage systems. Capacity of existing infiltration devices to accommodate any changes in runoff volume due to the increase in impervious surfaces should be evaluated at the time of design and must satisfy the guiding principles of the regulatory agencies required at the time of the design (see Table 5). If infiltration capacity is insufficient to accommodate the widened roads, additional infiltration devices or increases in existing infiltration basin capacity may be required. Any new infiltration devices should be placed within government right-of-way and should be located as far as possible from any existing production wells (with a minimum separation distance of 1000 ft).

GRN Location (Figures 11 and 12)	Added Paved Area?	Water Quality Classification	General Location	Length (ft)	Total New Impervious Area (ac)	Total Disturbed Area (ac)	Is Onsite Flow Concentrated ?	Is There Adequate Area for Biofiltration Devices?	Are Soils and Groundwater Depths Adequate for Infiltration?	Is Area Tributary to NGL Aquifer?	Potential BMPs	Remarks
Rte 1, Area 1	No	Moderate	South Guam, Apra Harbor Area	16,247	0.0	17.9	No	Yes	No	No	Bioswales/ strips	See Section 7 for exist flooding issues.
Rte 1, Area 2	No	Moderate	South Guam, Piti Bay Area	24,009	0.0	31.5	No	Some Locations	No	No	Bioswales/ strips	
Rte 1, Area 3	No	Moderate	South Guam, Agana Bay Area	9,042	0.0	14.9	Yes	No	No	No	CB Retrofits	
Rte 1, Area 4	At Intersect'ns	Moderate	South Guam, Tamuning	9,042	1.0	15.9	Yes	No	No	Yes	Flow Splitter, Media Filter or Bioswale	See Section 7 for BMP location.
Rte 1, Area 5	At Intersect'ns	Moderate	North Guam, Harmon Sink	13,563	0.0	22.4	Yes	No	Yes	Yes	Existing Detention, Exist Infiltration	See Figure 11 for exist infiltration basins

Rte 1, Area 6	At Intersect'ns	Moderate	North Guam, Rte 3 to Rte 28	6,867	0.0	11.4	Yes	No	Yes	Yes	Exist Infiltration, Catch Basin Retrofits	See Figure 11 for exist infiltration basins
Rte 1, Area 7	No	Moderate	North Guam, Rte 28 to Rte 9	30,450	0.0	33.6	No	Yes	Yes	Yes	Exist Infiltration, Bioswales/ Strips	See Figure 11 for exist infiltration basins
Rte 2A	No	Moderate	South Guam, Atantano Watershed	4,577	0.0	5.0	No	Yes	Yes	No	Bioswales/ strips	
Rte 3, Area 1	No	Moderate	North Guam, Rte 1 to Rte 28	13,500	0.0	14.9	No	Yes	Yes	Yes	Exist Infiltration, Bioswales/ Strips	See Figure 11 for exist infiltration basins
Rte 3, Area 2	Yes	Moderate	North Guam, Rte 28 to Rte 9	16,050	14.7	23.6	No	Yes	Yes	Yes	Bioswales/ strips, Exist Infiltration	See Figure 11 for exist infiltration basins
Rte 5	Yes	Moderate	South Guam, Atantano Watershed	10,333	3.8	9.5	No	Yes	Yes	No	Bioswales/ strips	
Rte 8, Area 1	Yes	Moderate	South Guam, Rte 1 to Airport	8,290	0.0	13.7	Yes	No	Yes	Yes	CB Retrofits, Media Filters, Infiltration

Rte 16, Area 1	No	Moderate	South Guam, Rte 8 to Rte 10A	8,691	0.0	9.6	No	Yes	Yes	Yes	Infiltration, Bioswales/ strips	
Rte 16, Area 2	Yes	Moderate	North Guam at Rte 10A	5,448	3.0	9.0	Yes	No	Yes	Yes	Exist Infiltration	See Figure 11 for exist infiltration basins
Rte 16, Area 3	No	Moderate	North Guam, Rte 10A to Rte 27	4,505	0.0	7.4	Yes	No	Yes	Yes	Exist Infiltration	See Figure 11 for exist infiltration basins
Rte 25	Yes	Moderate	North Guam, Rte 16 to Rte 26	8,050	2.2	8.9	Yes	No	Yes	Yes	Exist Infiltration	See Figure 11 for exist infiltration basins
Rte 26	Yes	Moderate	North Guam, Rte 15 to Rte 1	12,900	3.6	14.2	Yes	No	Yes	Yes	Exist Infiltration, Bioswales/ Strips	See Figure 11 for exist infiltration basins
Rte 27	No	Moderate	North Guam, Rte 16 to Rte 1	5,448	0.0	9.0	Yes	No	Yes	Yes	Exist Infiltration	See Figure 11 for exist infiltration basins
Rte 28	Yes	Moderate	North Guam, Rte 1 to Rte 3	21,000	13.5	25.1	No	Yes	Yes	Yes	Exist Infiltration, Bioswales/ Strips	See Figure 11 for exist infiltration basins

Chalan Lujana	Yes	Moderate	North Guam, Rte 15 to Rte 1	4,350	1.2	3.6	No	Yes	Yes	Yes	Infiltration, Bioswales/ strips	See Figure 11 for exist infiltration basins
Finegayan Conn	Yes	Moderate	North Guam, Rte 1 & Rte 16	18,910	17.4	30.4	No	Yes	Yes	Yes	Infiltration, Bioswales/ strips

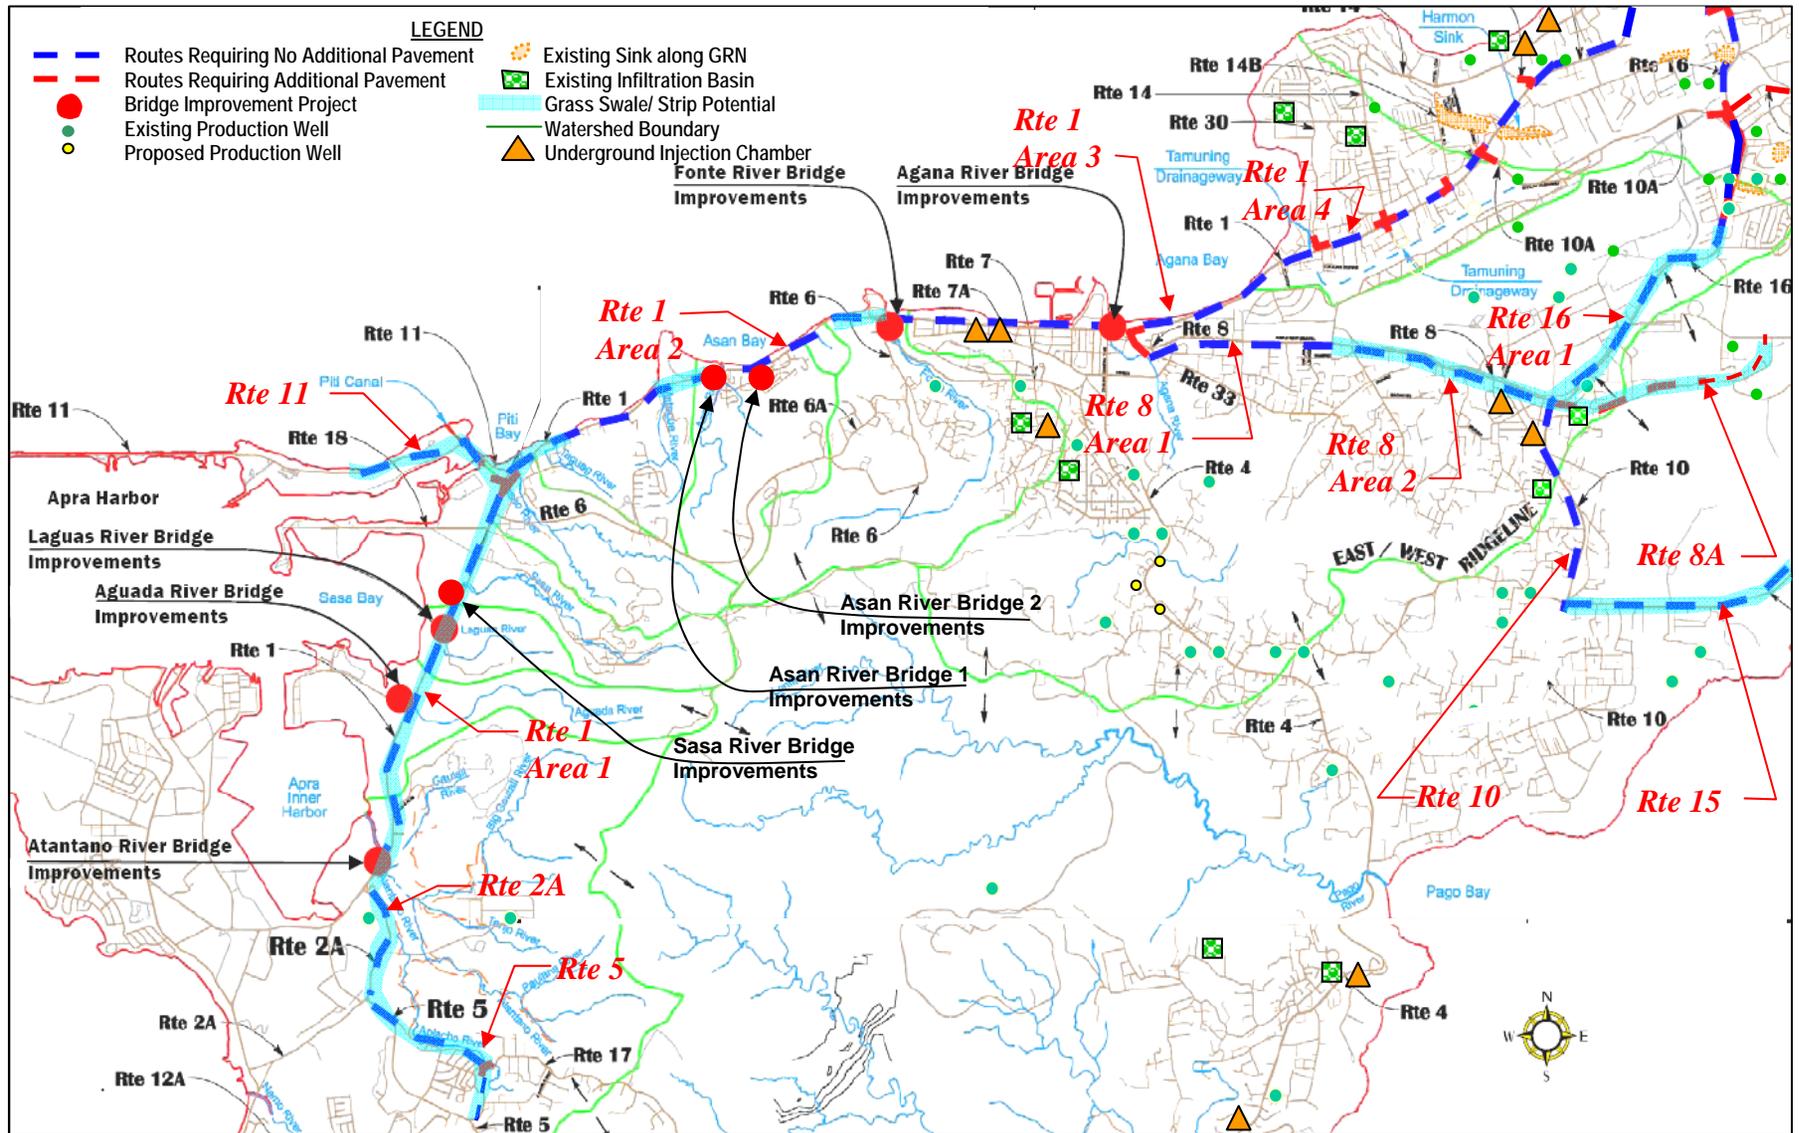
Figure 12 South Guam Road Network Corridor Identification

In Southern Guam, surface drainage generally flows to one of the numerous rivers that traverse the area (with the exception of portions of Route 8 and Route 10 where runoff enters existing manmade infiltration devices or natural sinks and infiltrates into the ground). Figure 12 displays the proposed GRN roadway projects within South Guam. The corridors highlighted in blue display roadway sections that have existing grass shoulders and/or swales generally of sufficient size to act as treatment BMPs for water pollution control of on-site drainage. Projects for the GRN within the south area of Guam mainly involve pavement strengthening with the exception of several intersection improvement projects and 8 bridge replacement projects. The discussion below provides an overview of the drainage patterns within the area though there may be localized ponding issues that need to be addressed during the design phase that may not be described in this section. Therefore, each project will require a specific drainage review that addresses localized ponding/flooding issues.

**Bridge Crossing Replacement Projects** - Several bridge crossings are to be replaced along the rural portion of Route 1 (see Figure 12 and Appendix F). Bridges and associated approach slabs within all areas generally concentrate flow since they are curbed. On-site runoff from the bridges must not be allowed to flow directly to the stream below through openings in the bridge. Instead, the runoff from the bridges should be directed to asphalt concrete (AC) spillways where the curbs beyond the bridge approach slabs generally end. Some form of energy dissipation such as rip rap will be required at the downstream end of the AC spillway to prevent erosion of the road embankment. The bridges also provide conveyance of off-site flows under the roadway. Off-site runoff design requirements are generally limited to source control BMPs such as streambank stabilization. Embankment stabilization in the vicinity of the bridges is important since embankment erosion is evident at all bridge sites. In order to control the erosion, simple source control improvements are recommended. These include improvements such as the placement of rip rap or gabions along the river's embankment immediately upstream and downstream of the bridges, concrete channel lining along the river's embankment, and/or wing wall replacement where necessary. The extent of the proposed improvements will be provided on a per-project basis during the design phase. Tables 7 and 8 show the GRN corridors and related projects which require bridge crossing replacement.

Flooding is prevalent along Route 1 in the vicinity of Apra Harbor from the Sasa River Bridge to the Atantano River Bridge (designated as Route 1, Area 1 in Figure 12). Here, the roadway is located above the tidal zone of the various rivers that flow to Apra Harbor. It has been noted that at periods of high tide and high flow in the river, the river's water surface is elevated above the outer pavement for Route 1 (which is generally crowned in this area). This has been observed

Rte 8, Area 2	No	Moderate	South Guam, Airport Area	7,904	0.0	8.7	No	Yes	Yes	Yes	Bioswales/ strips, Existing Injection Wells w/ Infiltration	See Figure 12 for exist injection wells
Rte 8A	Yes	Moderate	South Guam, East of Rte 10	8,865	3.3	8.2	No	Yes	Yes	Yes	Bioswales/ strips, Infiltration	
Rte 9	Yes	Moderate	North Guam, Rte 3 to Rte 1	15,500	8.5	17.1	No	Yes	Yes	Yes	Bioswales/ strips, Infiltration	See Figure 11 for exist infiltration basins
Rte 10	No	Moderate	South Guam, Rte 8 to Rte 15	7,847	0.0	8.6	Yes	No	Yes	Yes	Infiltration	See Figure 12 for exist infiltration basins
Rte 11	No	Moderate	South Guam, Apra Harbor Area	10,630	0.0	5.9	Yes	Yes	No	No	Bioswales/ strips	
Rte 15	No	Moderate	North/ South Guam, Rte 10 to Quarry North of Chalan Lujana	47,600	0.0	26.2	No	Yes	Yes	Yes	Infiltration, Bioswales/ strips	
Rte 15 Realignment	Yes	Moderate	North Guam, Rte 15 South of Ch Lujana	11,200	7.7	15.4	No	Yes	Yes	Yes	Infiltration, Bioswales/ strips

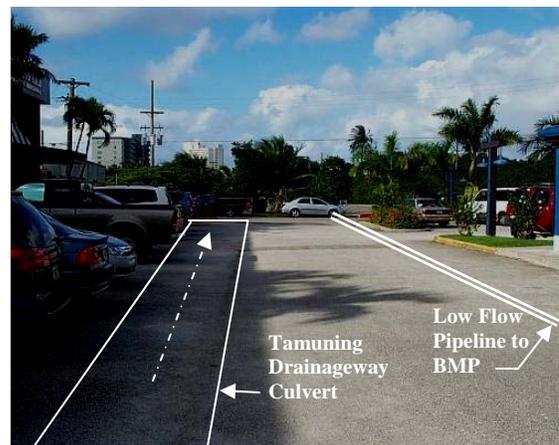
Figure 13 BMP Concept Tamuning Drainageway - 1

The drainage system for Route 1 in the vicinity of Tamuning is a large storm drain system that conveys flow to a single point of concentration, the Tamuning Drainageway. Strategic placement of a BMP at this location would enable treatment for several upstream projects. During design, the feasibility of a flow splitter placed in the on-site storm drain system at the Tamuning Drainageway should be evaluated. This could allow low flow roadway runoff to be directed to a treatment BMP located off-site, preferably on public property (see Figures 13 and 14). This may require a right of way easement for the incorporation of a low flow pipeline to the BMP location. Potential treatment for this location includes construction of a bioswale or media filter at the outlet.

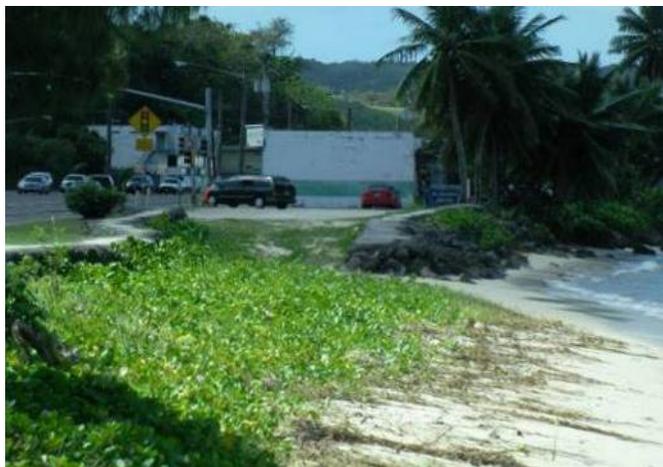
Figure 15: Coastal Erosion Protection along Rte 1

Flood Hazard Zone V or VE which is defined as a coastal flood zone with velocity hazard due to wave action. Currently, these areas are protected from erosion by gabion walls or rip rap slope protection. Figure 15 shows a typical area along Route 1 within the coastal flood zone and where coastal erosion control has been used along the embankment in the form of riprap revetment. Field investigations indicate that several sections of the coastline within the limits of Route 1, Area 2 (see Figure 12) have little to no protection. Coastal erosion appears to encroach into the roadway right-of-way at one or two locations within this area.

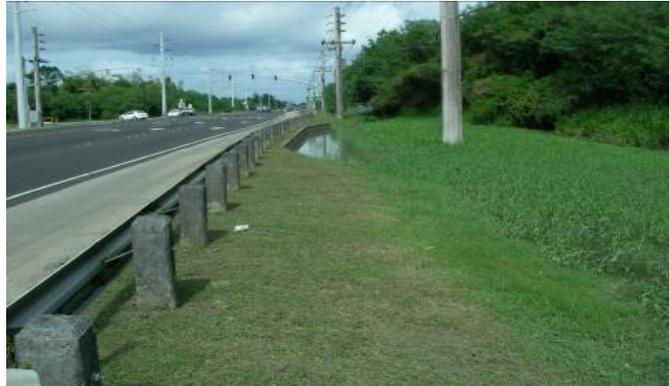
*Figure 16: Route 1 Flood Prone Area – Apra Harbor*

to occur at a frequency of approximately once every two years. Figure 16 displays a cross-culvert in this area during normal high tide condition. The only way to remedy this situation is to raise the road surface which is beyond the scope of the GRN projects since the only work to be done in this area is with respect to pavement strengthening. In order to improve the drainage in this area (i.e. the area designated as Route 1, Area 1 in Figure 12), it is recommended that the grass shoulders be graded to drain (currently the grass shoulder is allowed to grow onto the pavement causing flow to concentrate along the edge of pavement, rendering sheet flow ineffective). The level of the adjacent ground surface should be at the elevation of the edge of pavement and the grass shoulders should slope away from the pavement. This will: 1) improve the drainage characteristics for this area, 2) enable use of the grass shoulders as treatment devices, 3) promote infiltration of the roadway runoff prior to entering the offsite receiving waters, and 4) improve flooding characteristics from offsite flows.

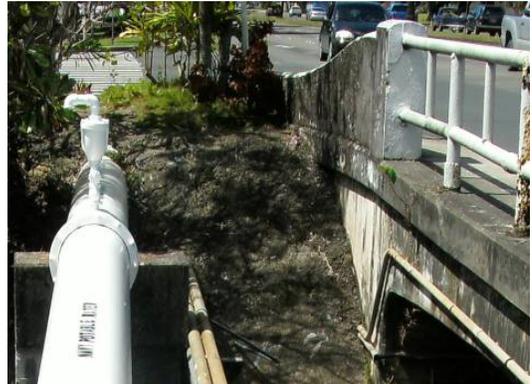
*Figure F-1 Agana Bridge Upstream Embankment*

- Agana Bridge - This concrete structure spans 42 ft over the Agana (Hagatna) River for a length of 87 ft under Route 1 and shows signs of decay through severe cracking, delamination and spalling of concrete. Erosion along the abutments was apparent on the upstream side of the bridge (see Figure F-1).

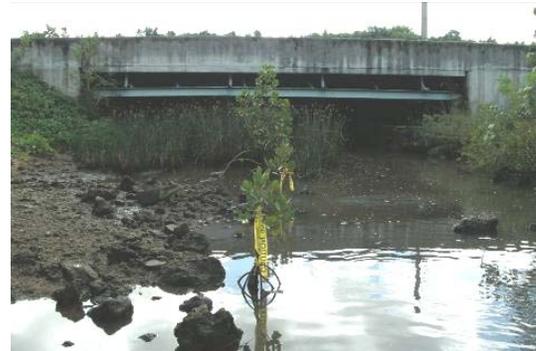
*Figure F-2 Laguas Bridge Upstream Section*

- Laguas Bridge - This single span box girder bridge spans 46 ft over Laguas River for a length of 81 ft under Route 1. The bridge exhibits moderate cracking and spalling in the beams and scour in the north abutment. The bottom of the channel upstream of the bridge had been removed of vegetation, increasing erosion potential along the channel bottom (see Figure F-2).

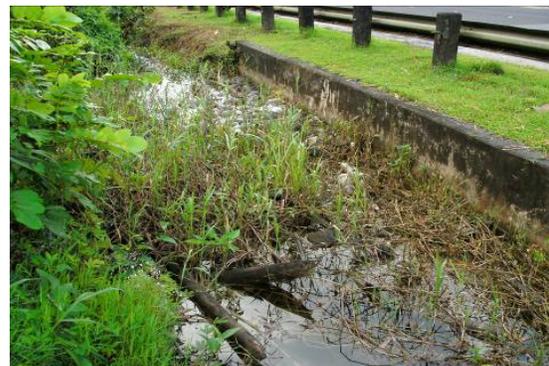
*Figure F-3 Agueda Bridge Downstream Obstructions*

- Agueda Bridge - This 3-barrel concrete box culvert spans 27 ft over the Agueda River for a length of 81 ft under Route 1. Downstream obstructions have produced backwater effects upstream of the culvert (see Figure F-3), since at the time of inspection, the culvert openings were inundated. Erosion was apparent at the upstream wingwalls.

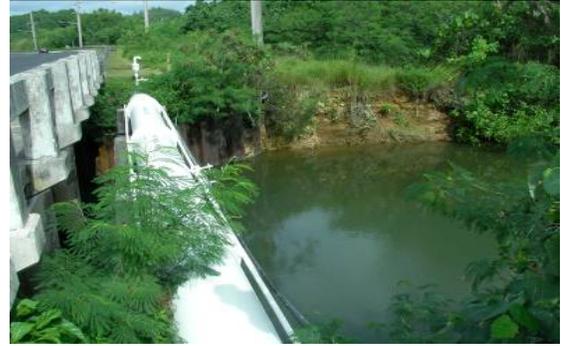
*Figure F-4: Rte 1 at Atantano Bridge*

- Atantano Bridge - This 3-span cast-in-place concrete T-beam structure spans 46 ft over the Atantano River for a length of 81 feet under Route 1. Abutment settlement, cracking of the pier walls and deck and spalling at the deck corners is apparent. Vegetation along the channel embankment is thick with some apparent erosion under the high water mark, leaving the embankments unlined at several locations (see Figure F-4). Here, the embankment exhibits relatively steep slopes which could lead to additional erosion along the upstream segment.

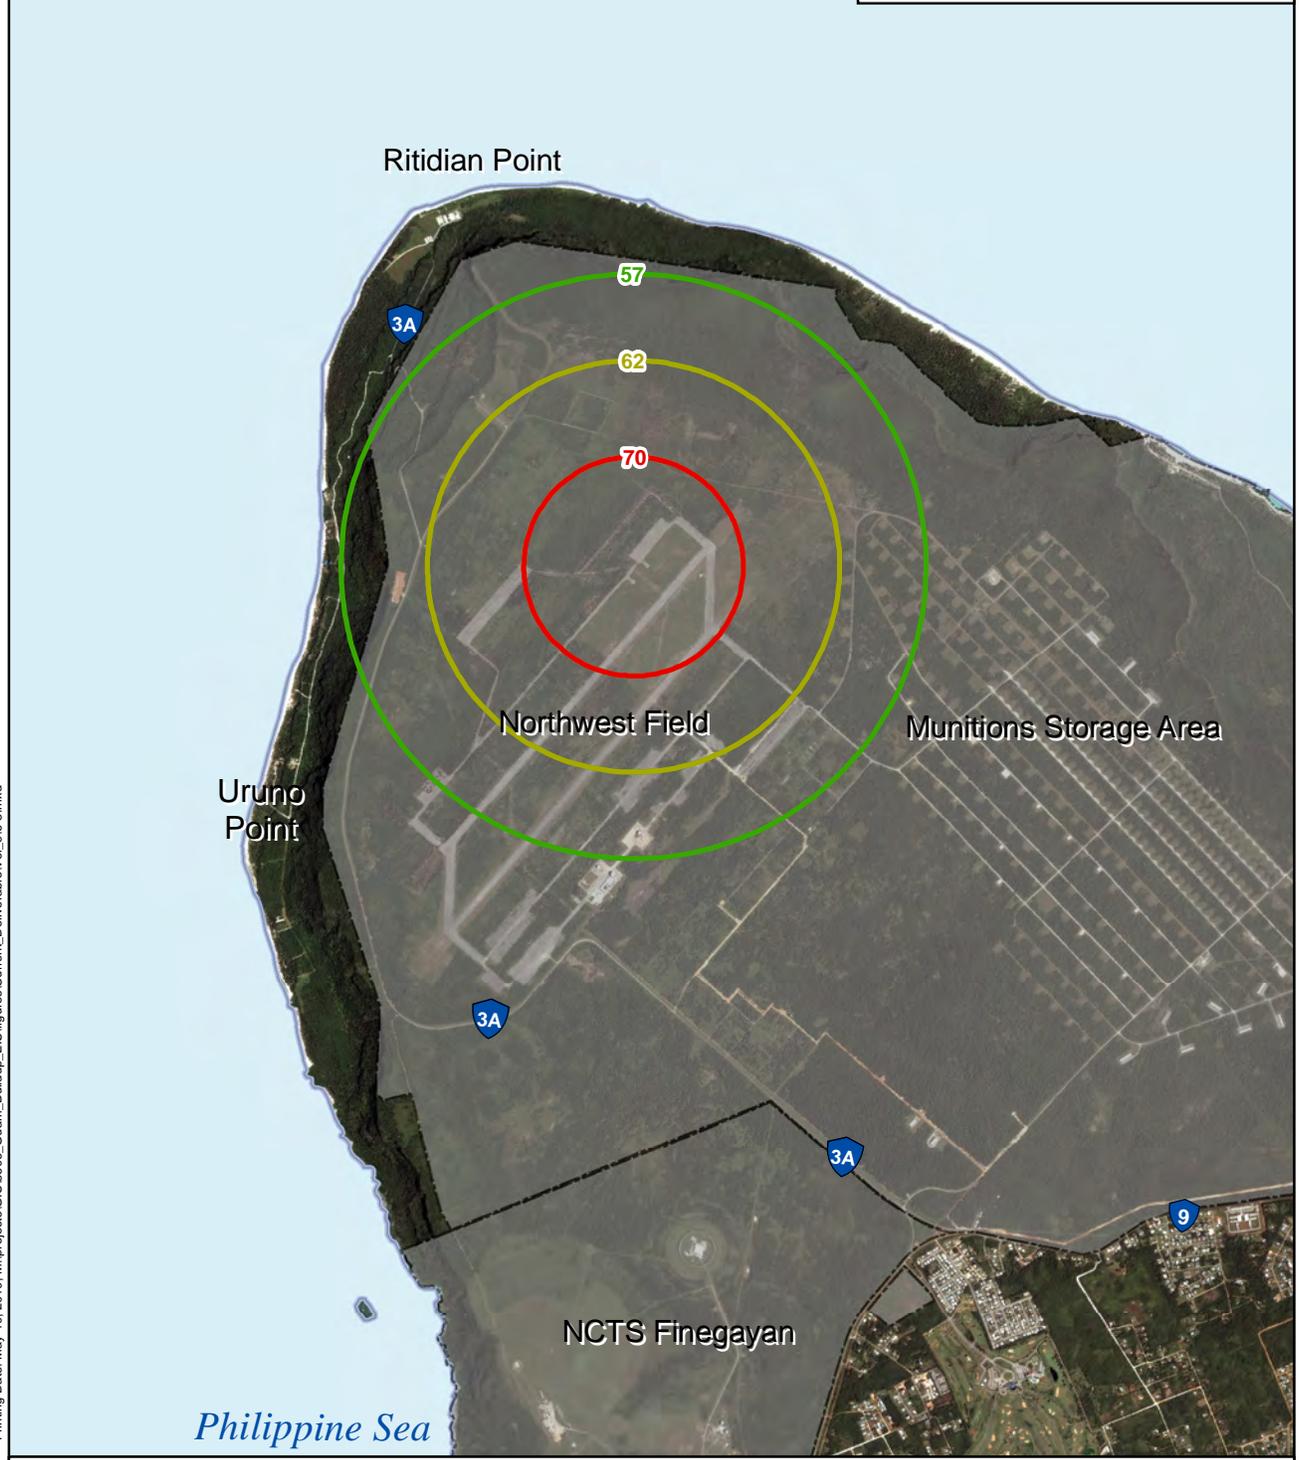
**Figure 6-3**  
Existing Demolition Operational Noise Contours at Northwest Field

<b>Appendix Figure</b>	<b>EIS Figure</b>
6-1: Existing Noise Contours at Andersen AFB	6.1-2: Existing Noise Contours at Andersen AFB
6-2: Proposed Noise Contours at Andersen AFB	6.2-1: Proposed Noise Contours at Andersen AFB
6-3: Existing Demolition Operational Noise Contours at Northwest Field	6.1-3: Existing Demolition Operational Noise Contours at Northwest Field
6-4: Projected Demolition Operational Noise Contours	6.2-2: Projected Demolition Operational Noise Contours
6-5: Aviation Training Noise Contours at Andersen South	6.2-3: Aviation Training Noise Contours at Andersen South
6-6a: Noise Contours and Complaint Risk Contours for the Breacher House and Hand Grenade Range - Alternative A	6.2-4: Noise Contours and Complaint Risk Contours for the Breacher Houses and Hand Grenade Range
6-6b: Noise Contours and Complaint Risk Contours for the Breacher House and Hand Grenade Range - Alternative B	6.2-4: Noise Contours and Complaint Risk Contours for the Breacher Houses and Hand Grenade Range

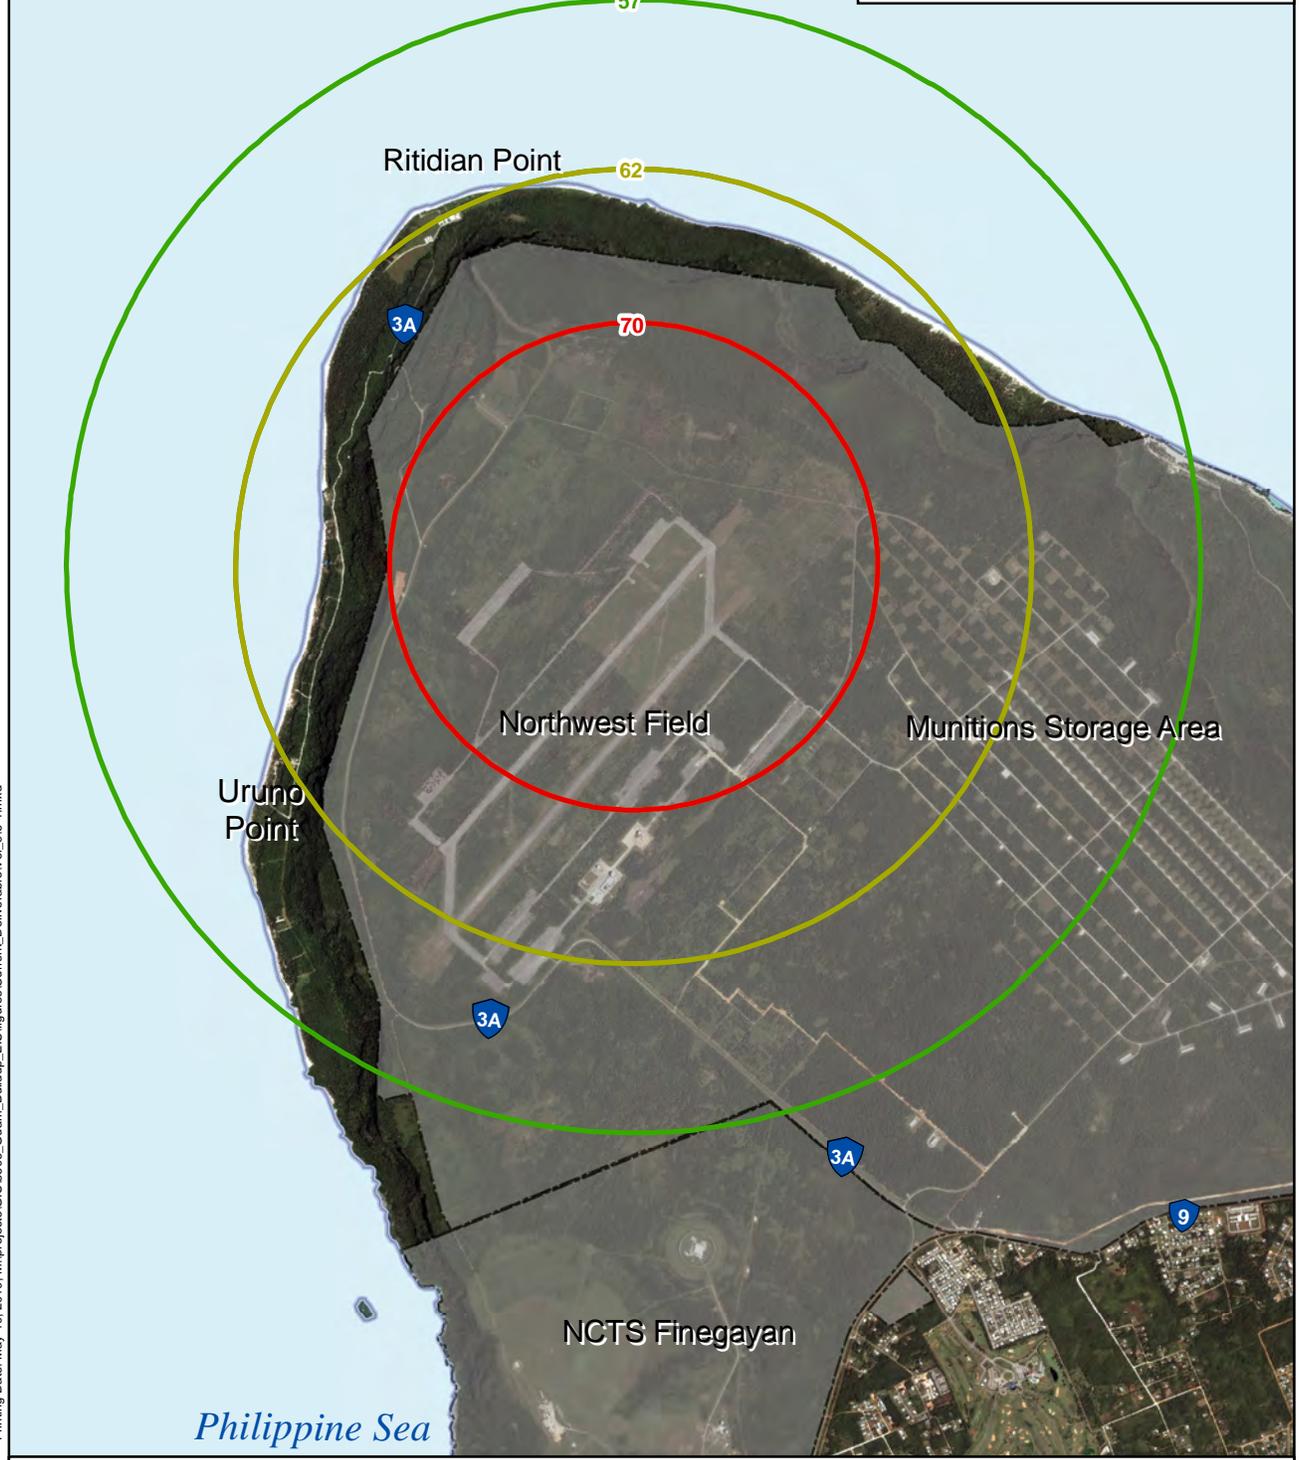
**Figure 6-4**  
**Projected Demolition Operational Noise Contours**

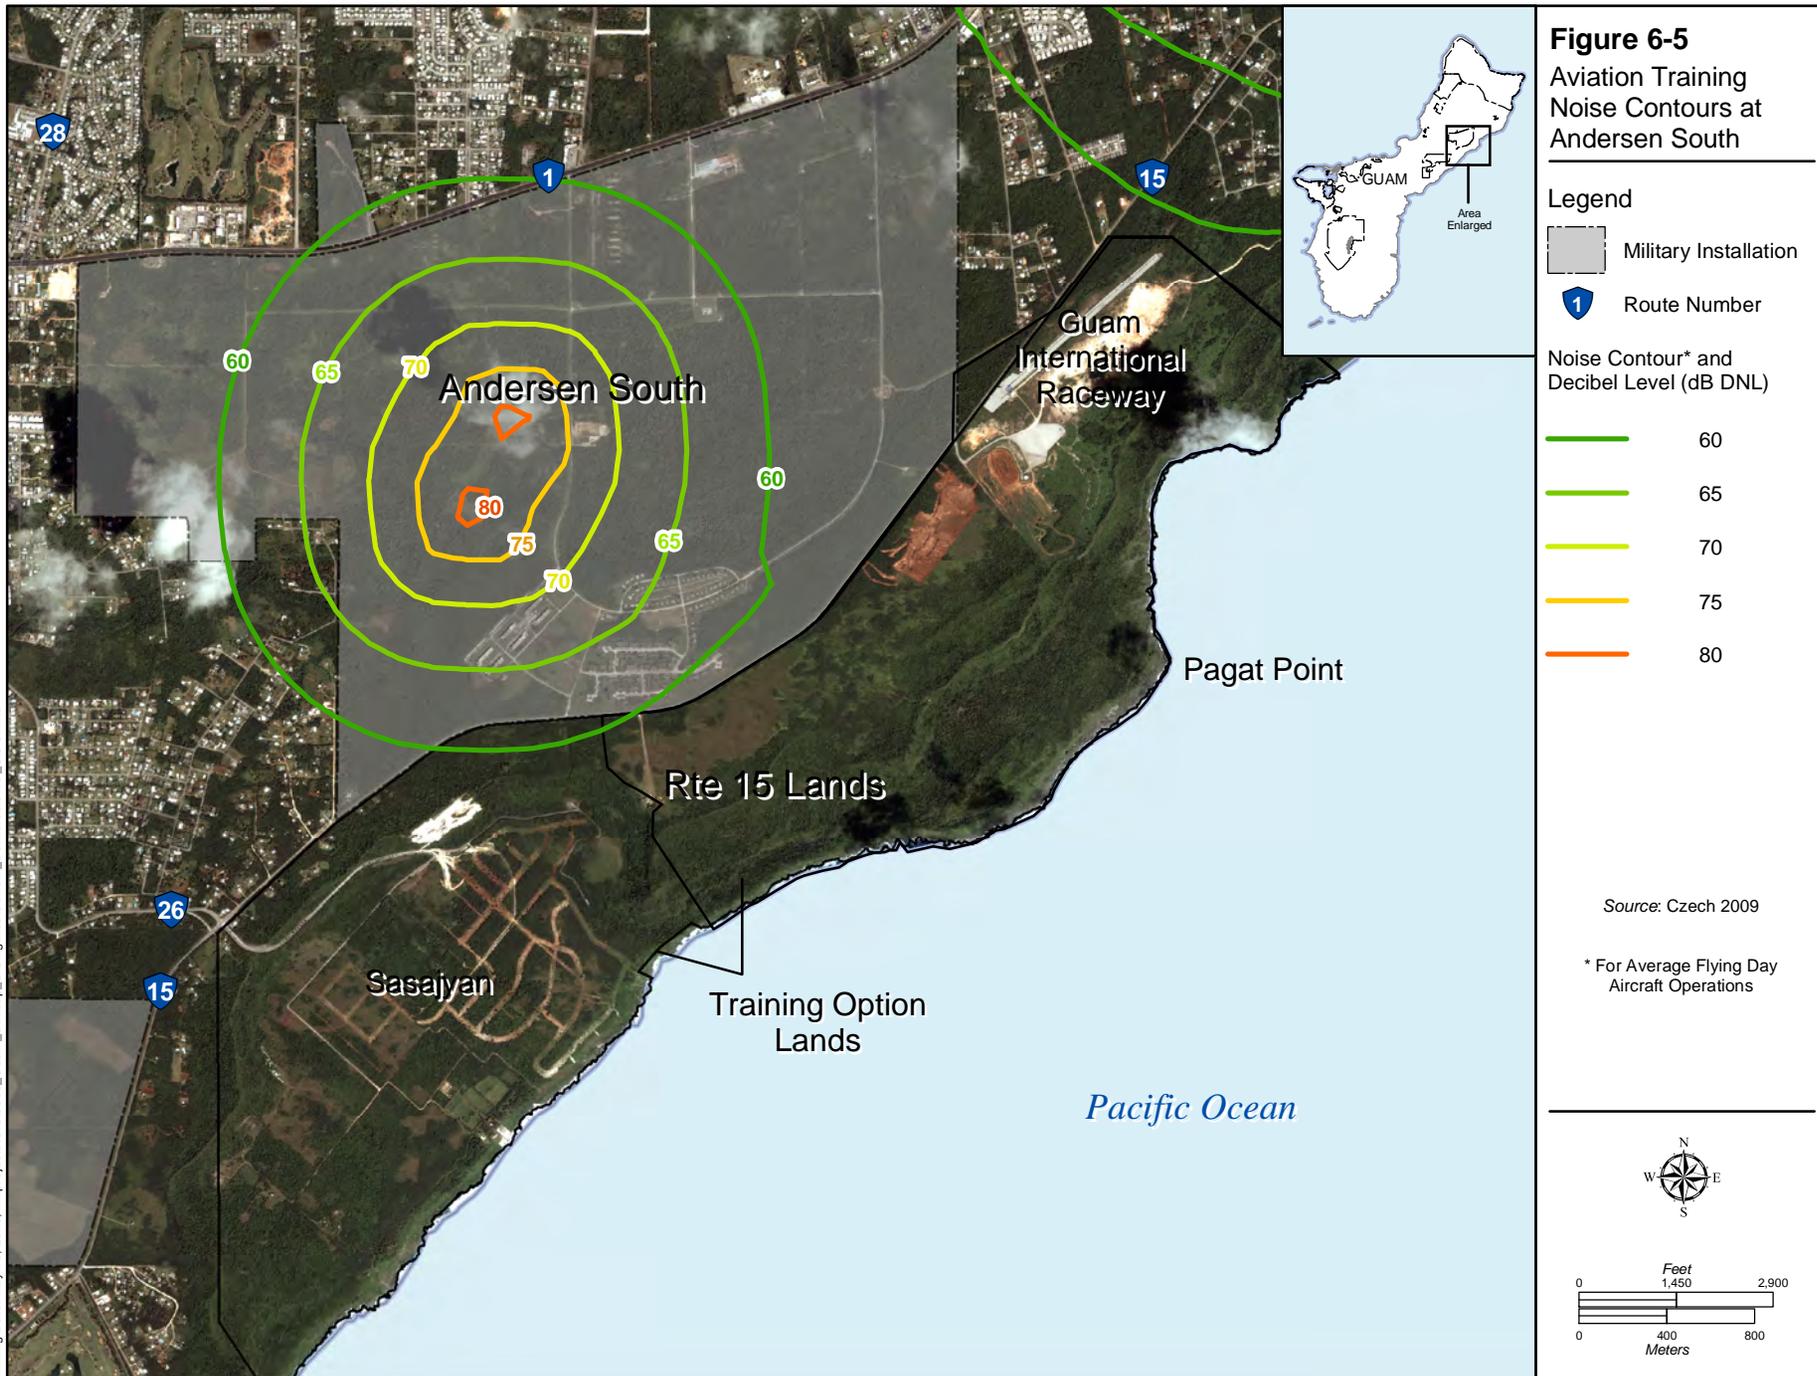
**Figure 6-5**  
 Aviation Training  
 Noise Contours at  
 Andersen South
