## Appendix G

### EIS Resource Technical Appendix

# Guam and CNMI Military Relocation EIS

## Volume 9: EIS Resource Technical Appendix

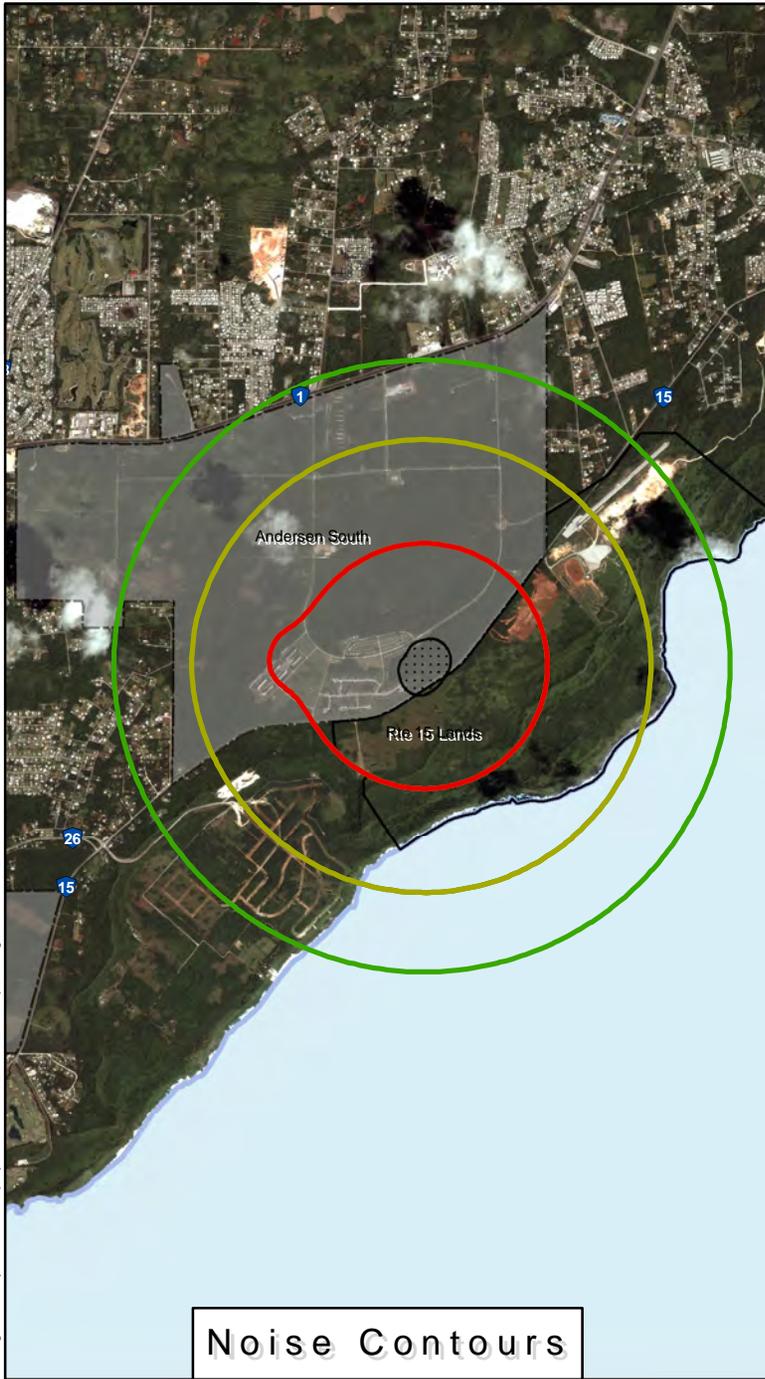
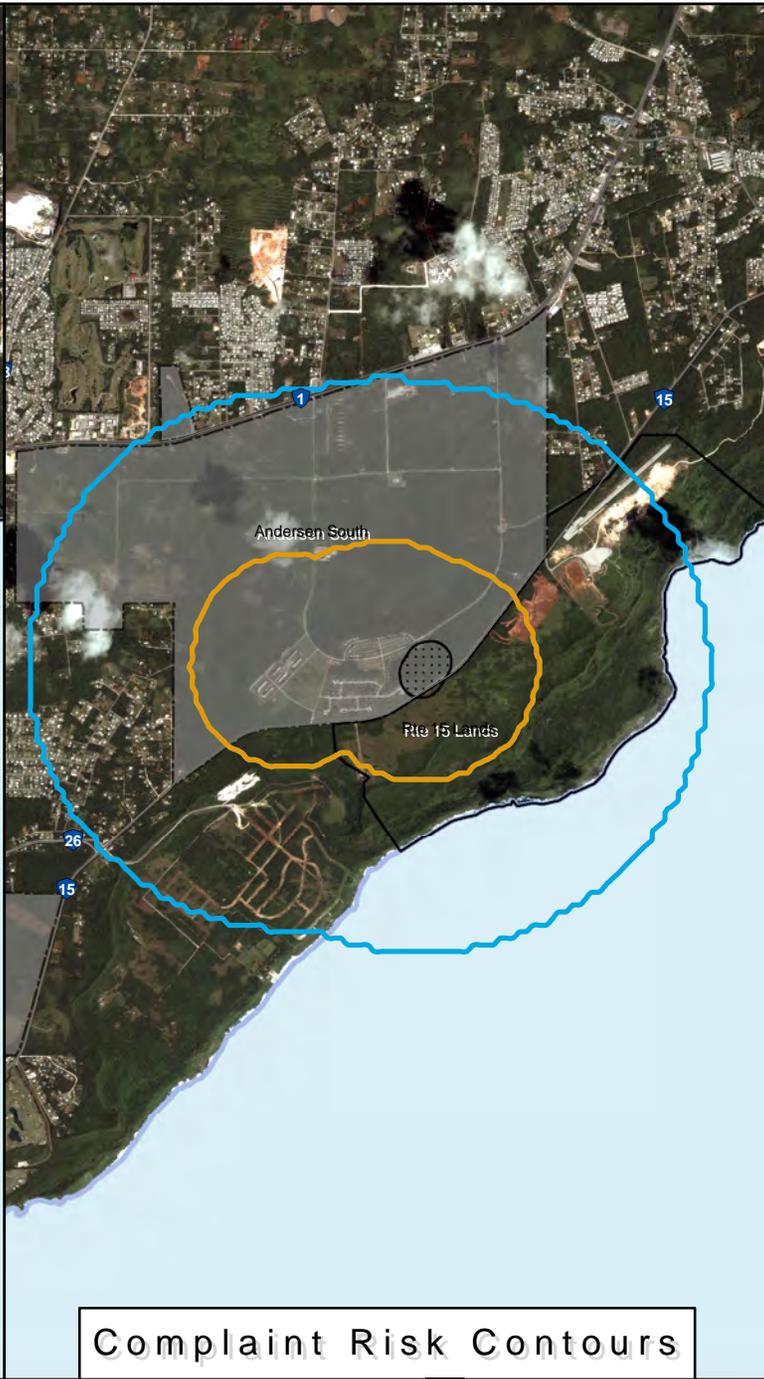
Noise Contours

Complaint Risk Contours

**Figure 6-6a**  
Noise Contours and  
Complaint Risk  
Contours for the  
Breacher House  
and Hand Grenade  
Range - Alternative A

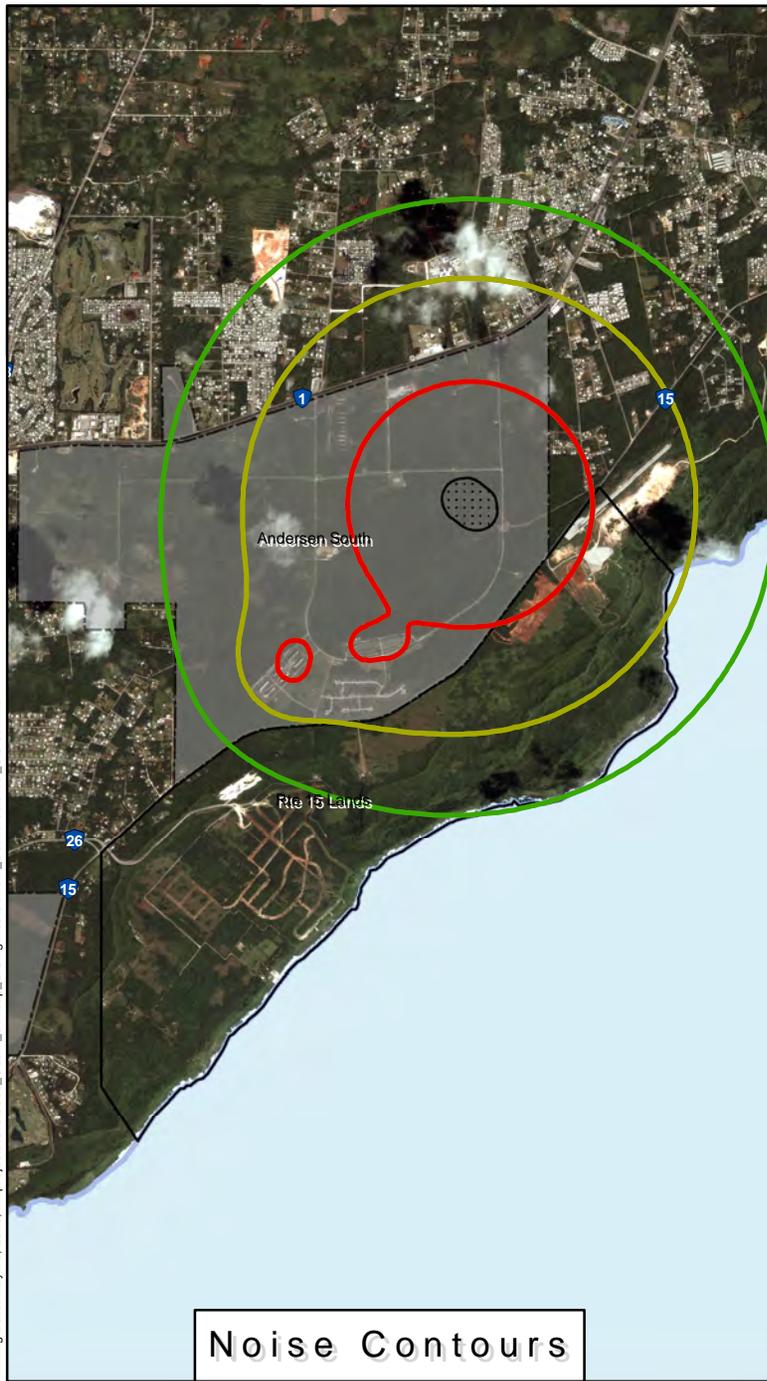
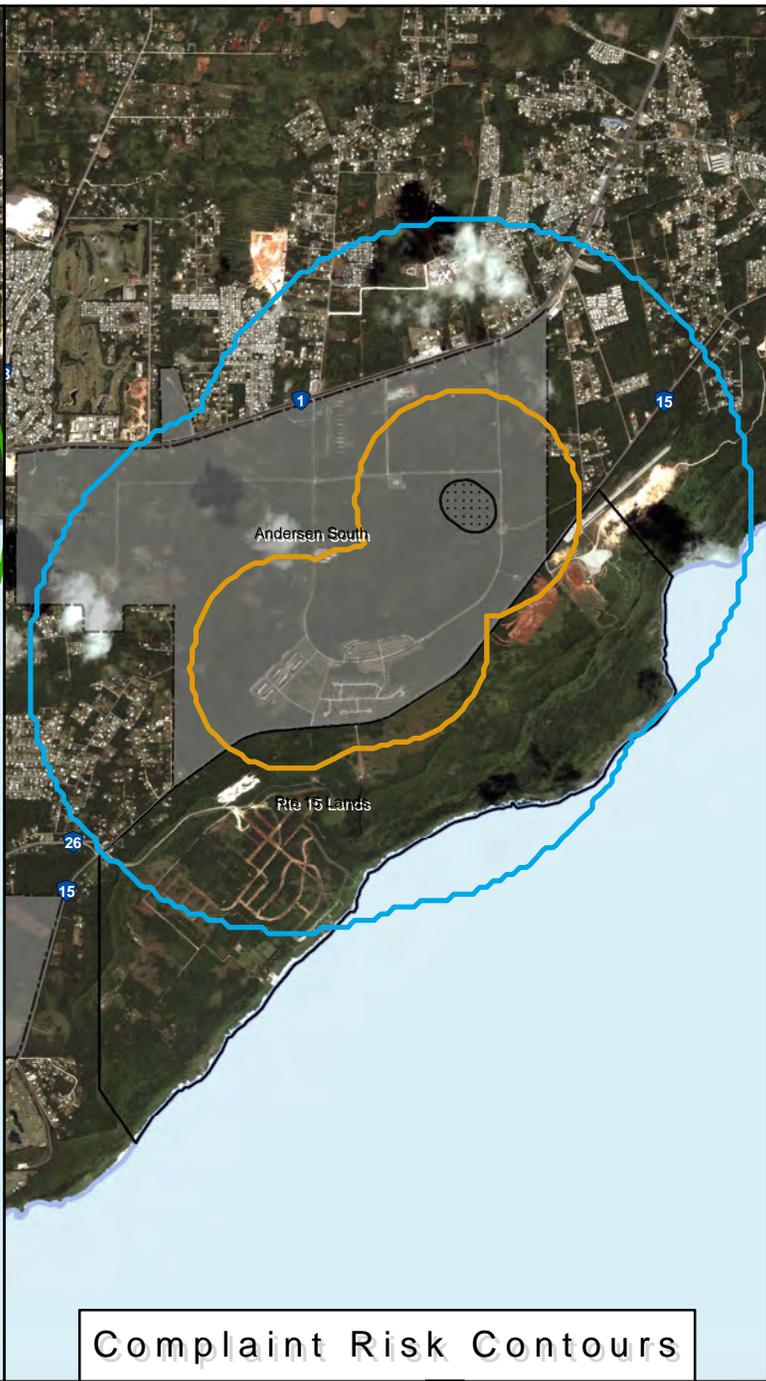
**Figure 6-6b**  
Noise Contours and  
Complaint Risk  
Contours for the  
Breacher House  
and Hand Grenade  
Range - Alternative B

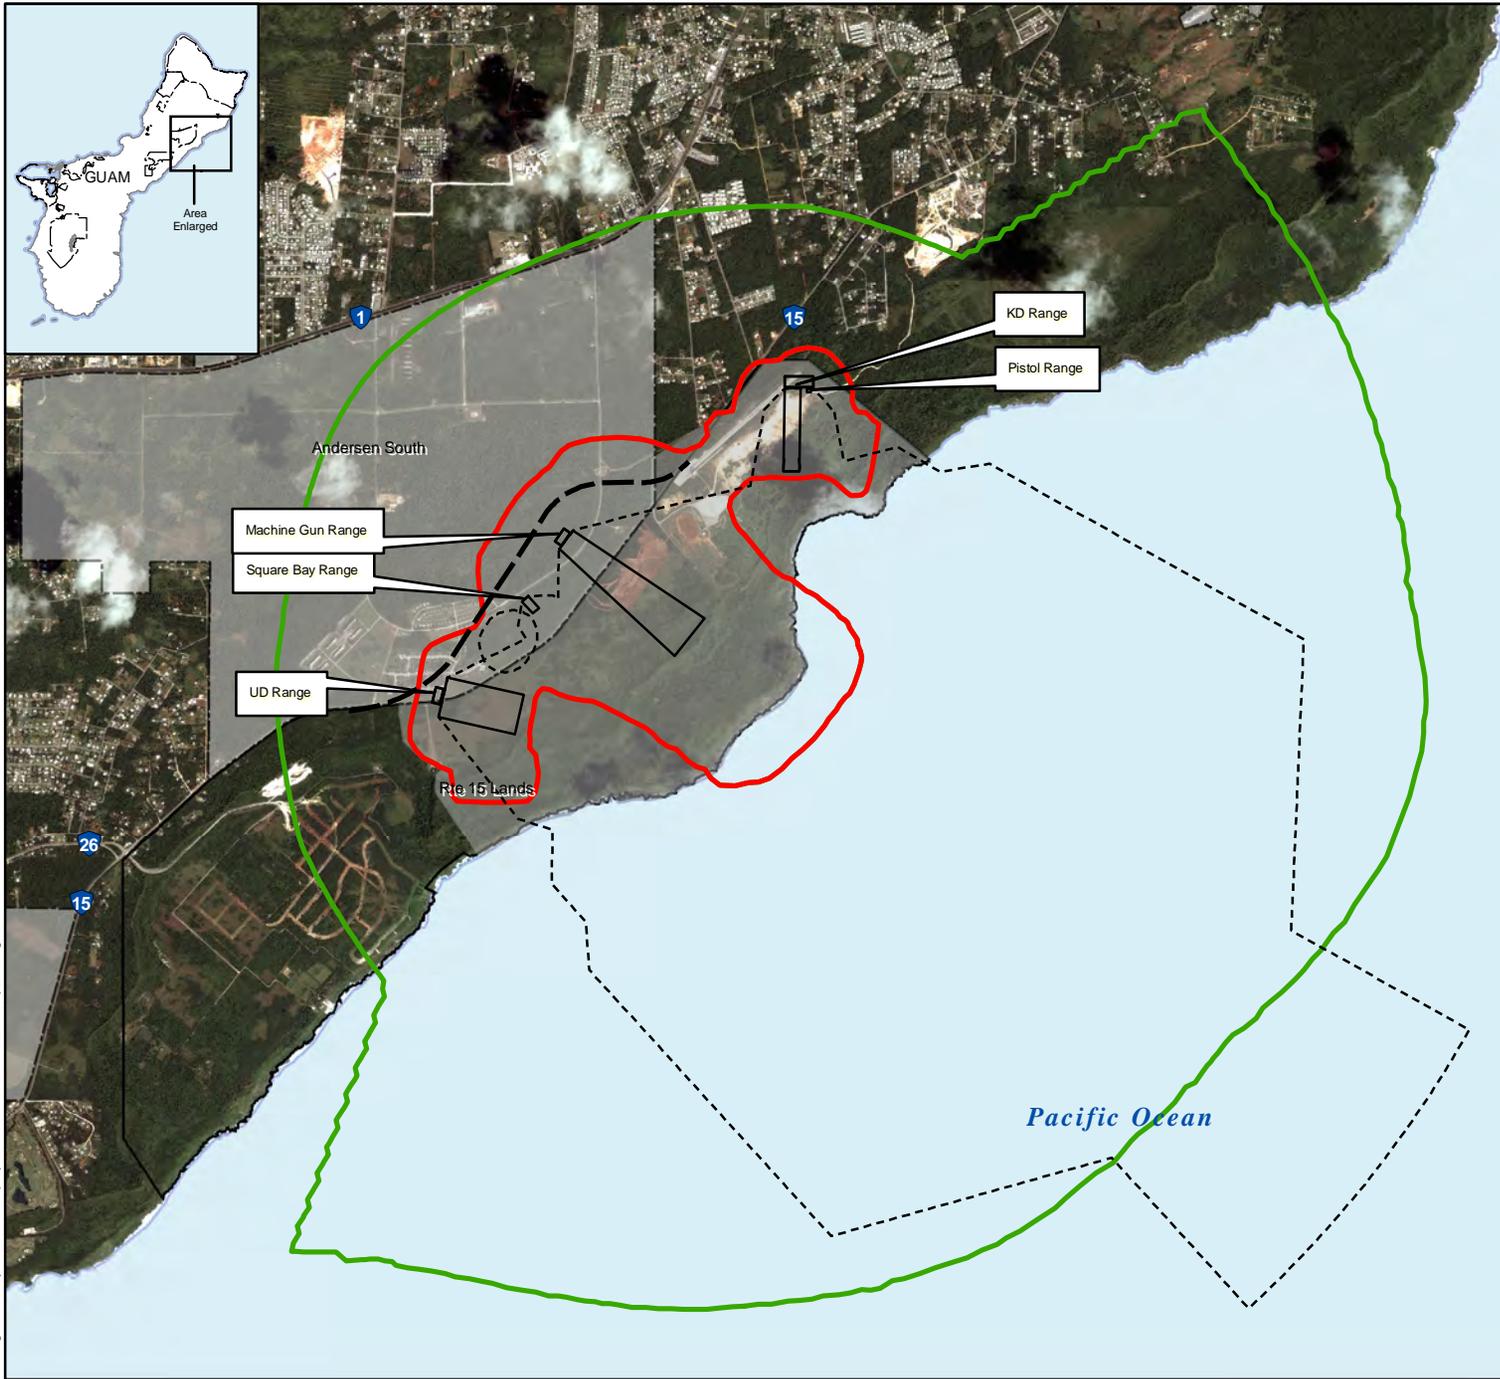
**Figure 6-7a**  
Noise Contours for  
Route 15 Small  
Arms Ranges -  
Alternative A

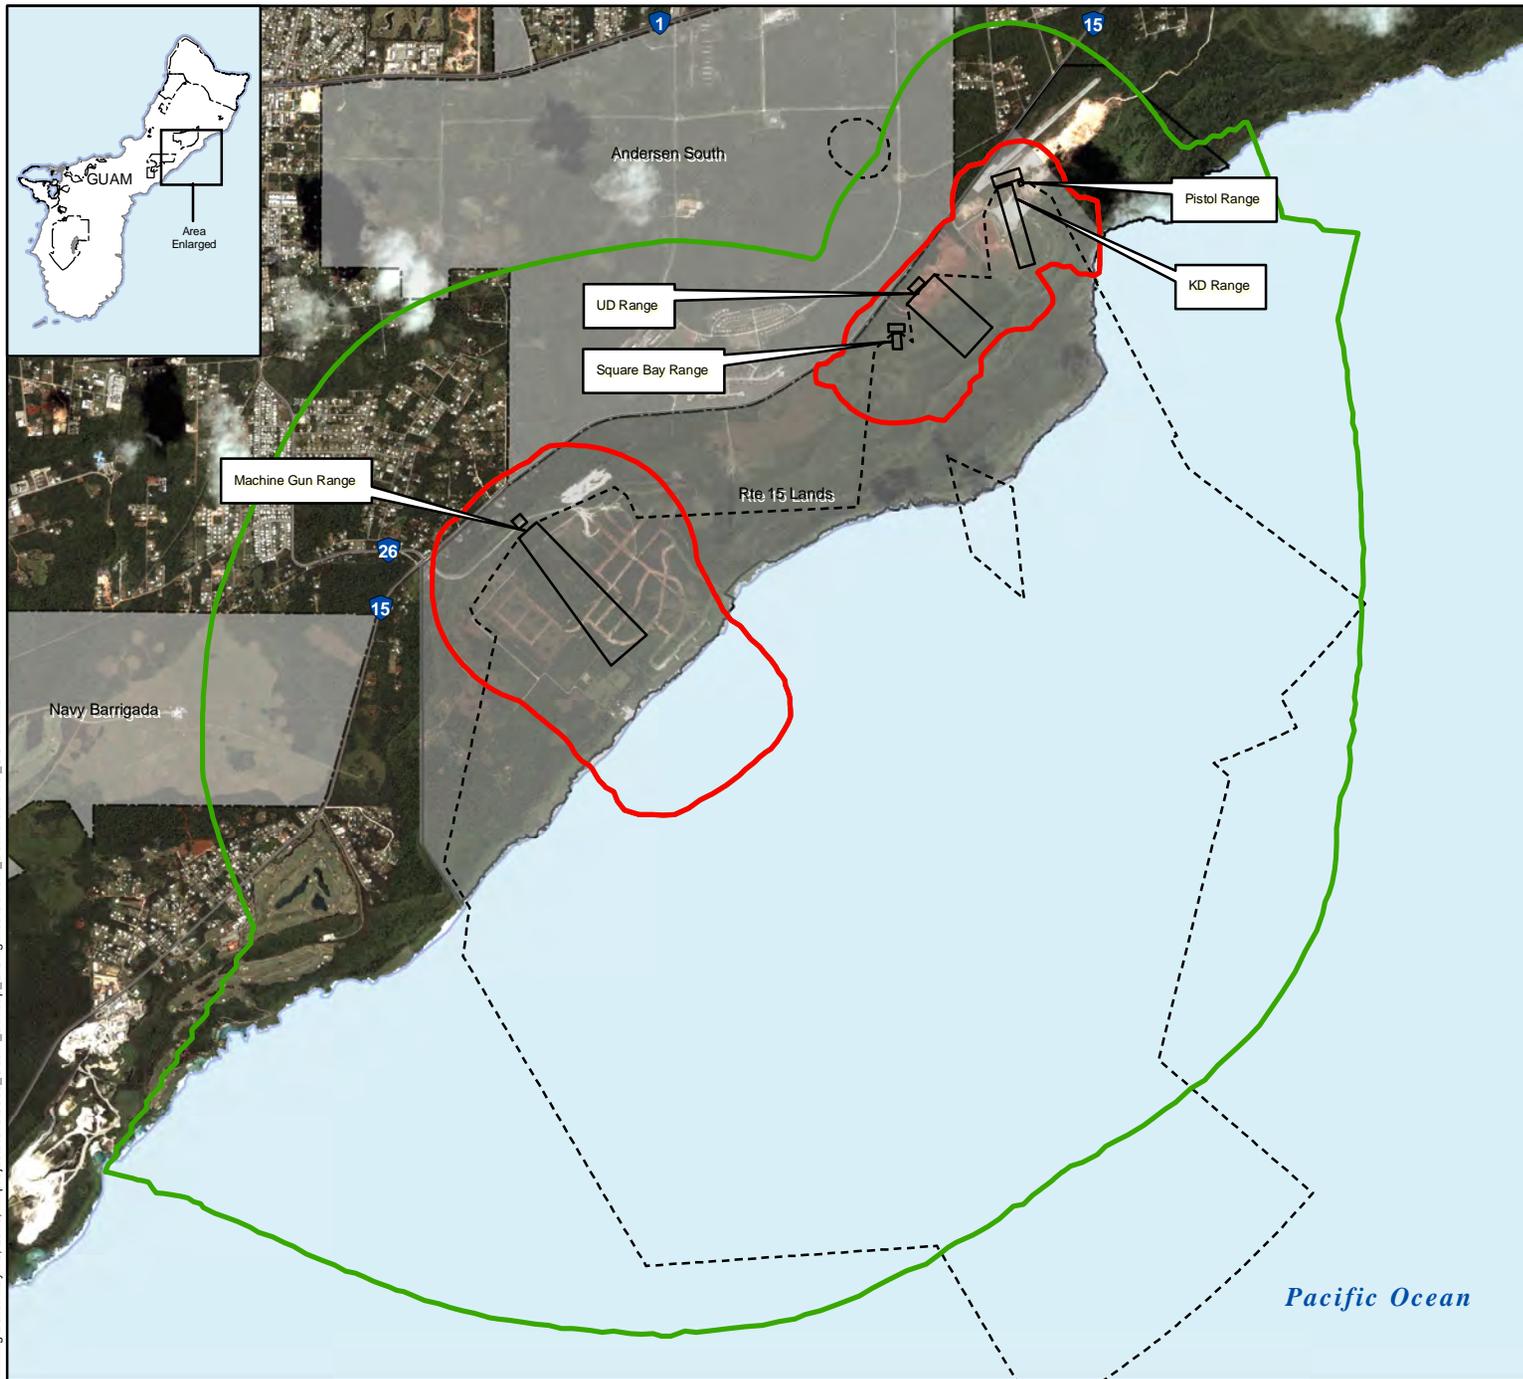
**Figure 6-7b**  
Noise Contours for  
Route 15 Small  
Arms Ranges -  
Alternative B

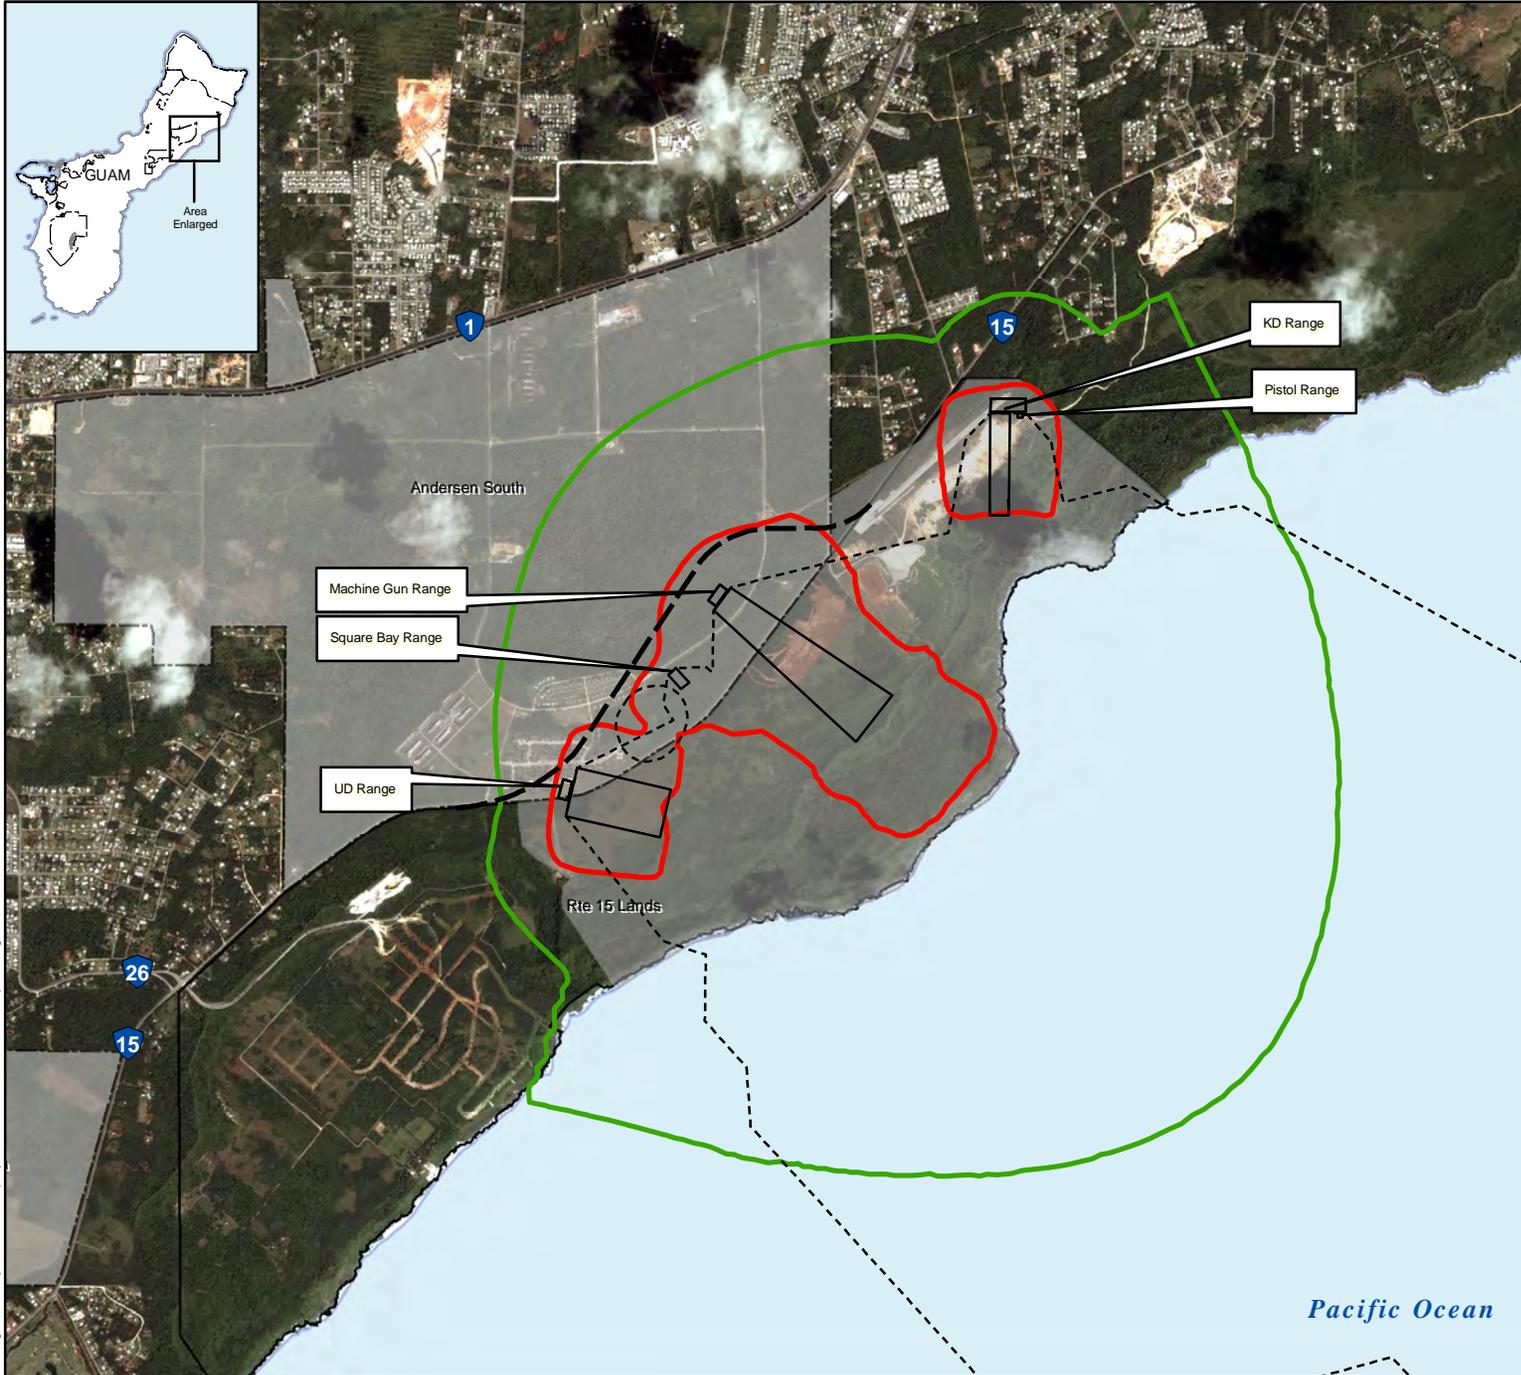
**Figure 6-8a**  
Projected Small  
Caliber Operational  
Noise Contours  
with Foliage  
Attenuation -  
Alternative A

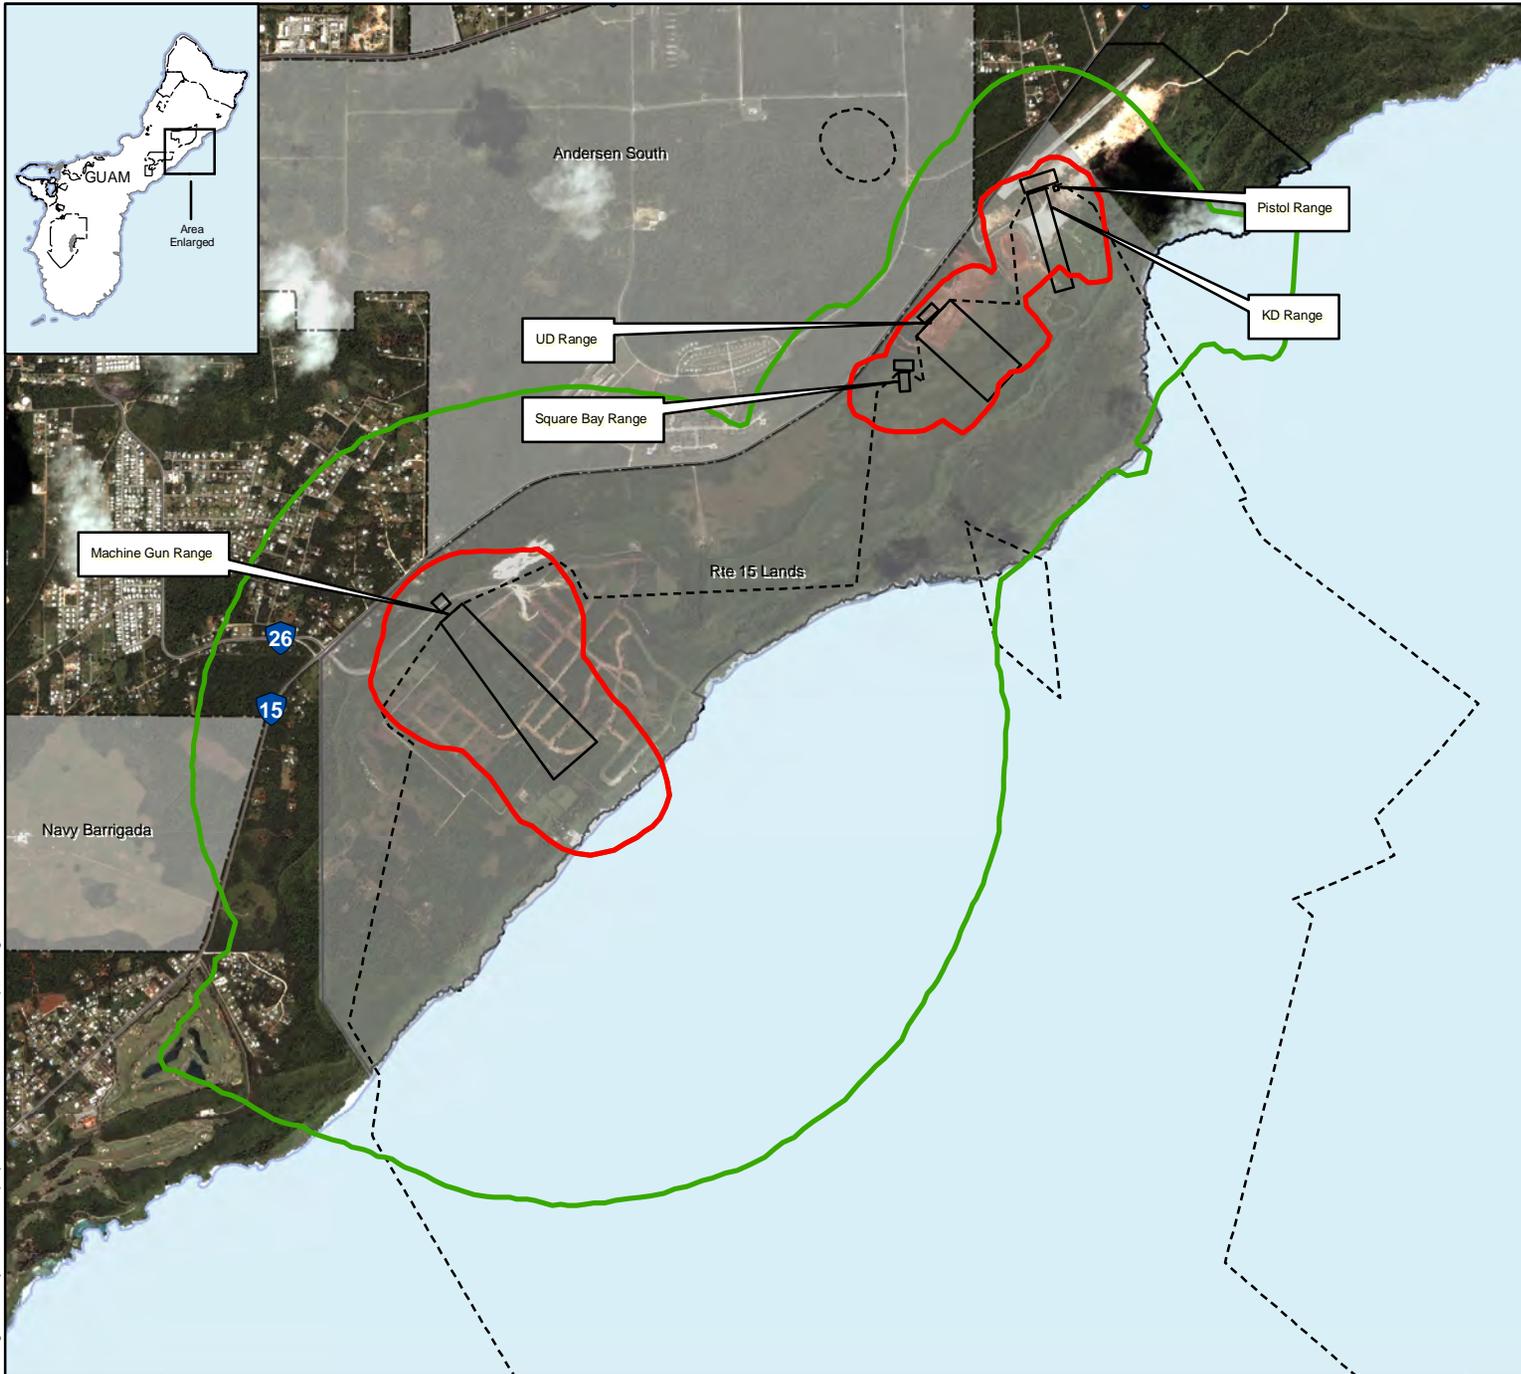
**Figure 6-8b**  
Projected Small  
Caliber Operational  
Noise Contours  
with Foliage  
Attenuation -  
Alternative B

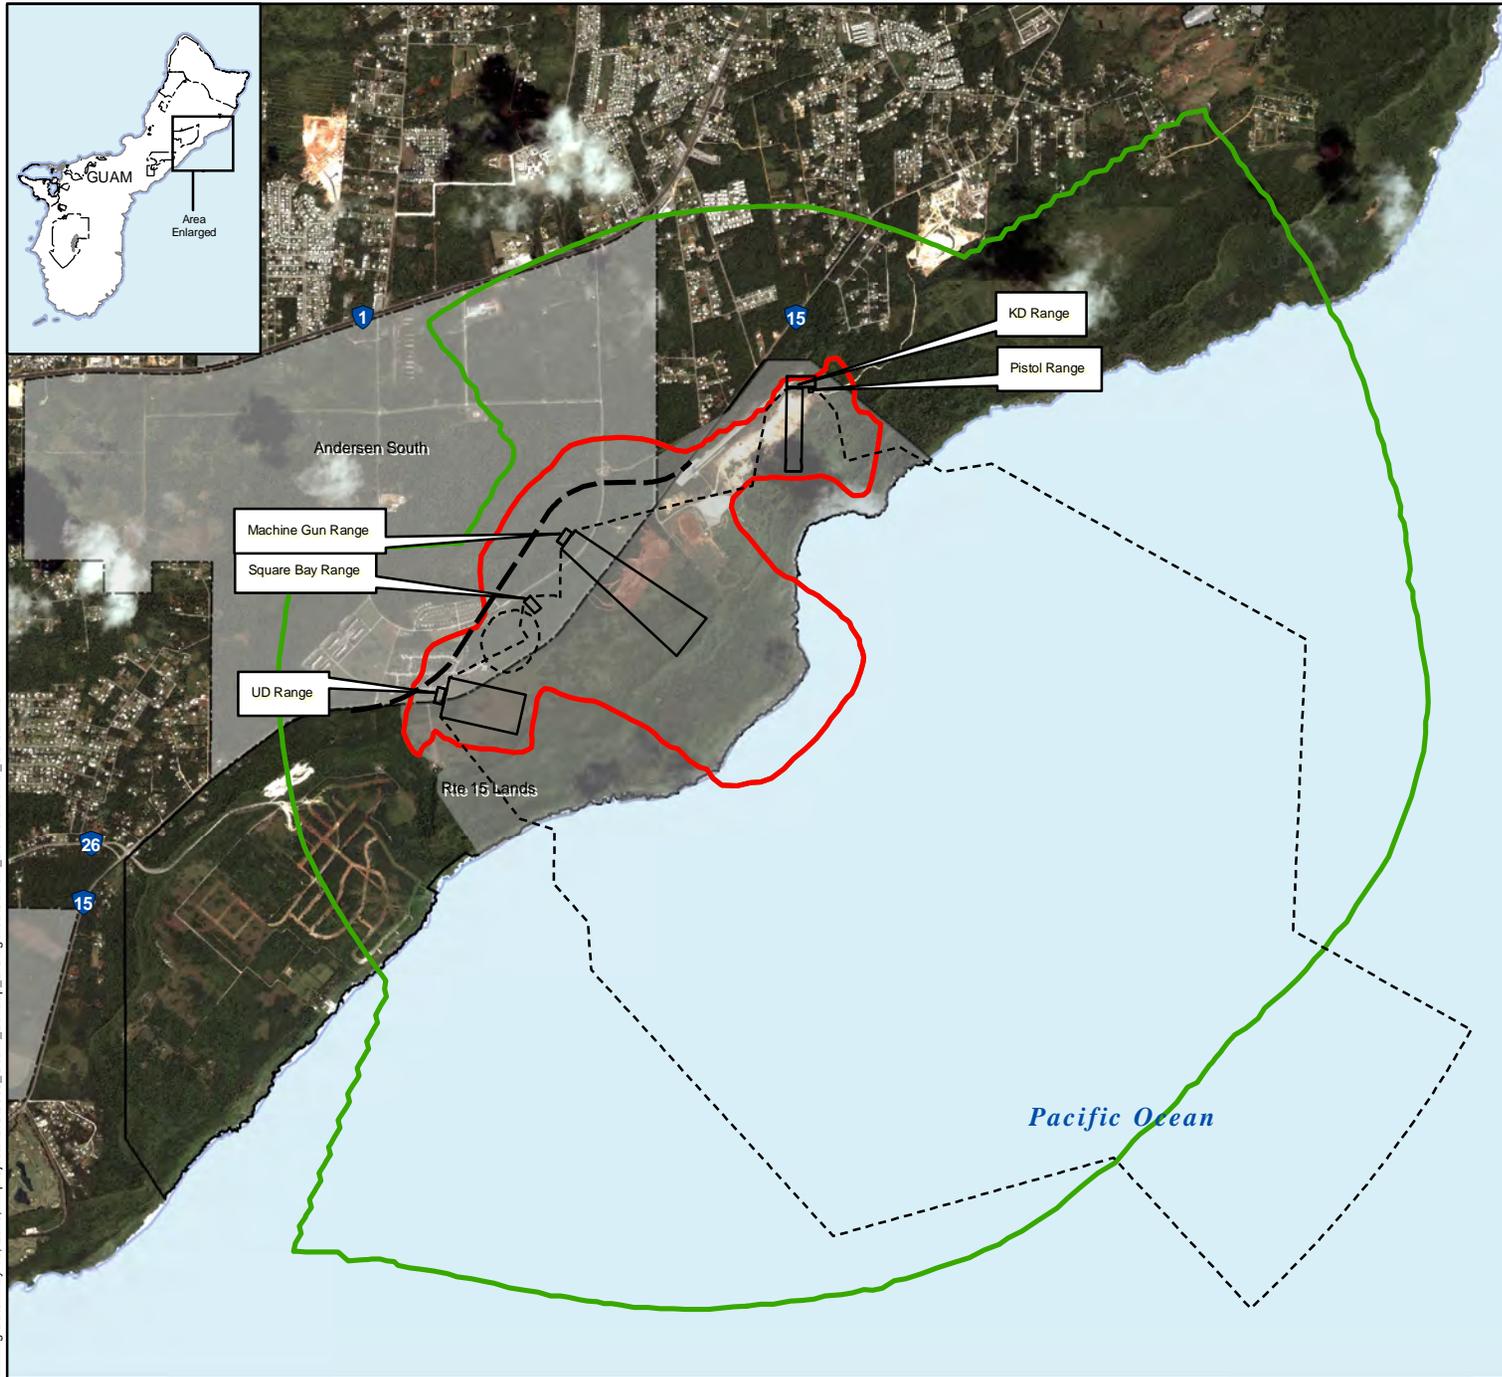
**Figure 6-9a**  
Projected Small  
Caliber Operational  
Noise Contours with  
Barrier Attenuation -  
Alternative A

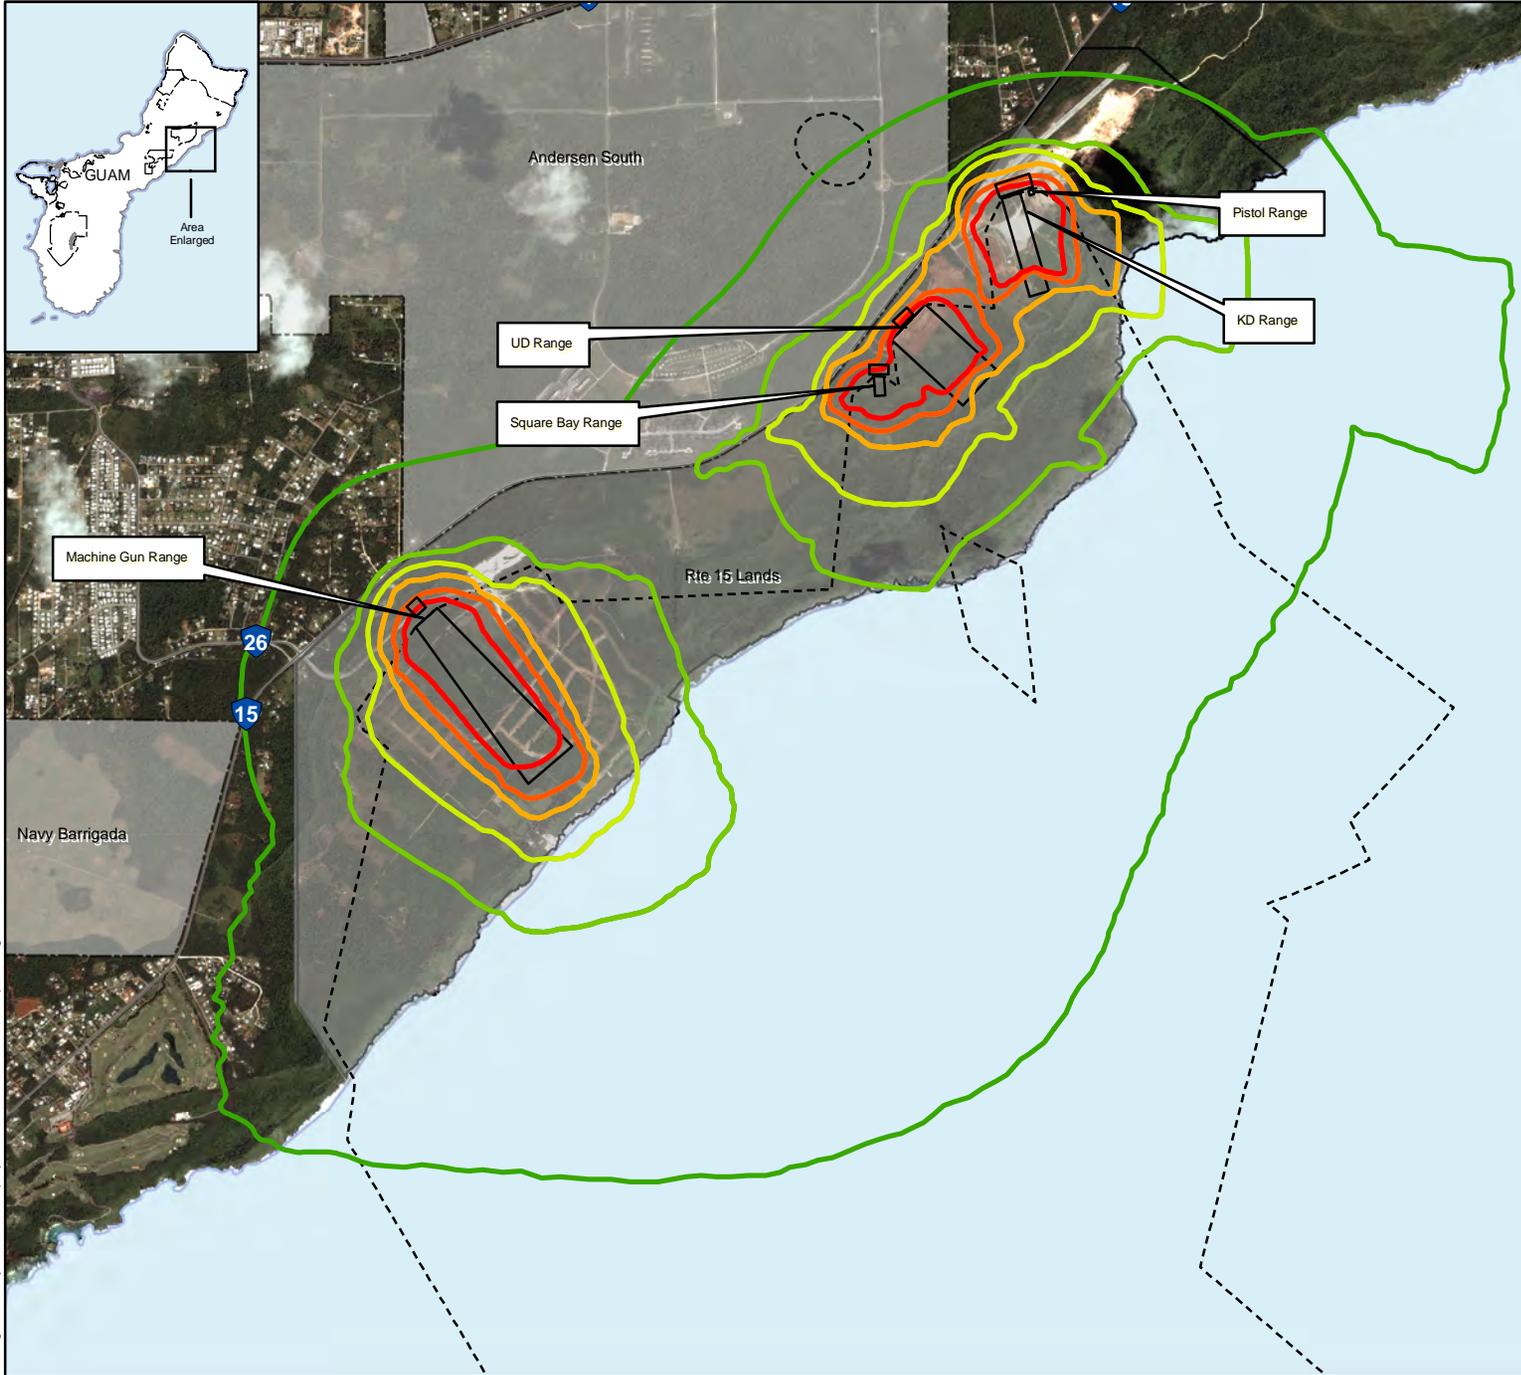
**Figure 6-10b**  
 Projected Small Caliber ADNL Noise Contours without Barrier Attenuation - Alternative B

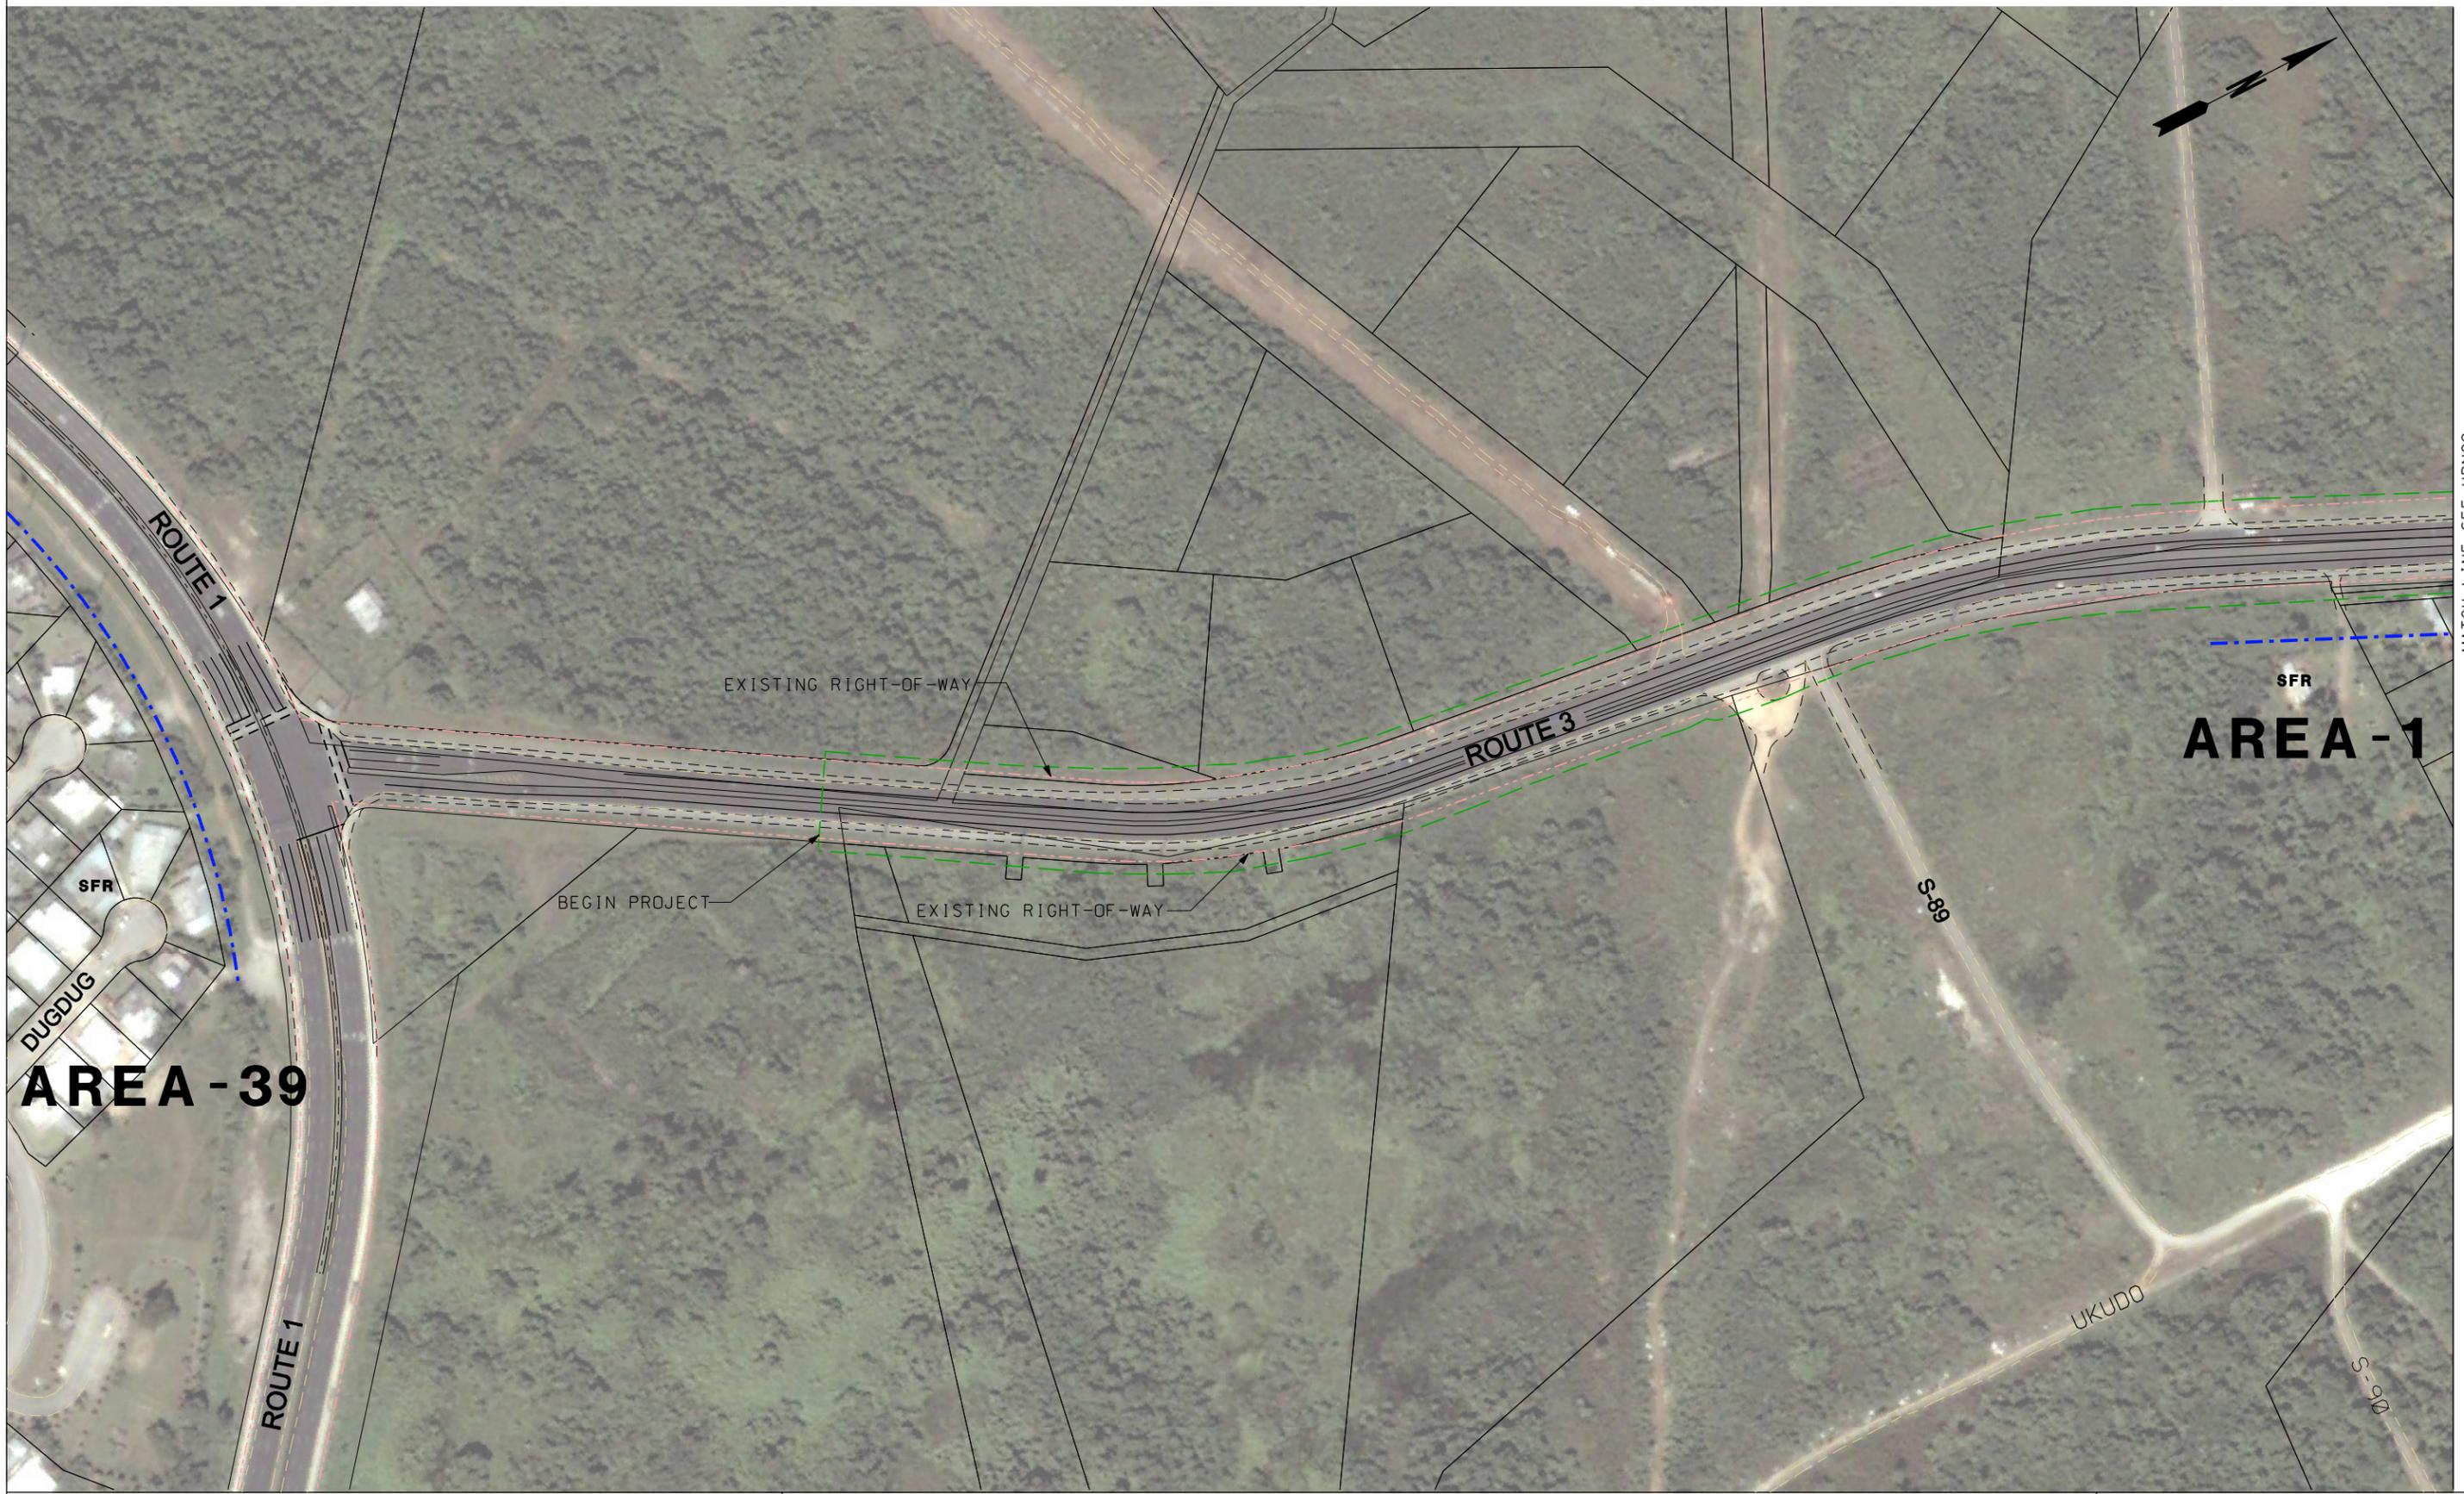
Scale 1"=200' | Drawing HRN008 | Sheet 1 of 69

**66 dBA NOISE  
IMPACT CONTOUR LINE  
FOR NON ABATEMENT**
