## Appendix G

### EIS Resource Technical Appendix

# Guam and CNMI Military Relocation EIS

## Volume 9: EIS Resource Technical Appendix

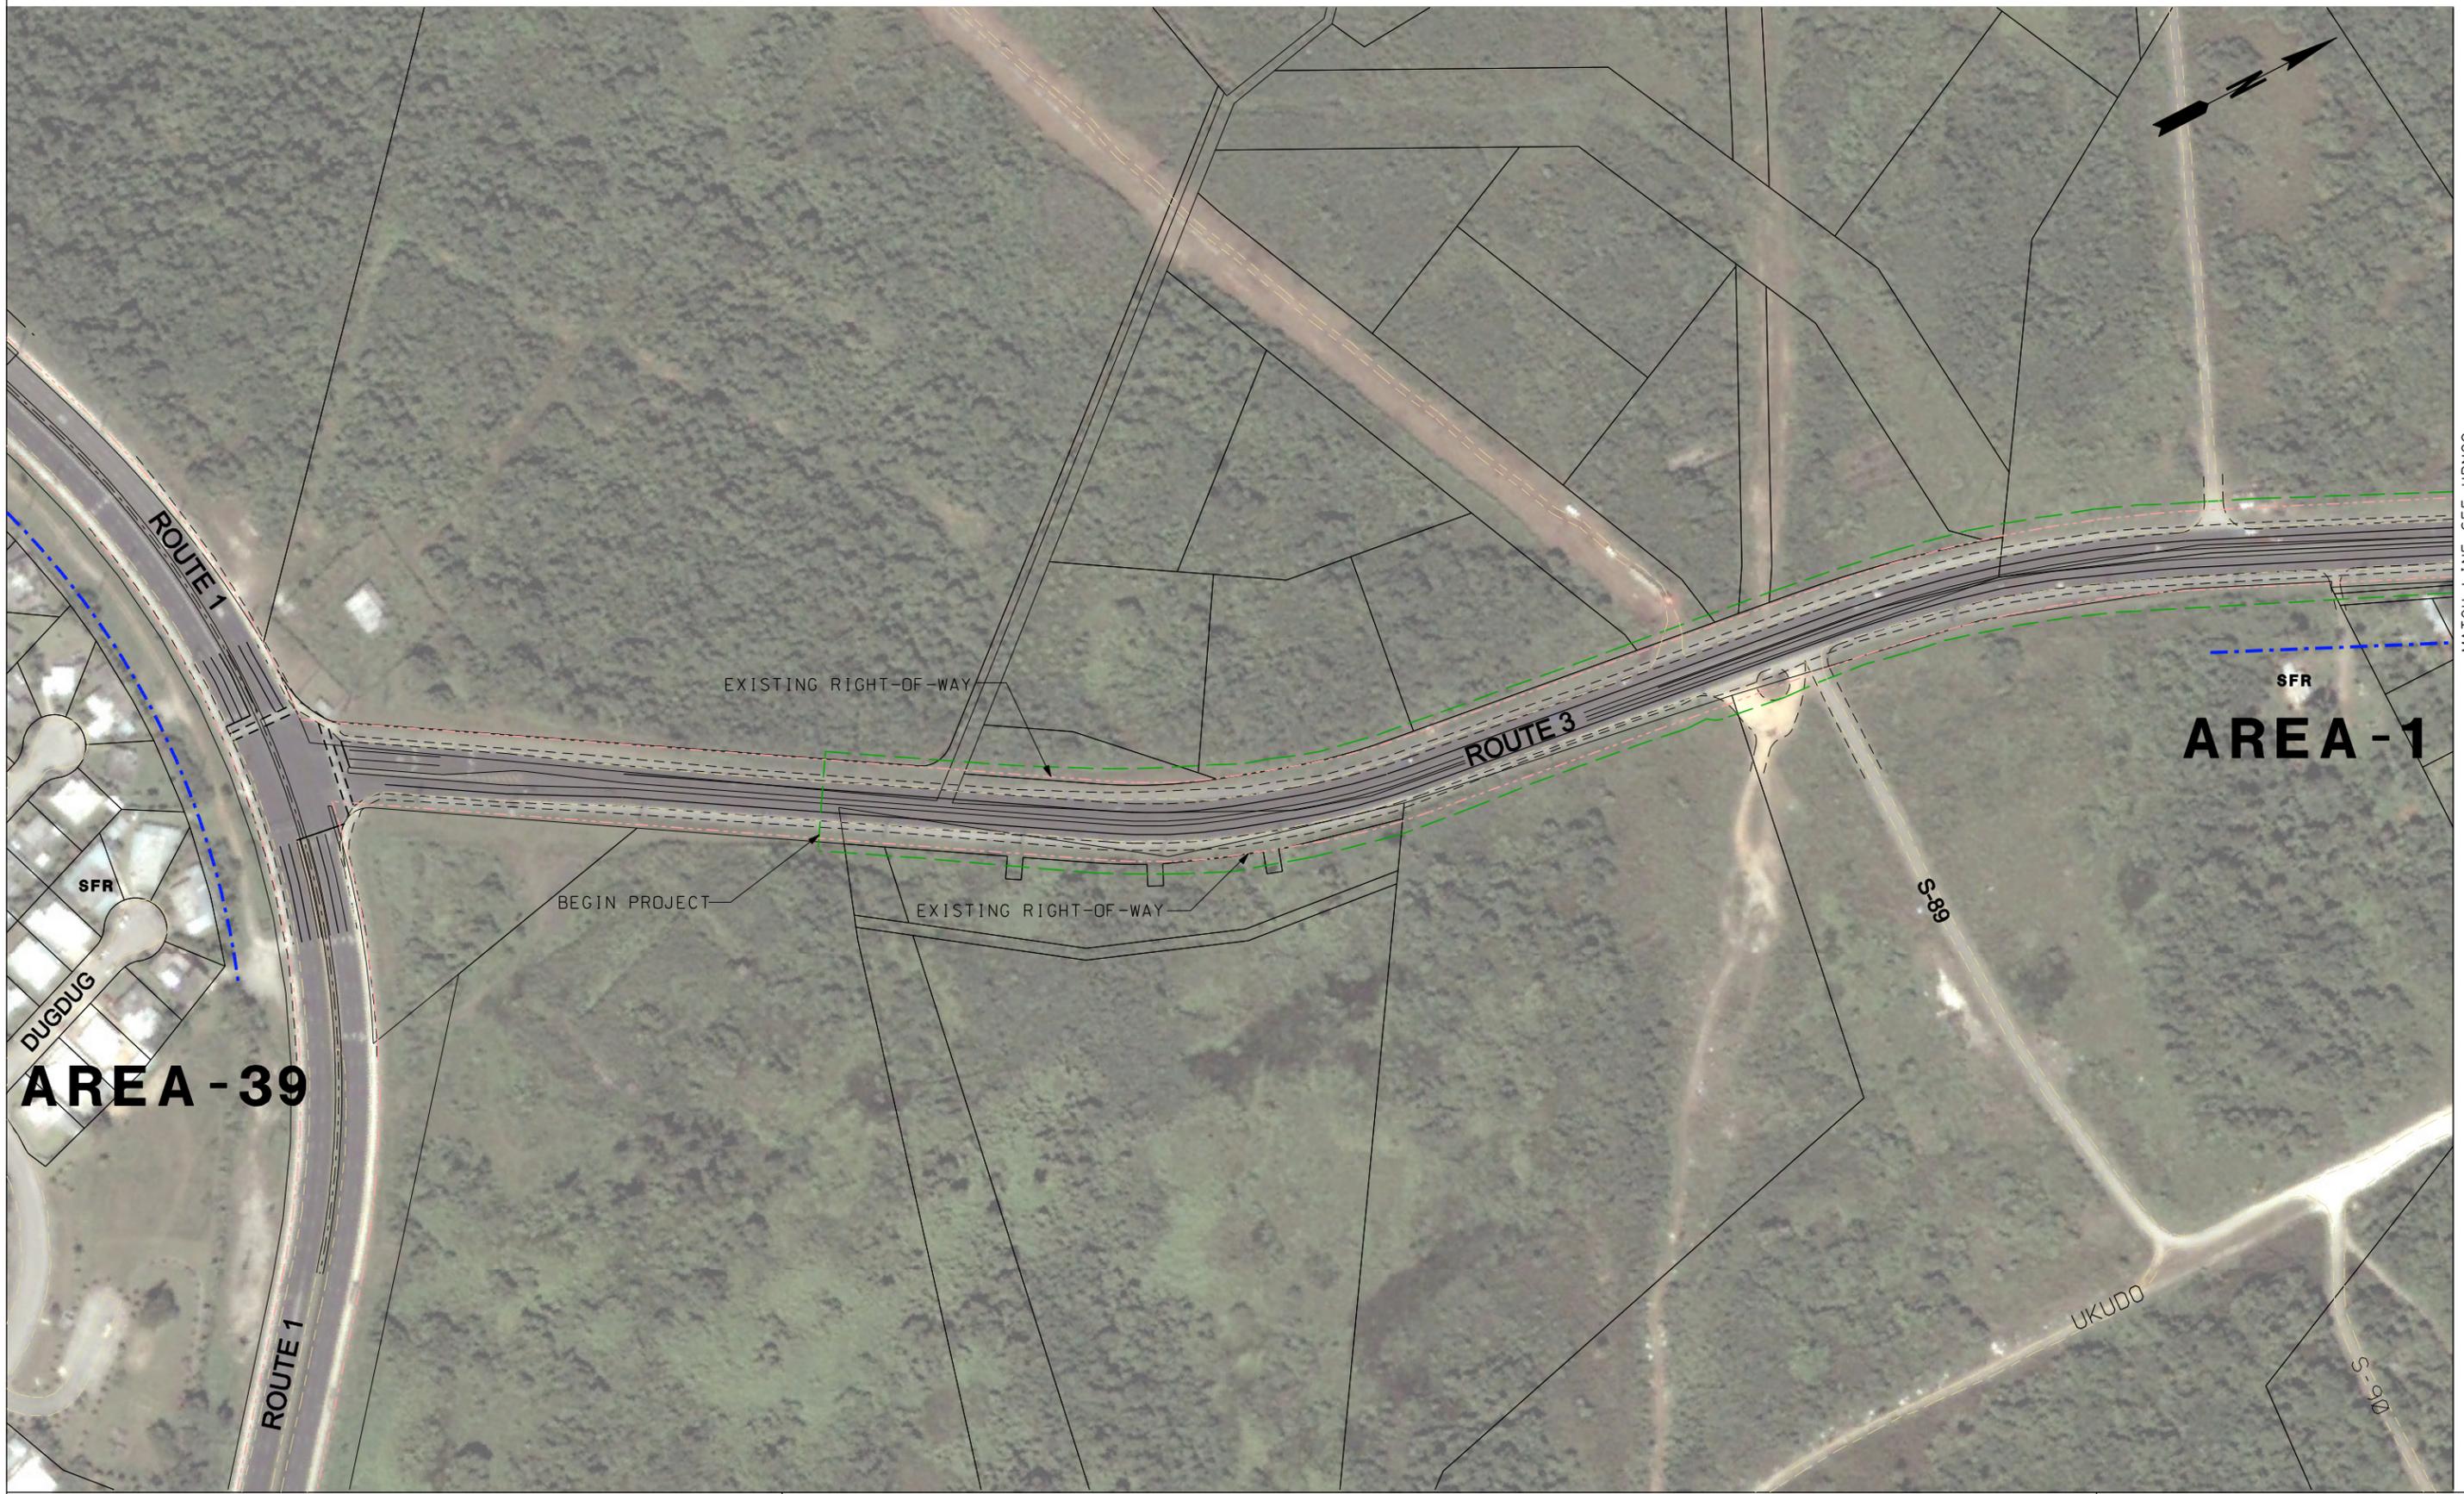
Scale 1"=200' | Drawing HRN008 | Sheet 1B of 69

**66 dBA NOISE  
IMPACT CONTOUR LINE  
FOR NON ABATEMENT**

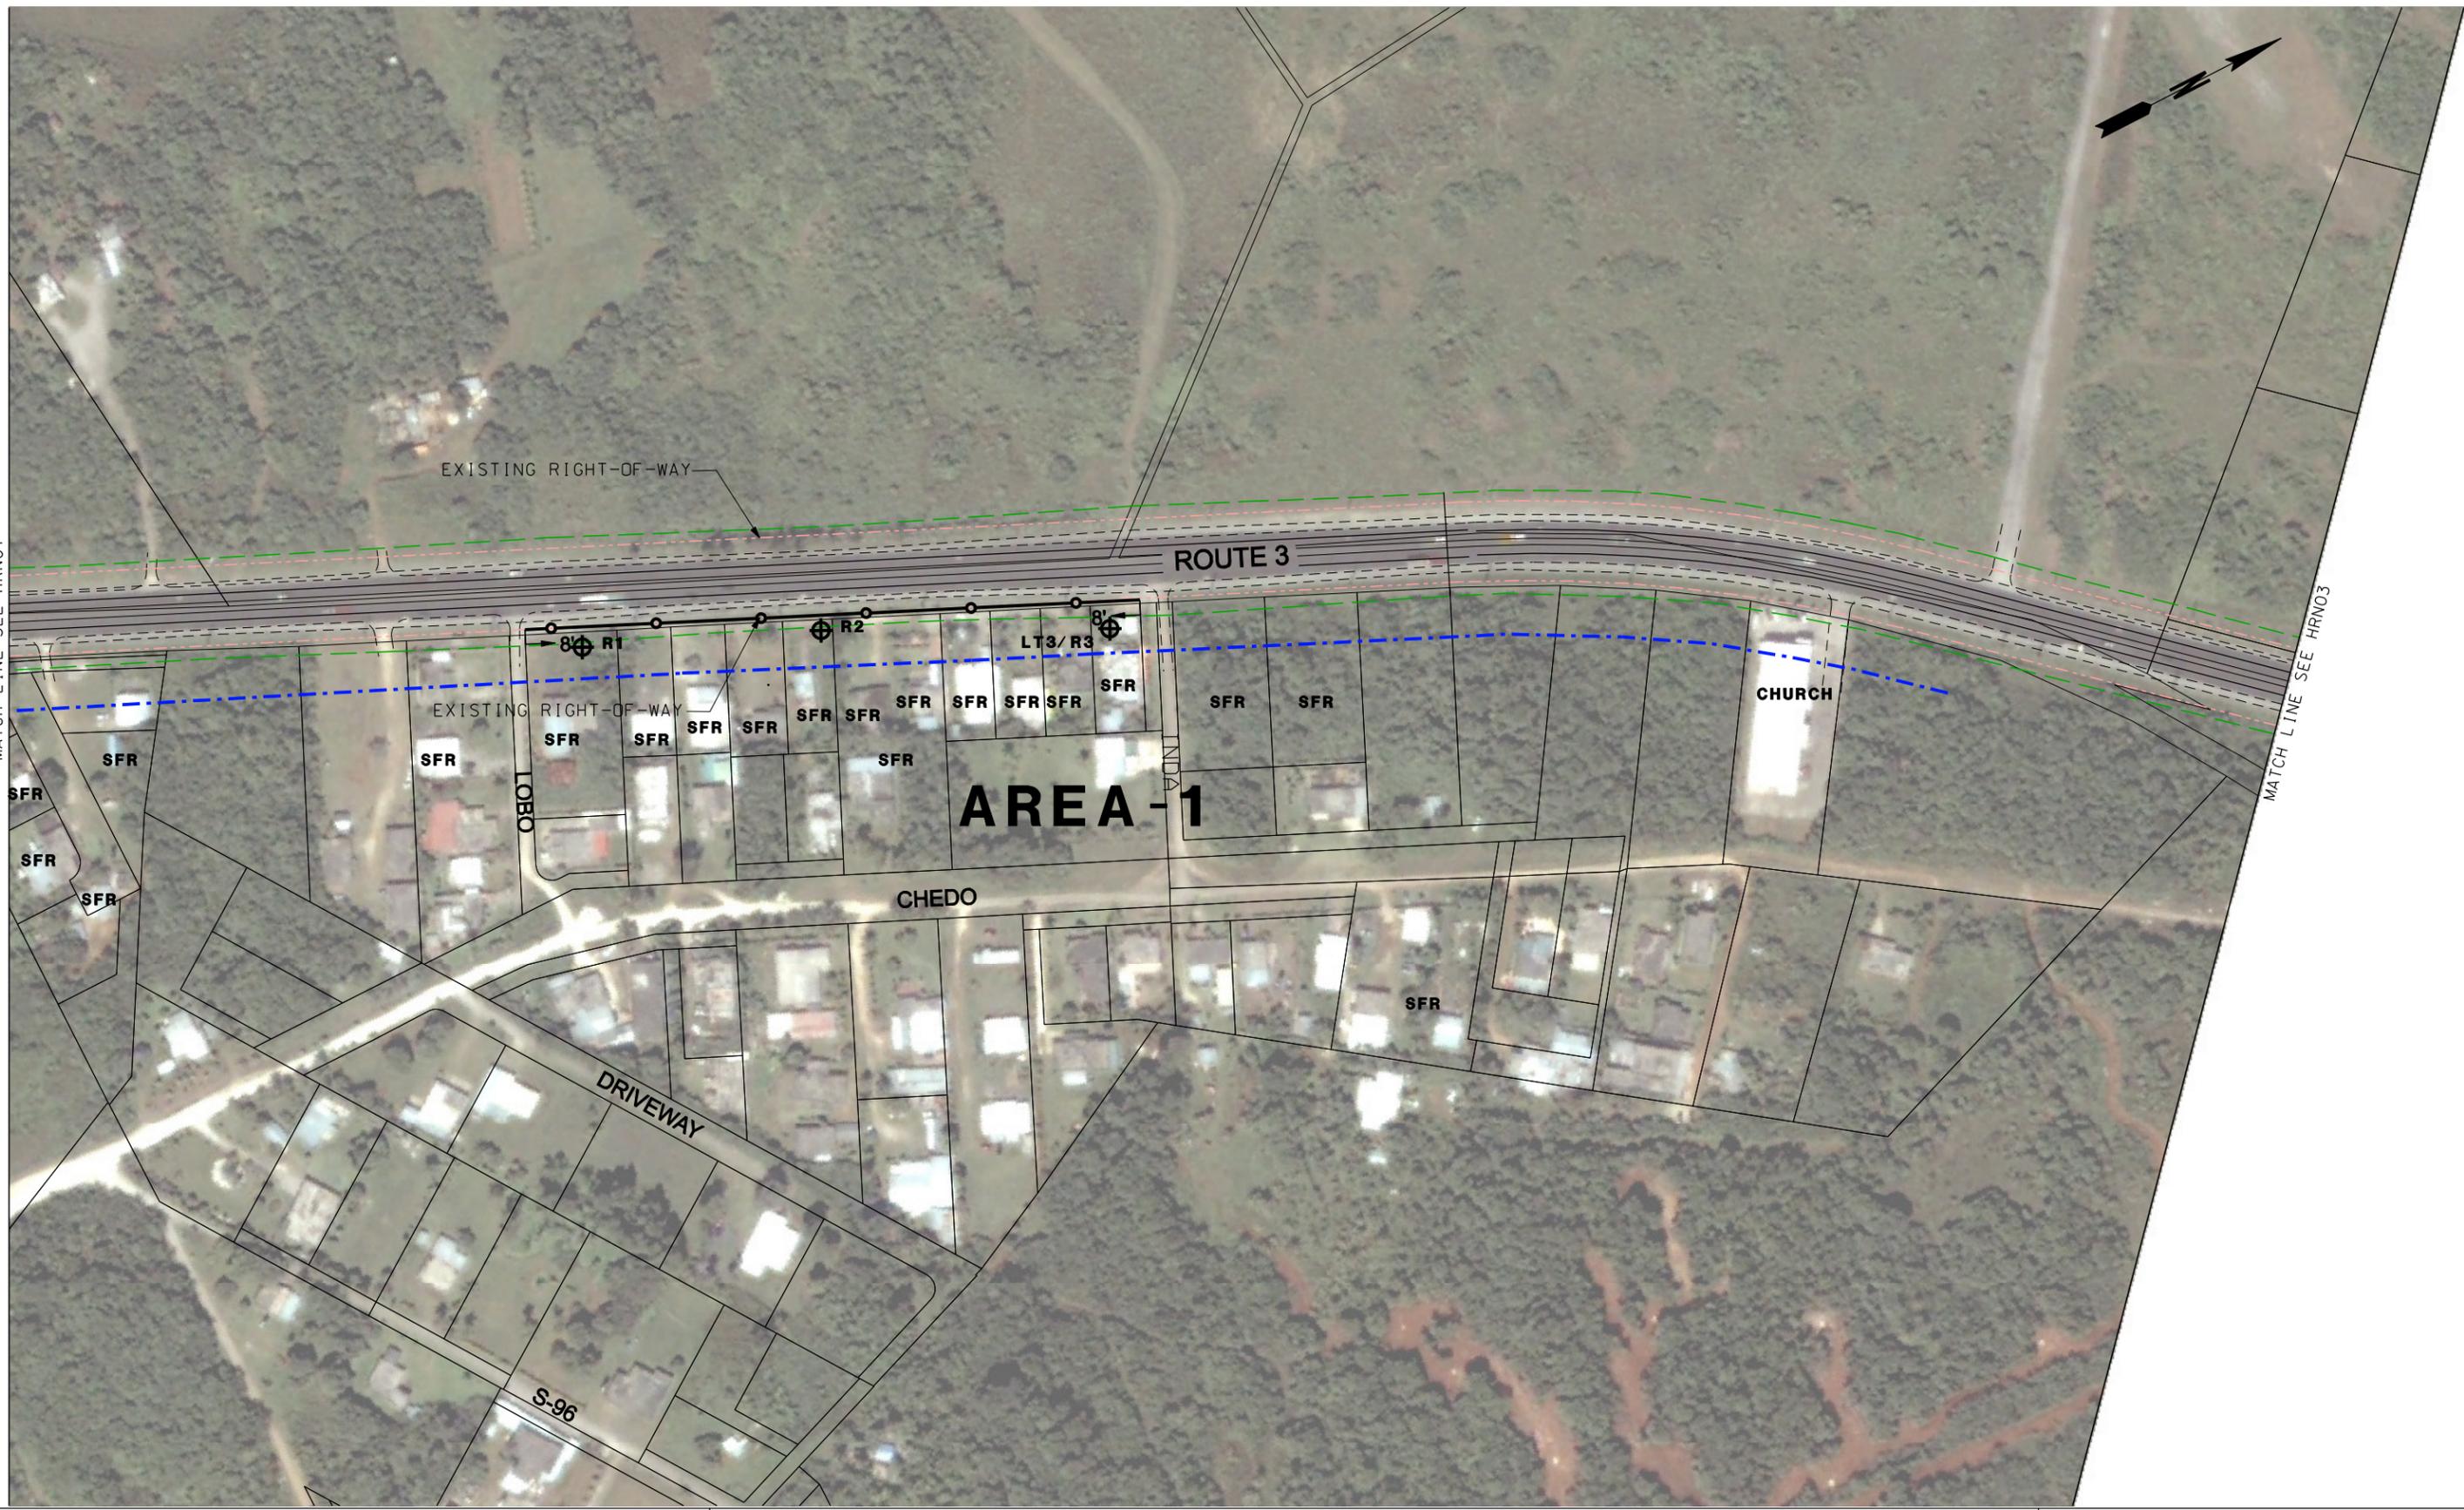
Scale 1"=200' Drawing HRN008 Sheet 2 of 69

**66 dBA NOISE  
IMPACT CONTOUR LINE  
FOR NON ABATEMENT**

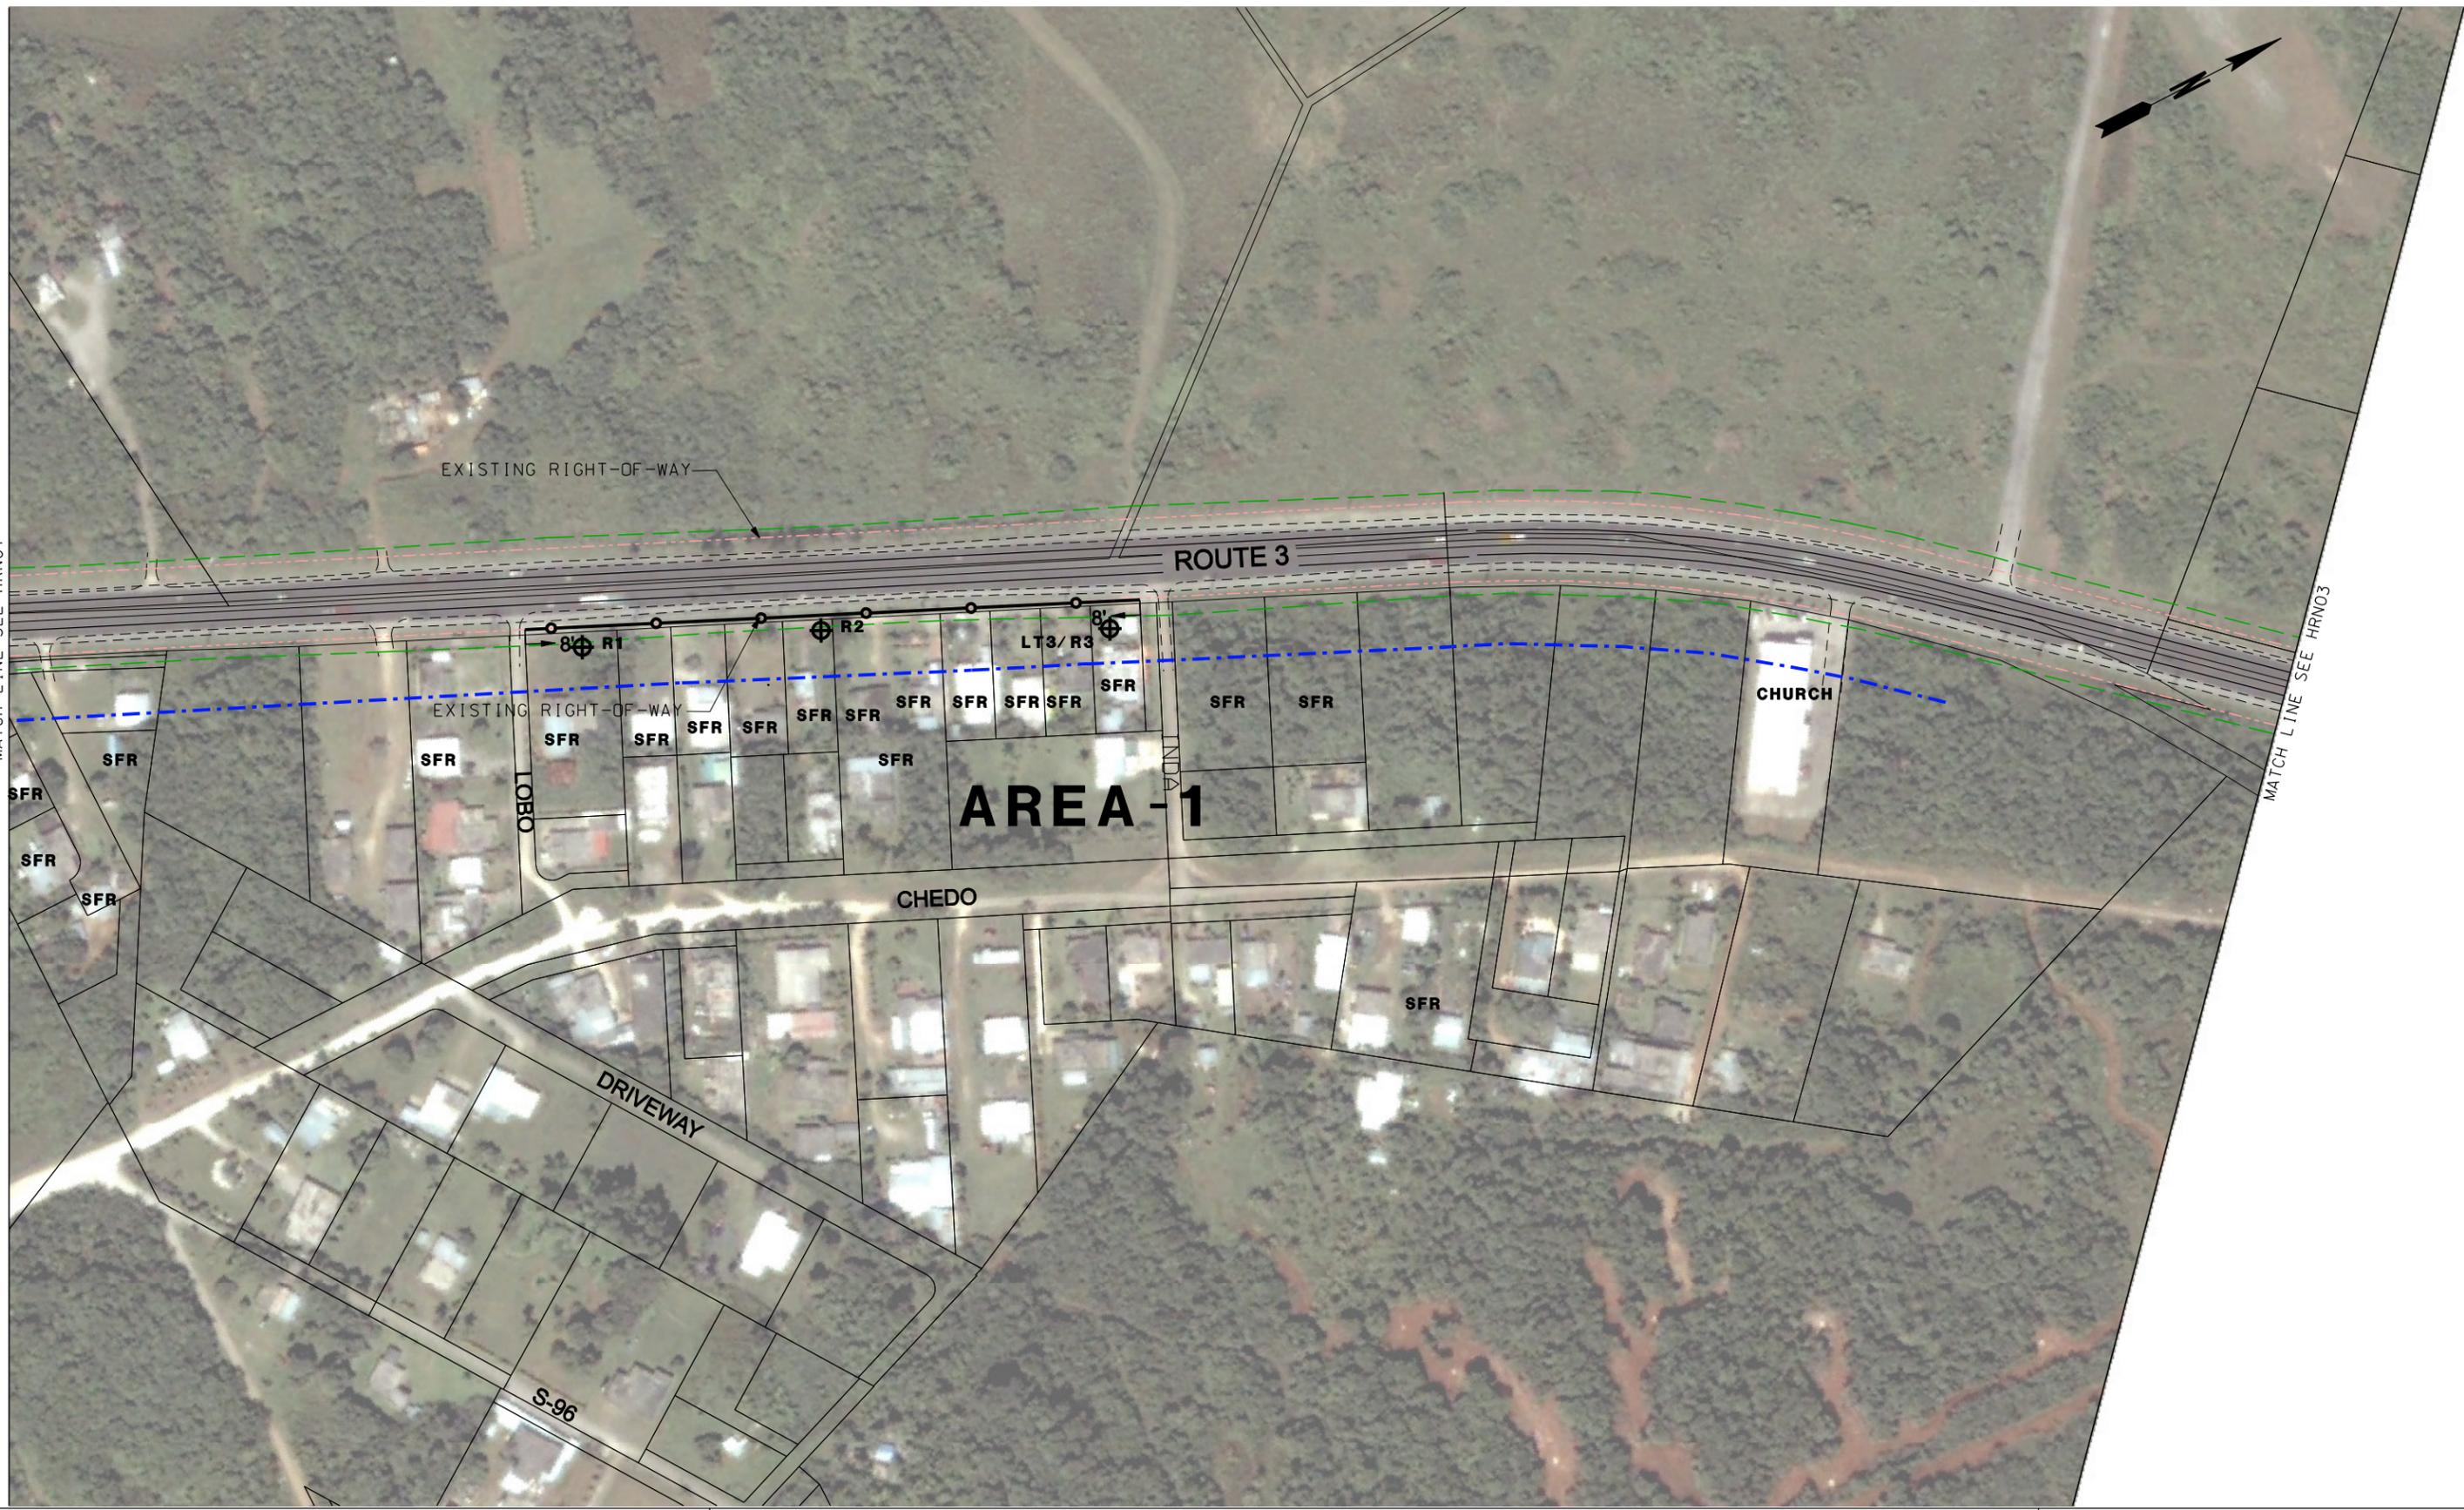
Scale 1"=200' Drawing HRN008 Sheet 2B of 69

**66 dBA NOISE  
IMPACT CONTOUR LINE  
FOR NON ABATEMENT**

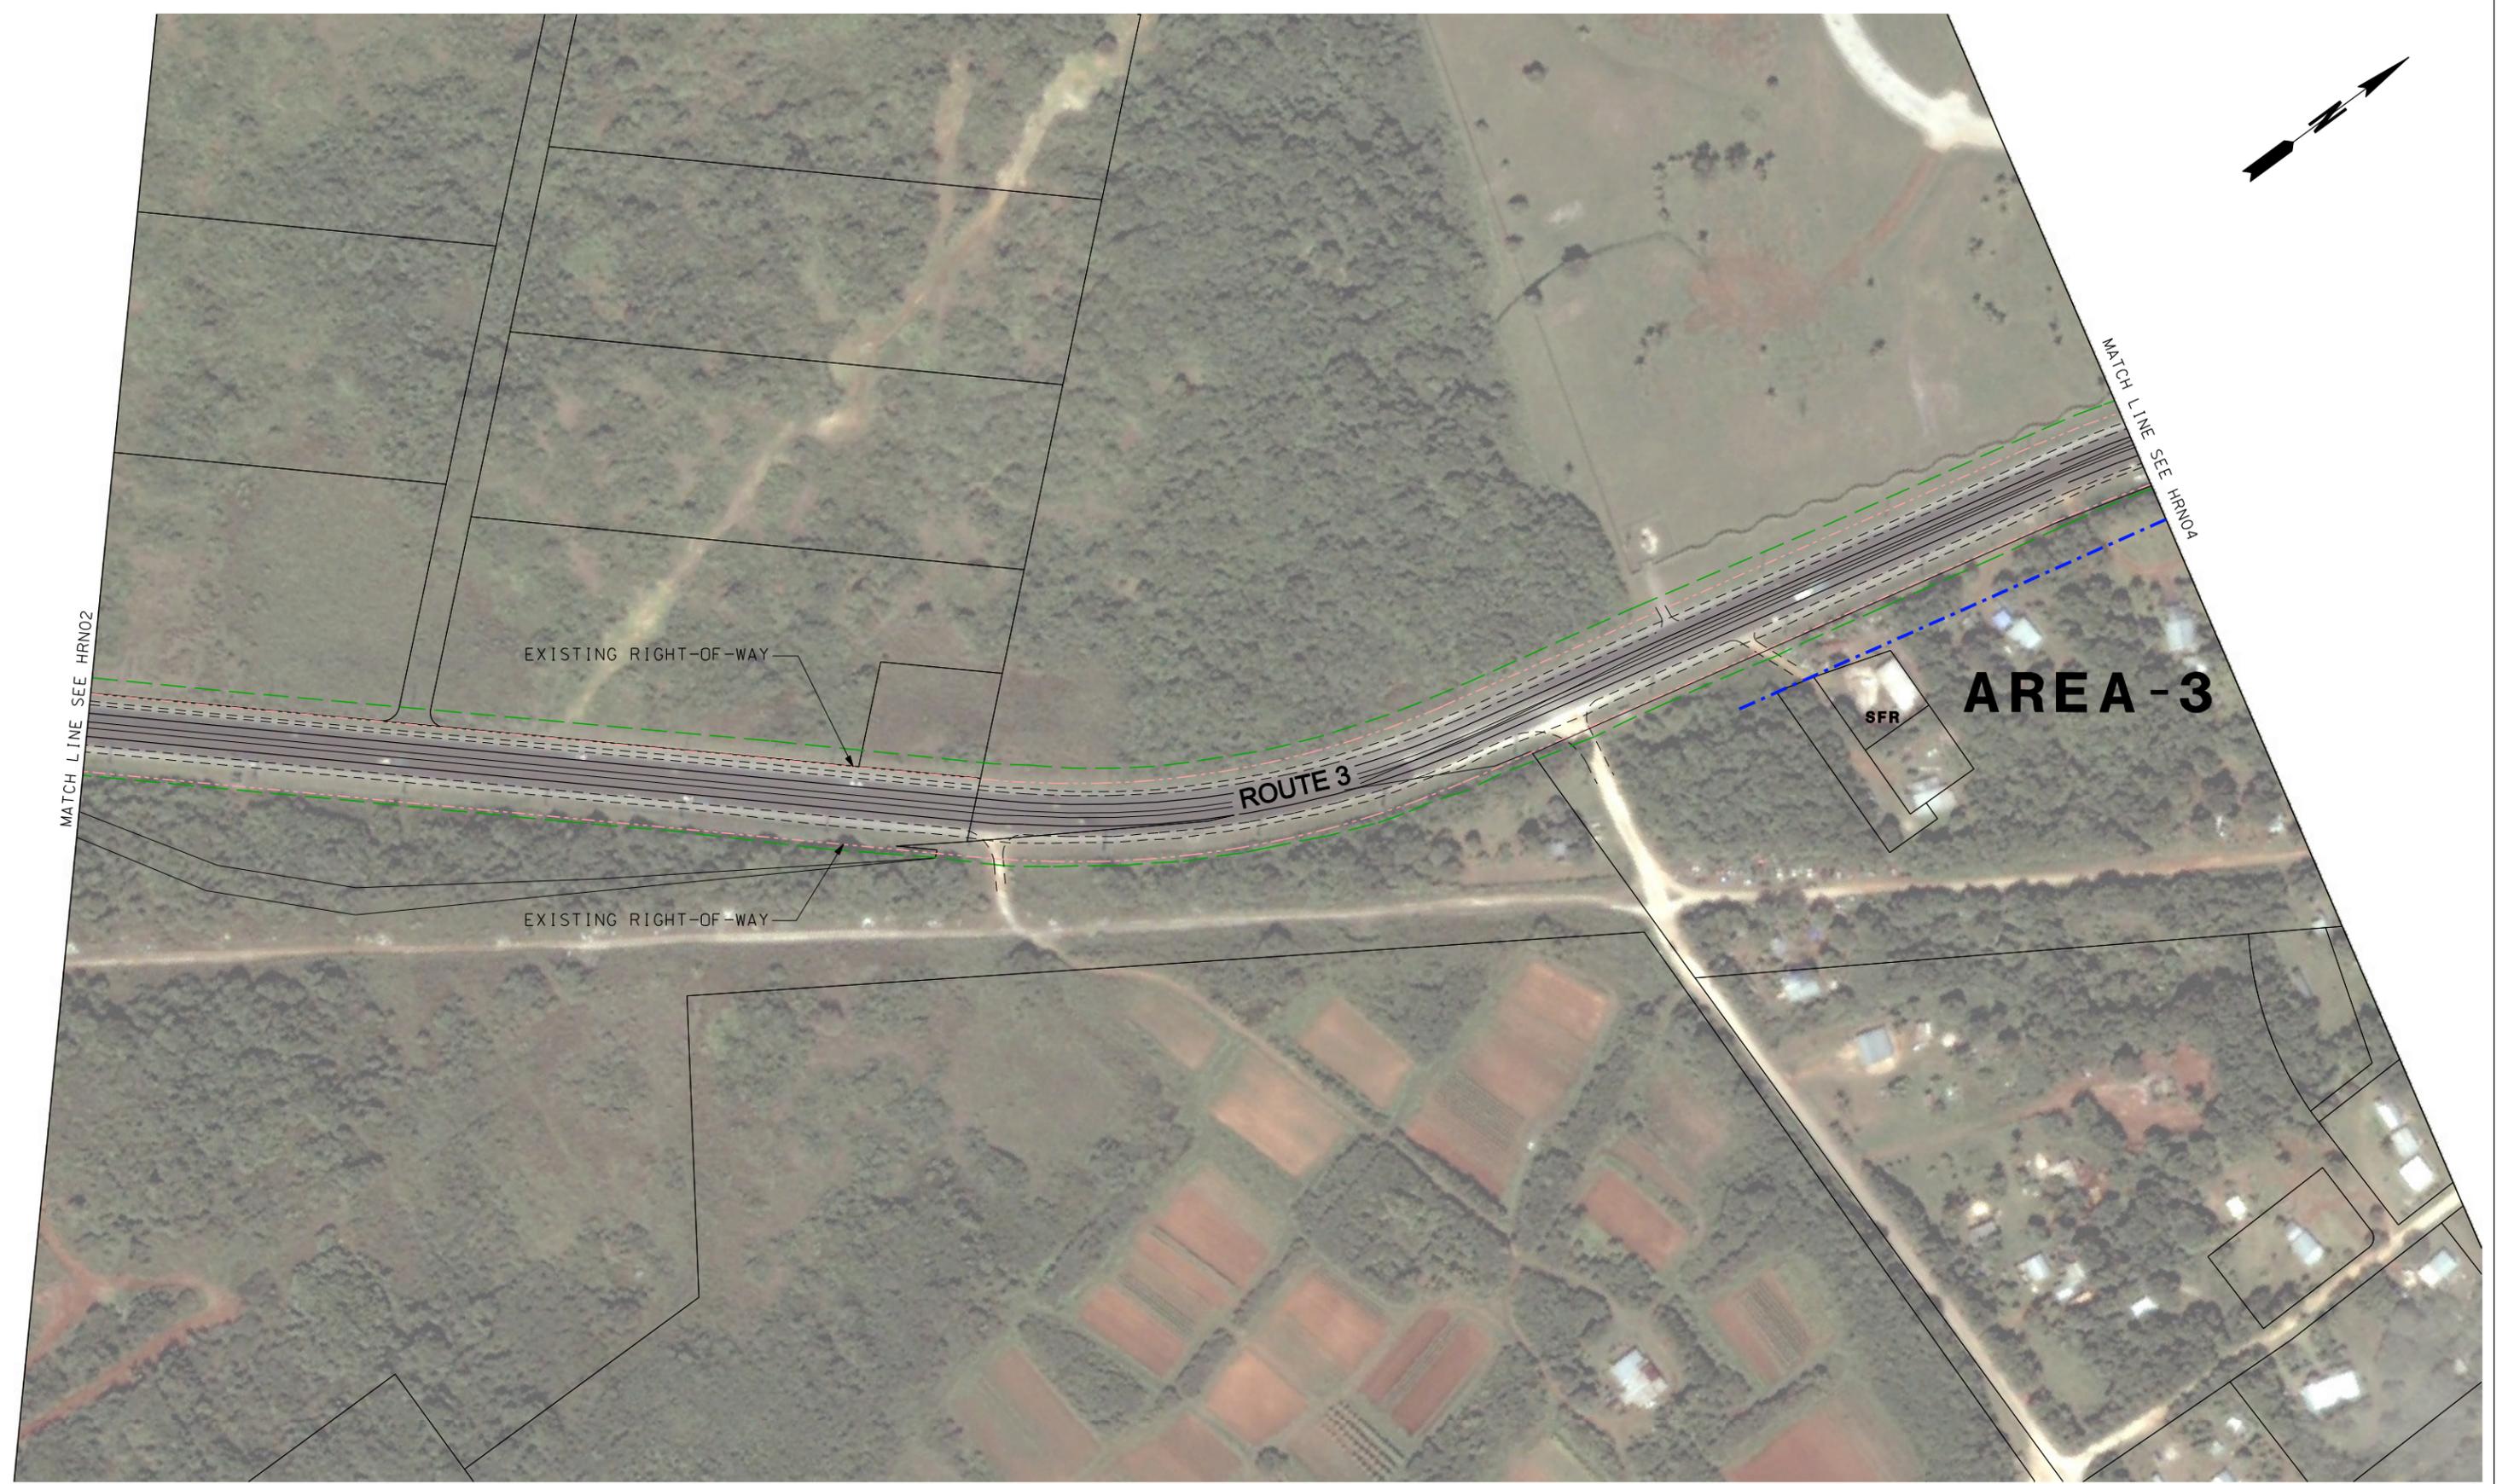
Scale 1"=200' | Drawing HRN008 | Sheet 3 of 69

**66 dBA NOISE  
IMPACT CONTOUR LINE  
FOR NON ABATEMENT**

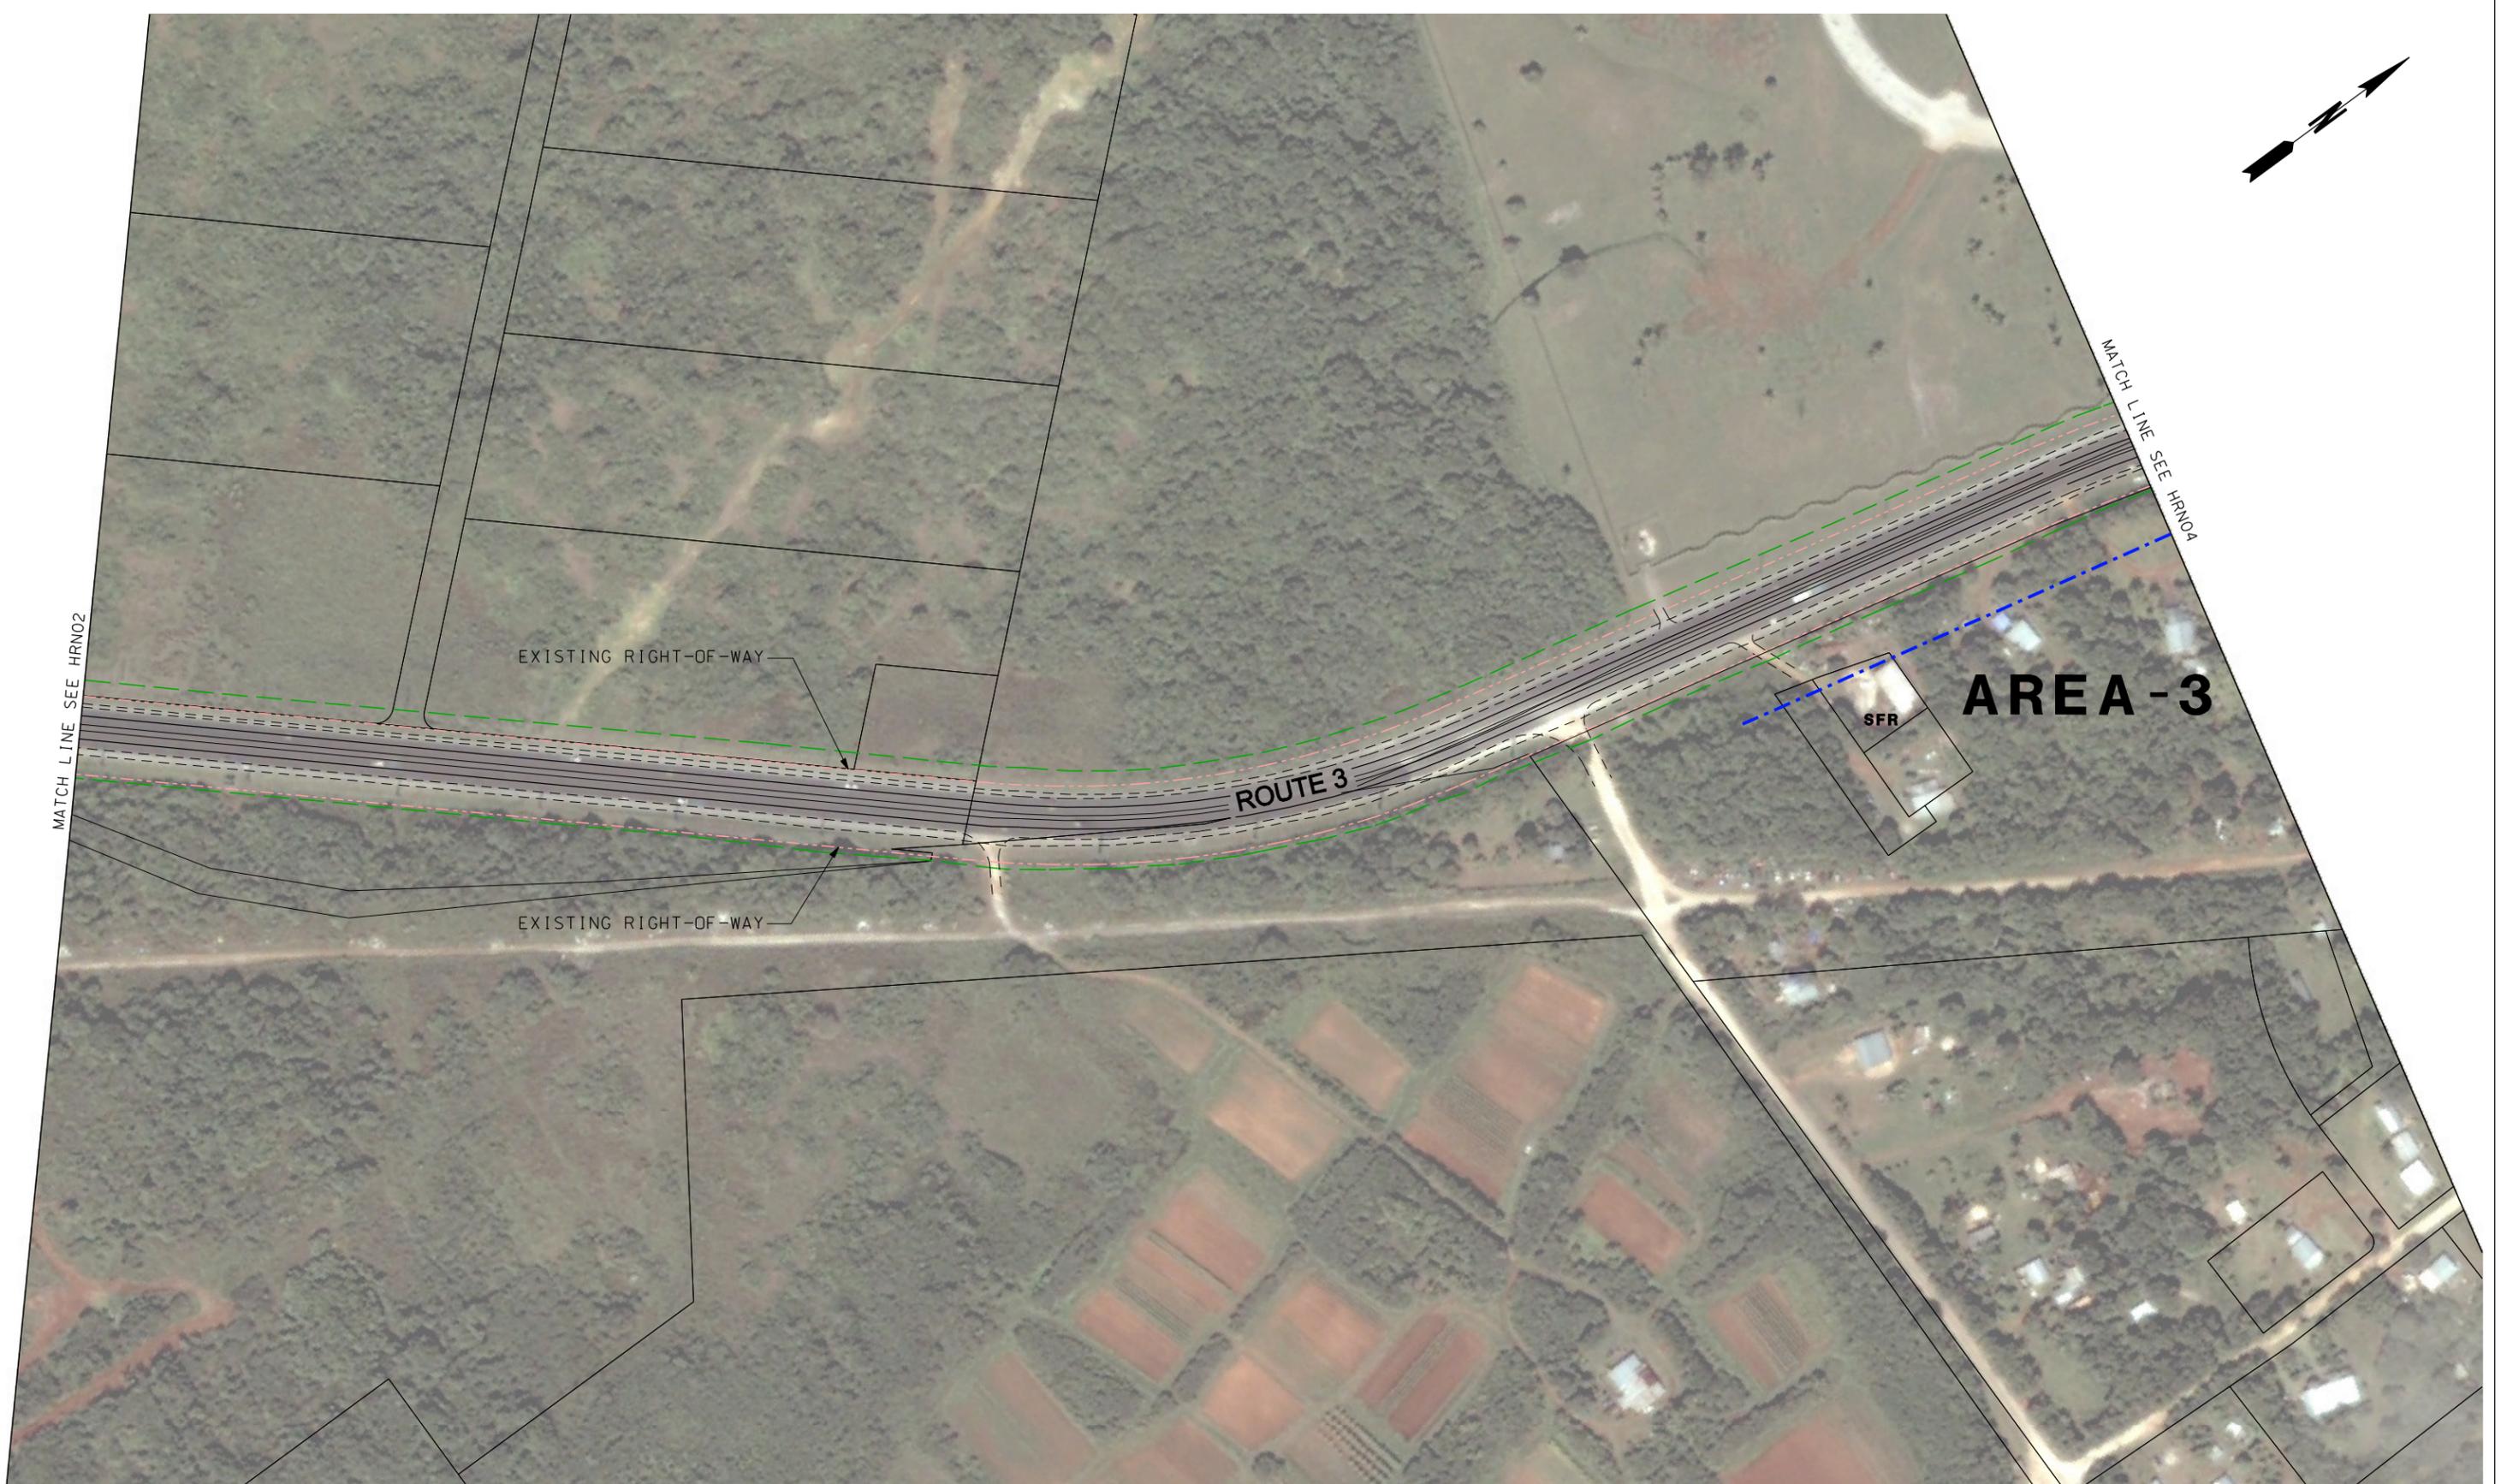
Scale 1"=200' Drawing HRN008 Sheet 3B of 69

**66 dBA NOISE  
IMPACT CONTOUR LINE  
FOR NON ABATEMENT**

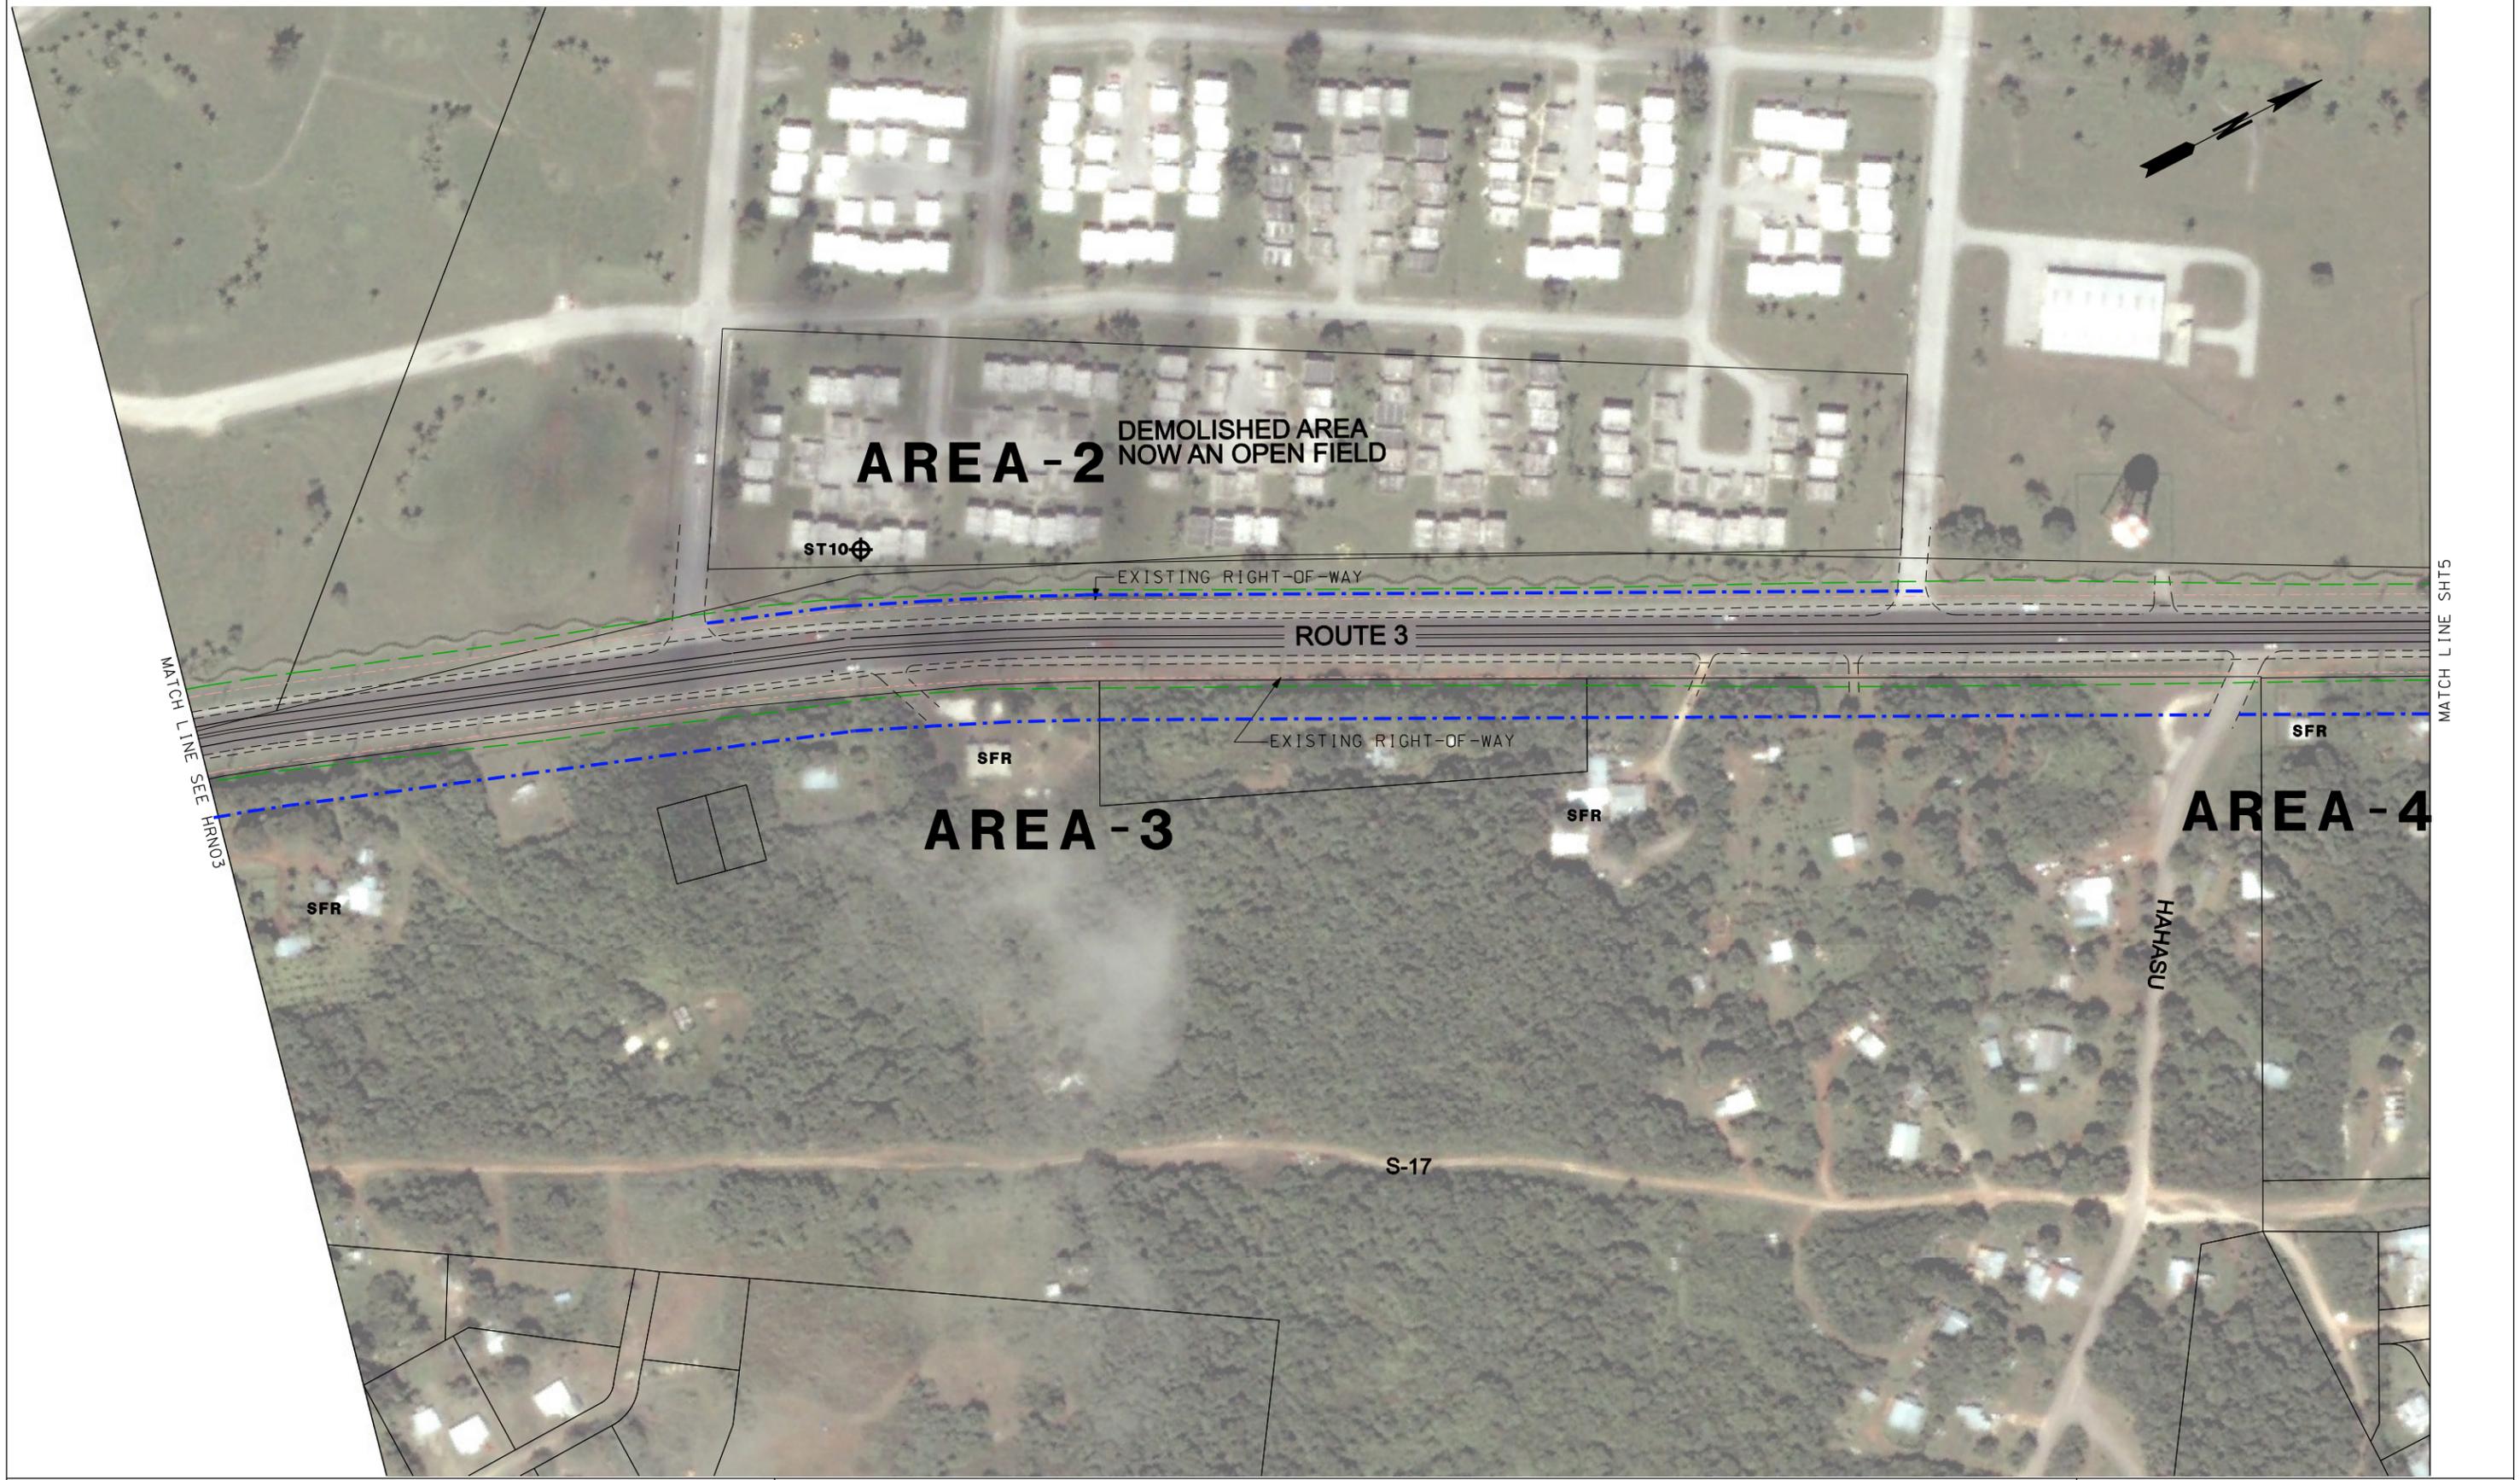
Scale 1"=200' Drawing HRN008 Sheet 4 of 69

**66 dBA NOISE  
IMPACT CONTOUR LINE  
FOR NON ABATEMENT**
