## Appendix G

### EIS Resource Technical Appendix

# Guam and CNMI Military Relocation EIS

## Volume 9: EIS Resource Technical Appendix

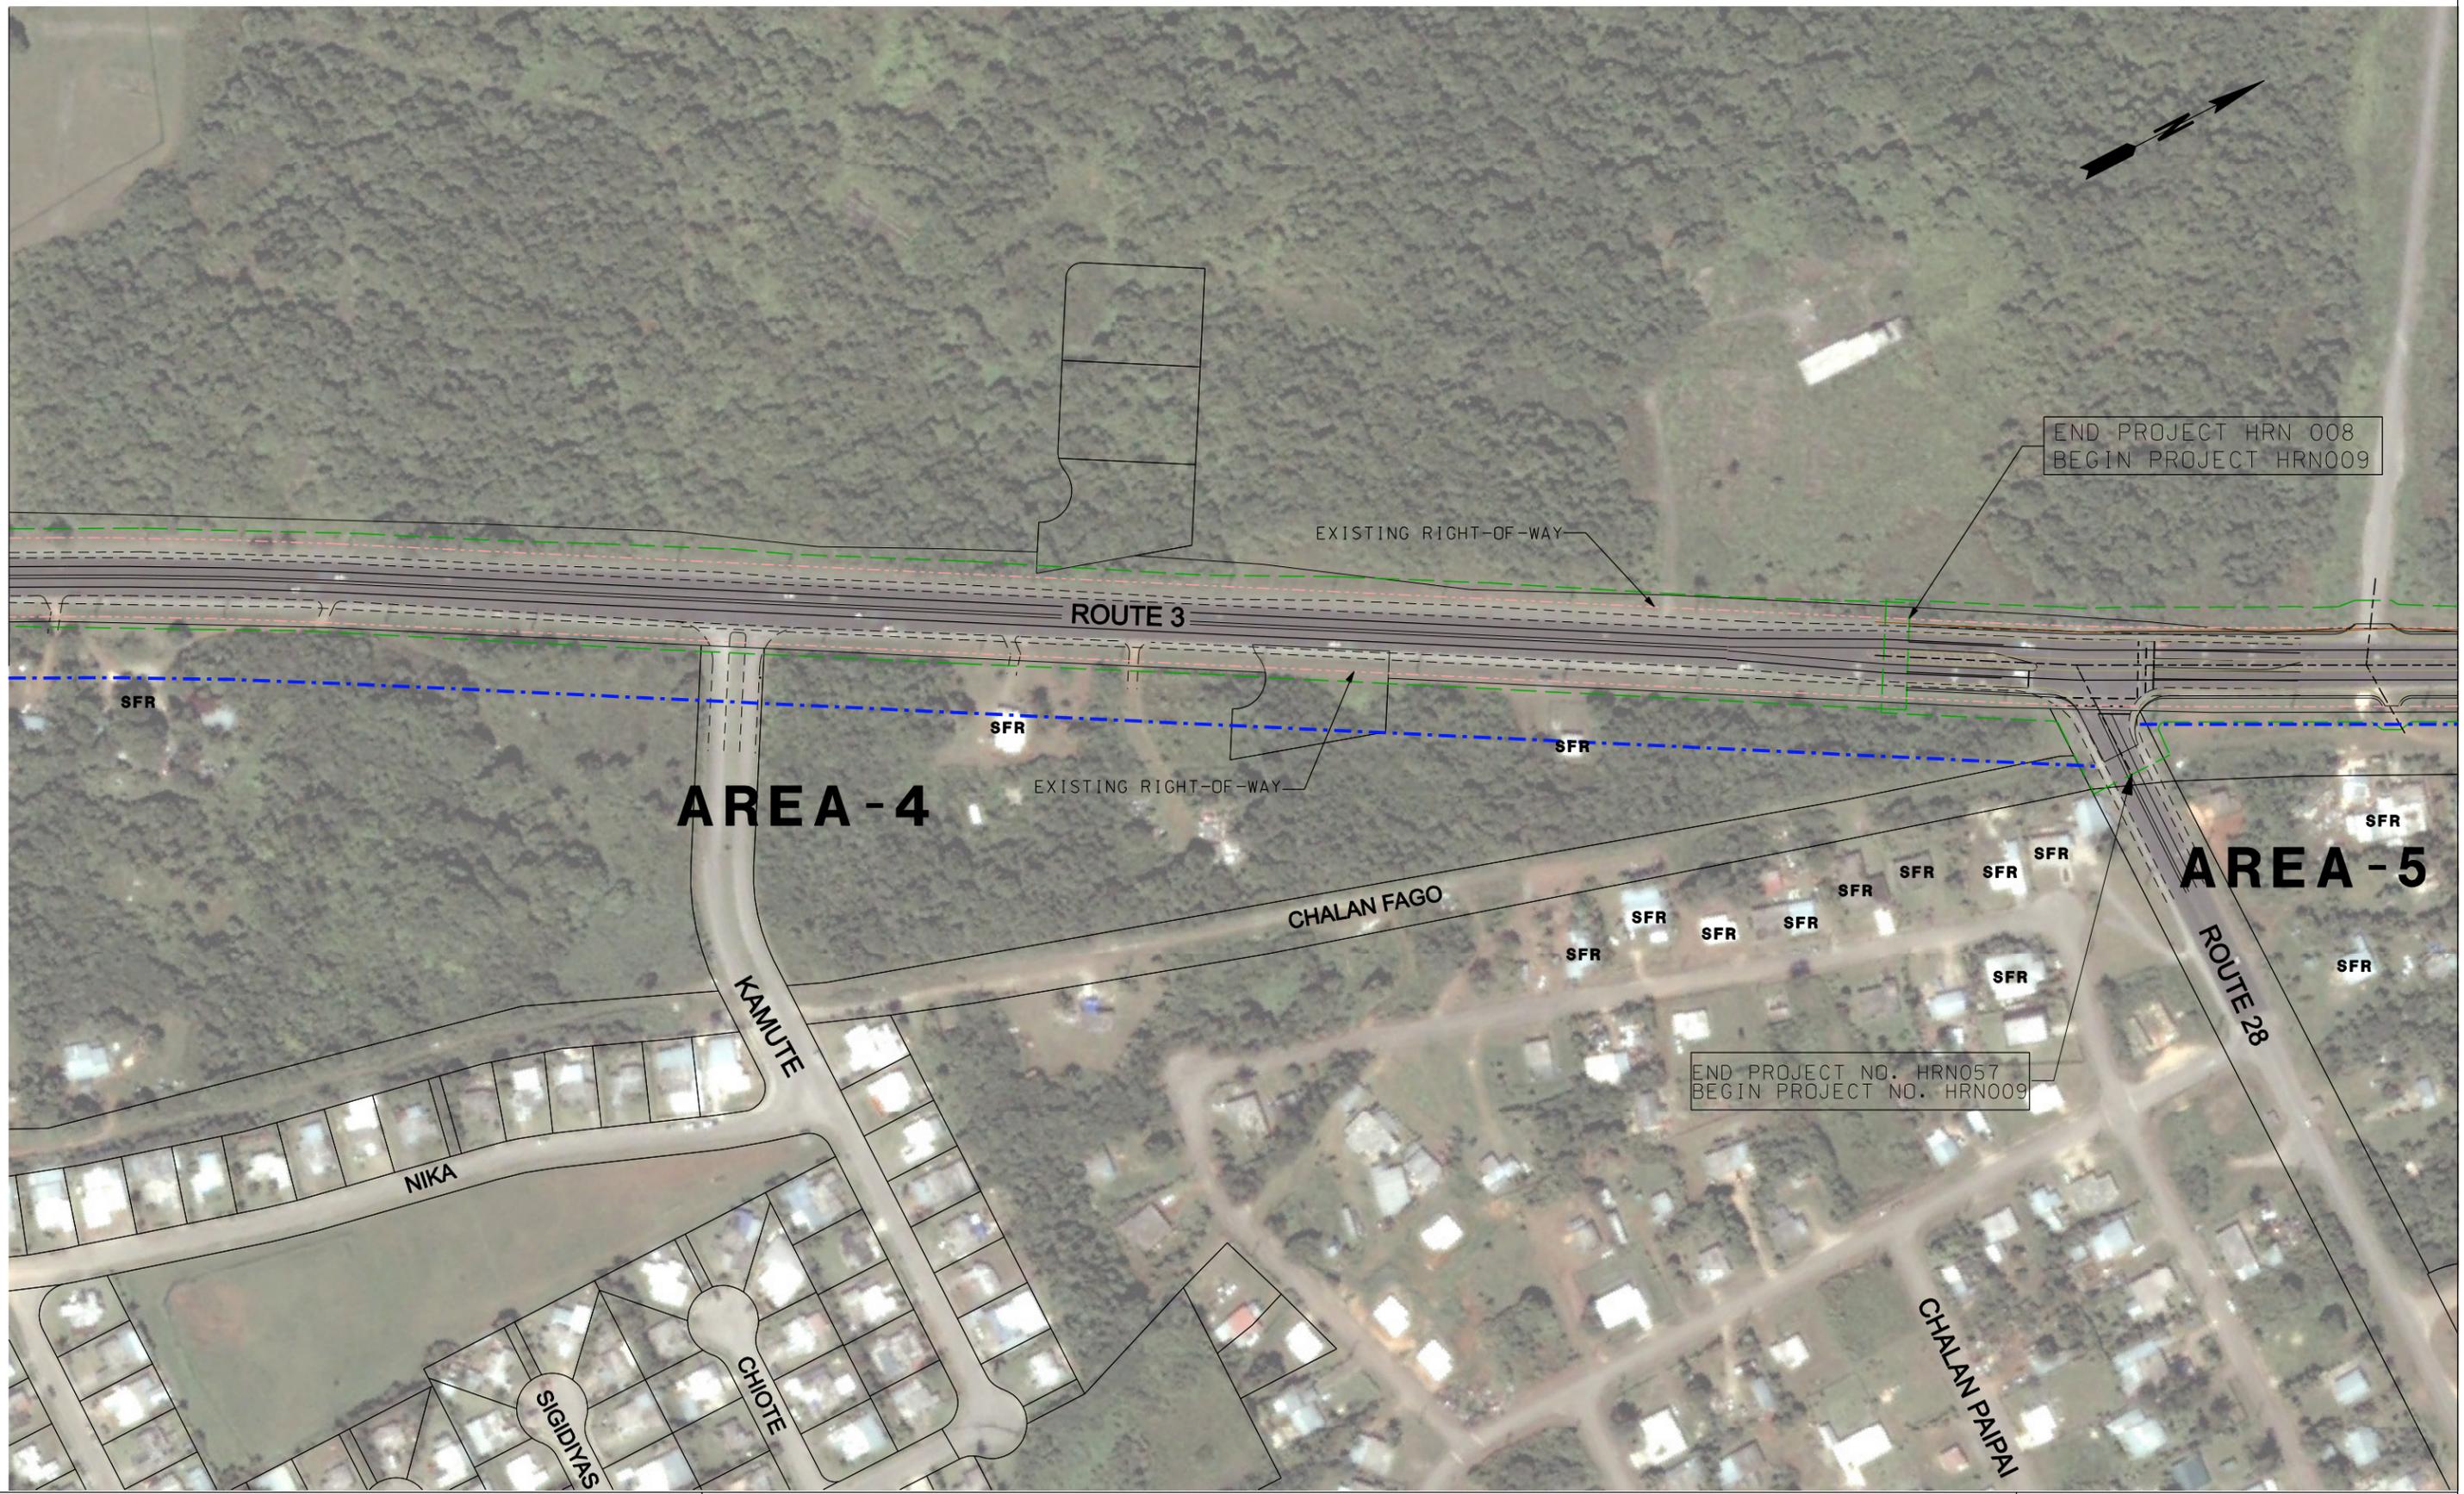
Scale 1"=200' Drawing HRN008 Sheet 5B of 69

**66 dBA NOISE  
IMPACT CONTOUR LINE  
FOR NON ABATEMENT**

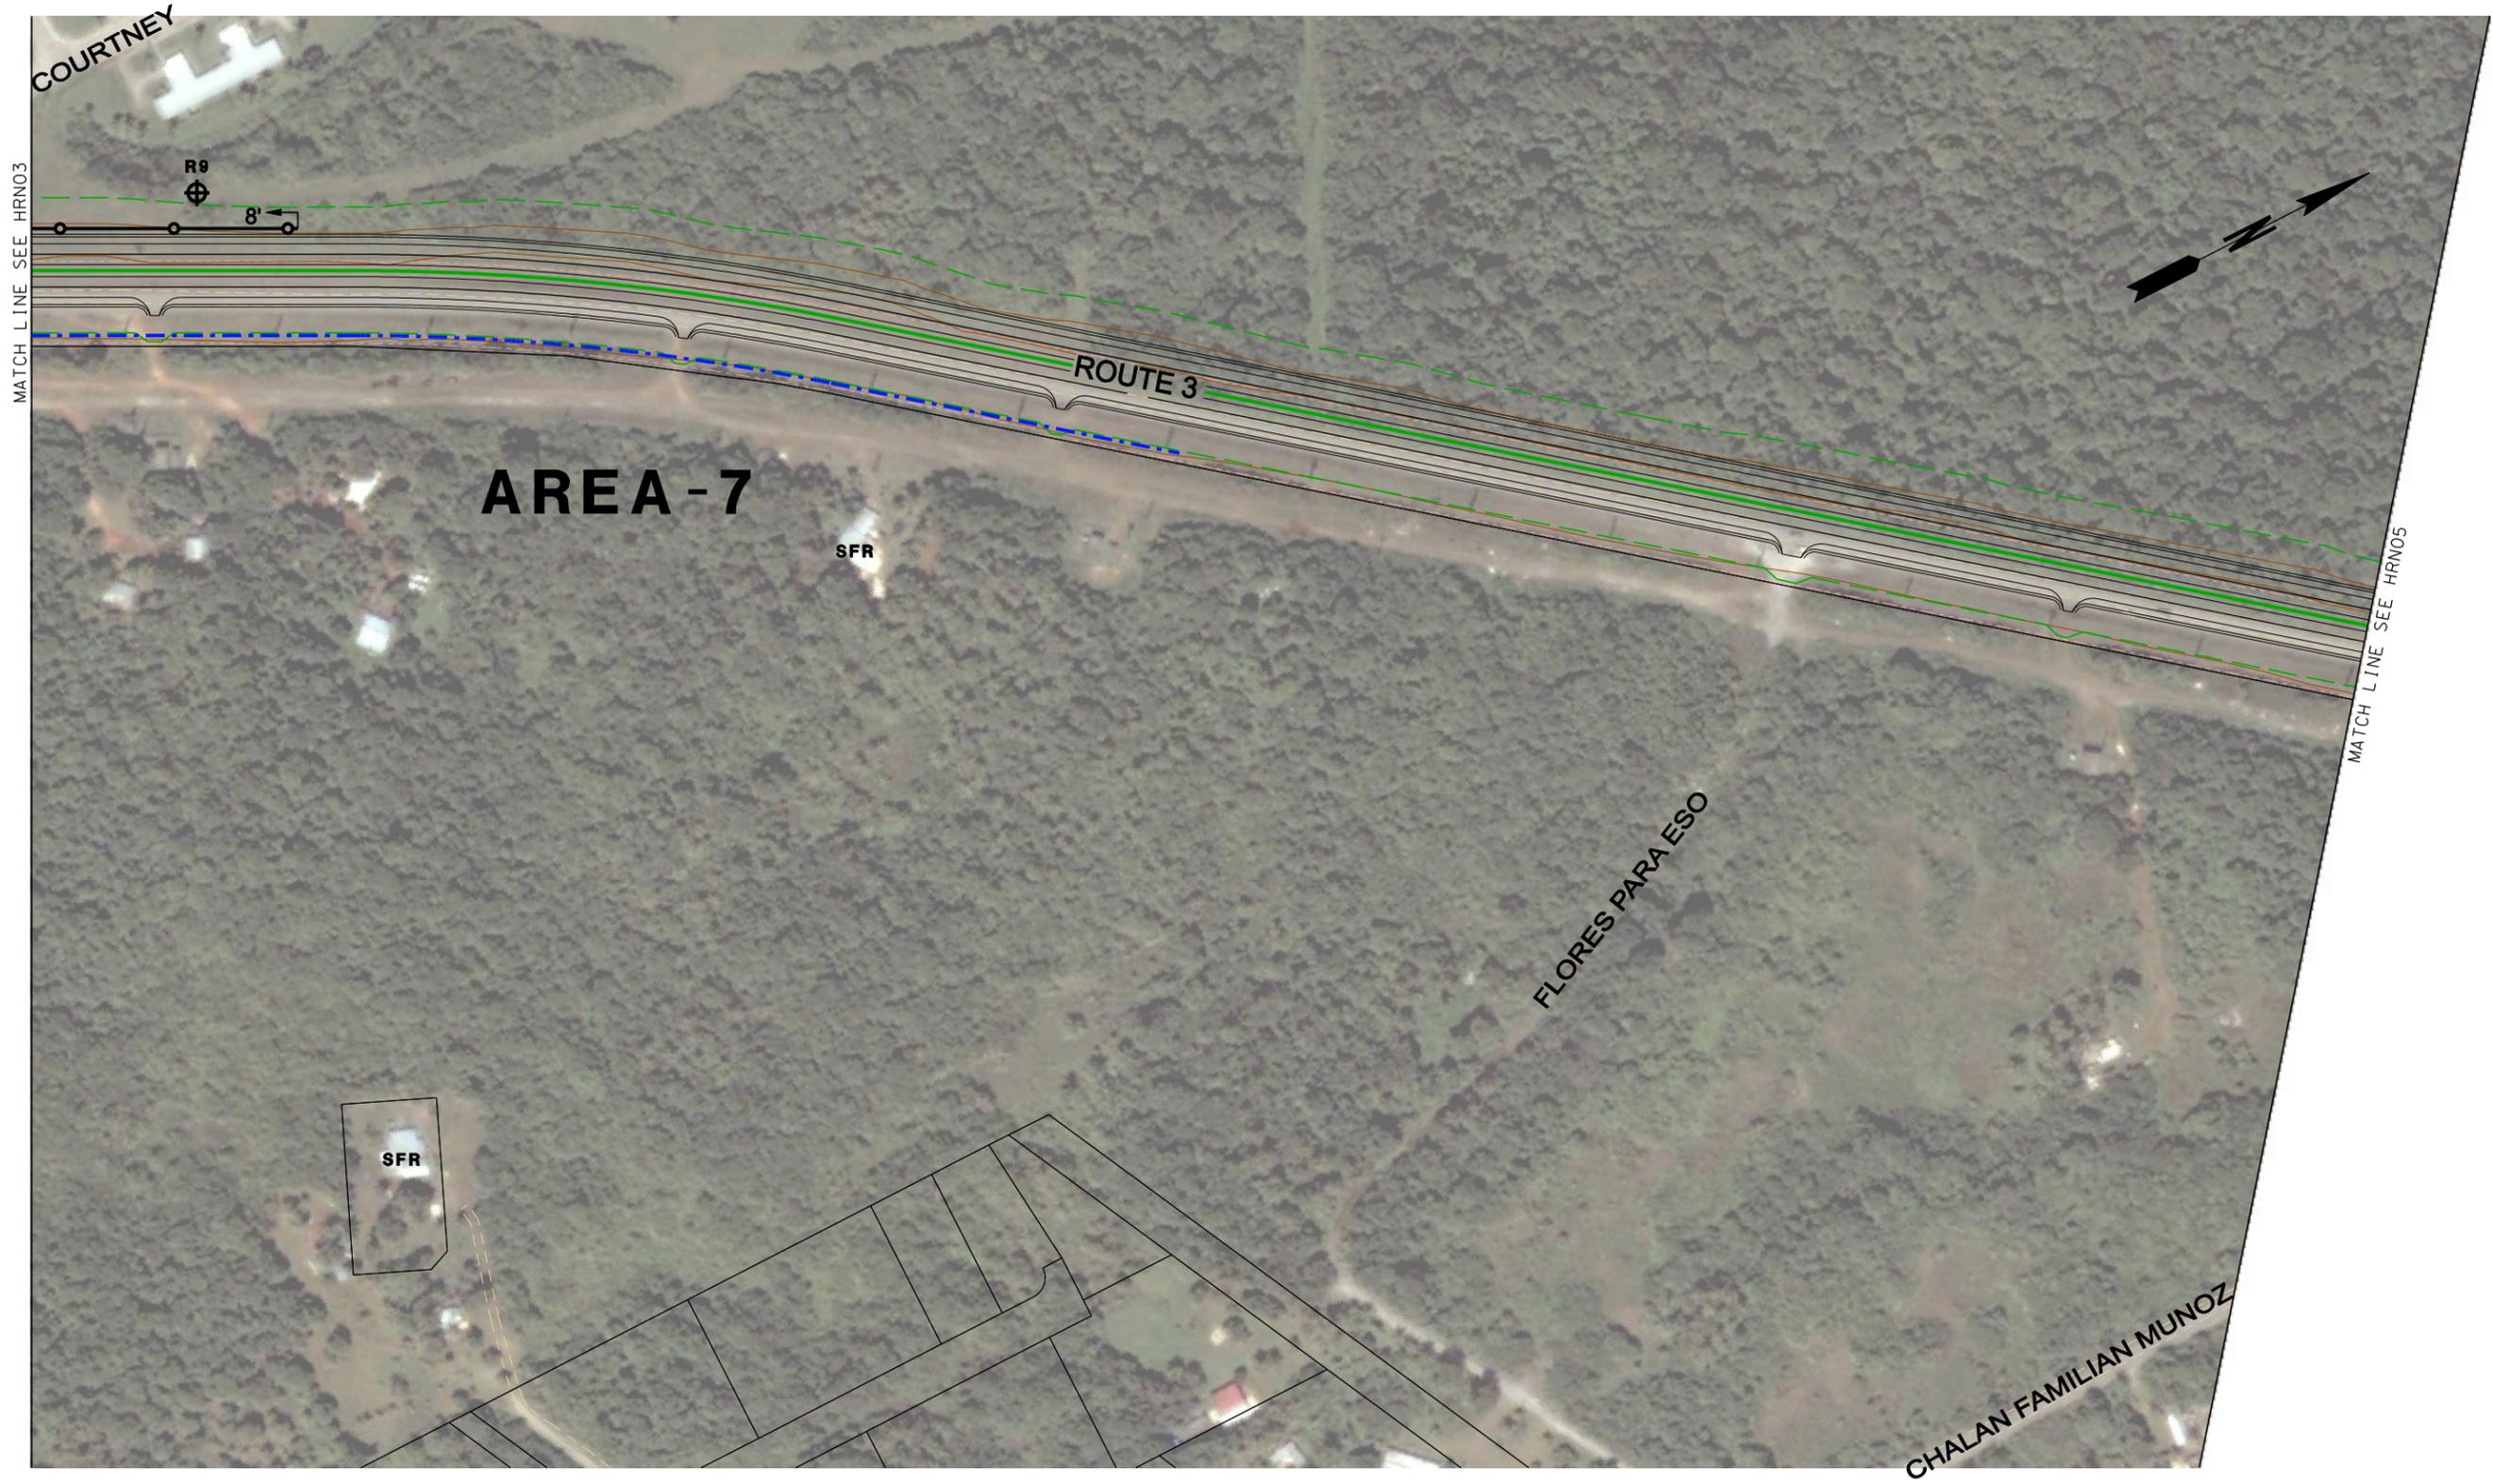
Scale 1"=200' Drawing HRN009 Sheet 8 of 69

**66 dBA NOISE  
IMPACT CONTOUR LINE  
FOR NON ABATEMENT**

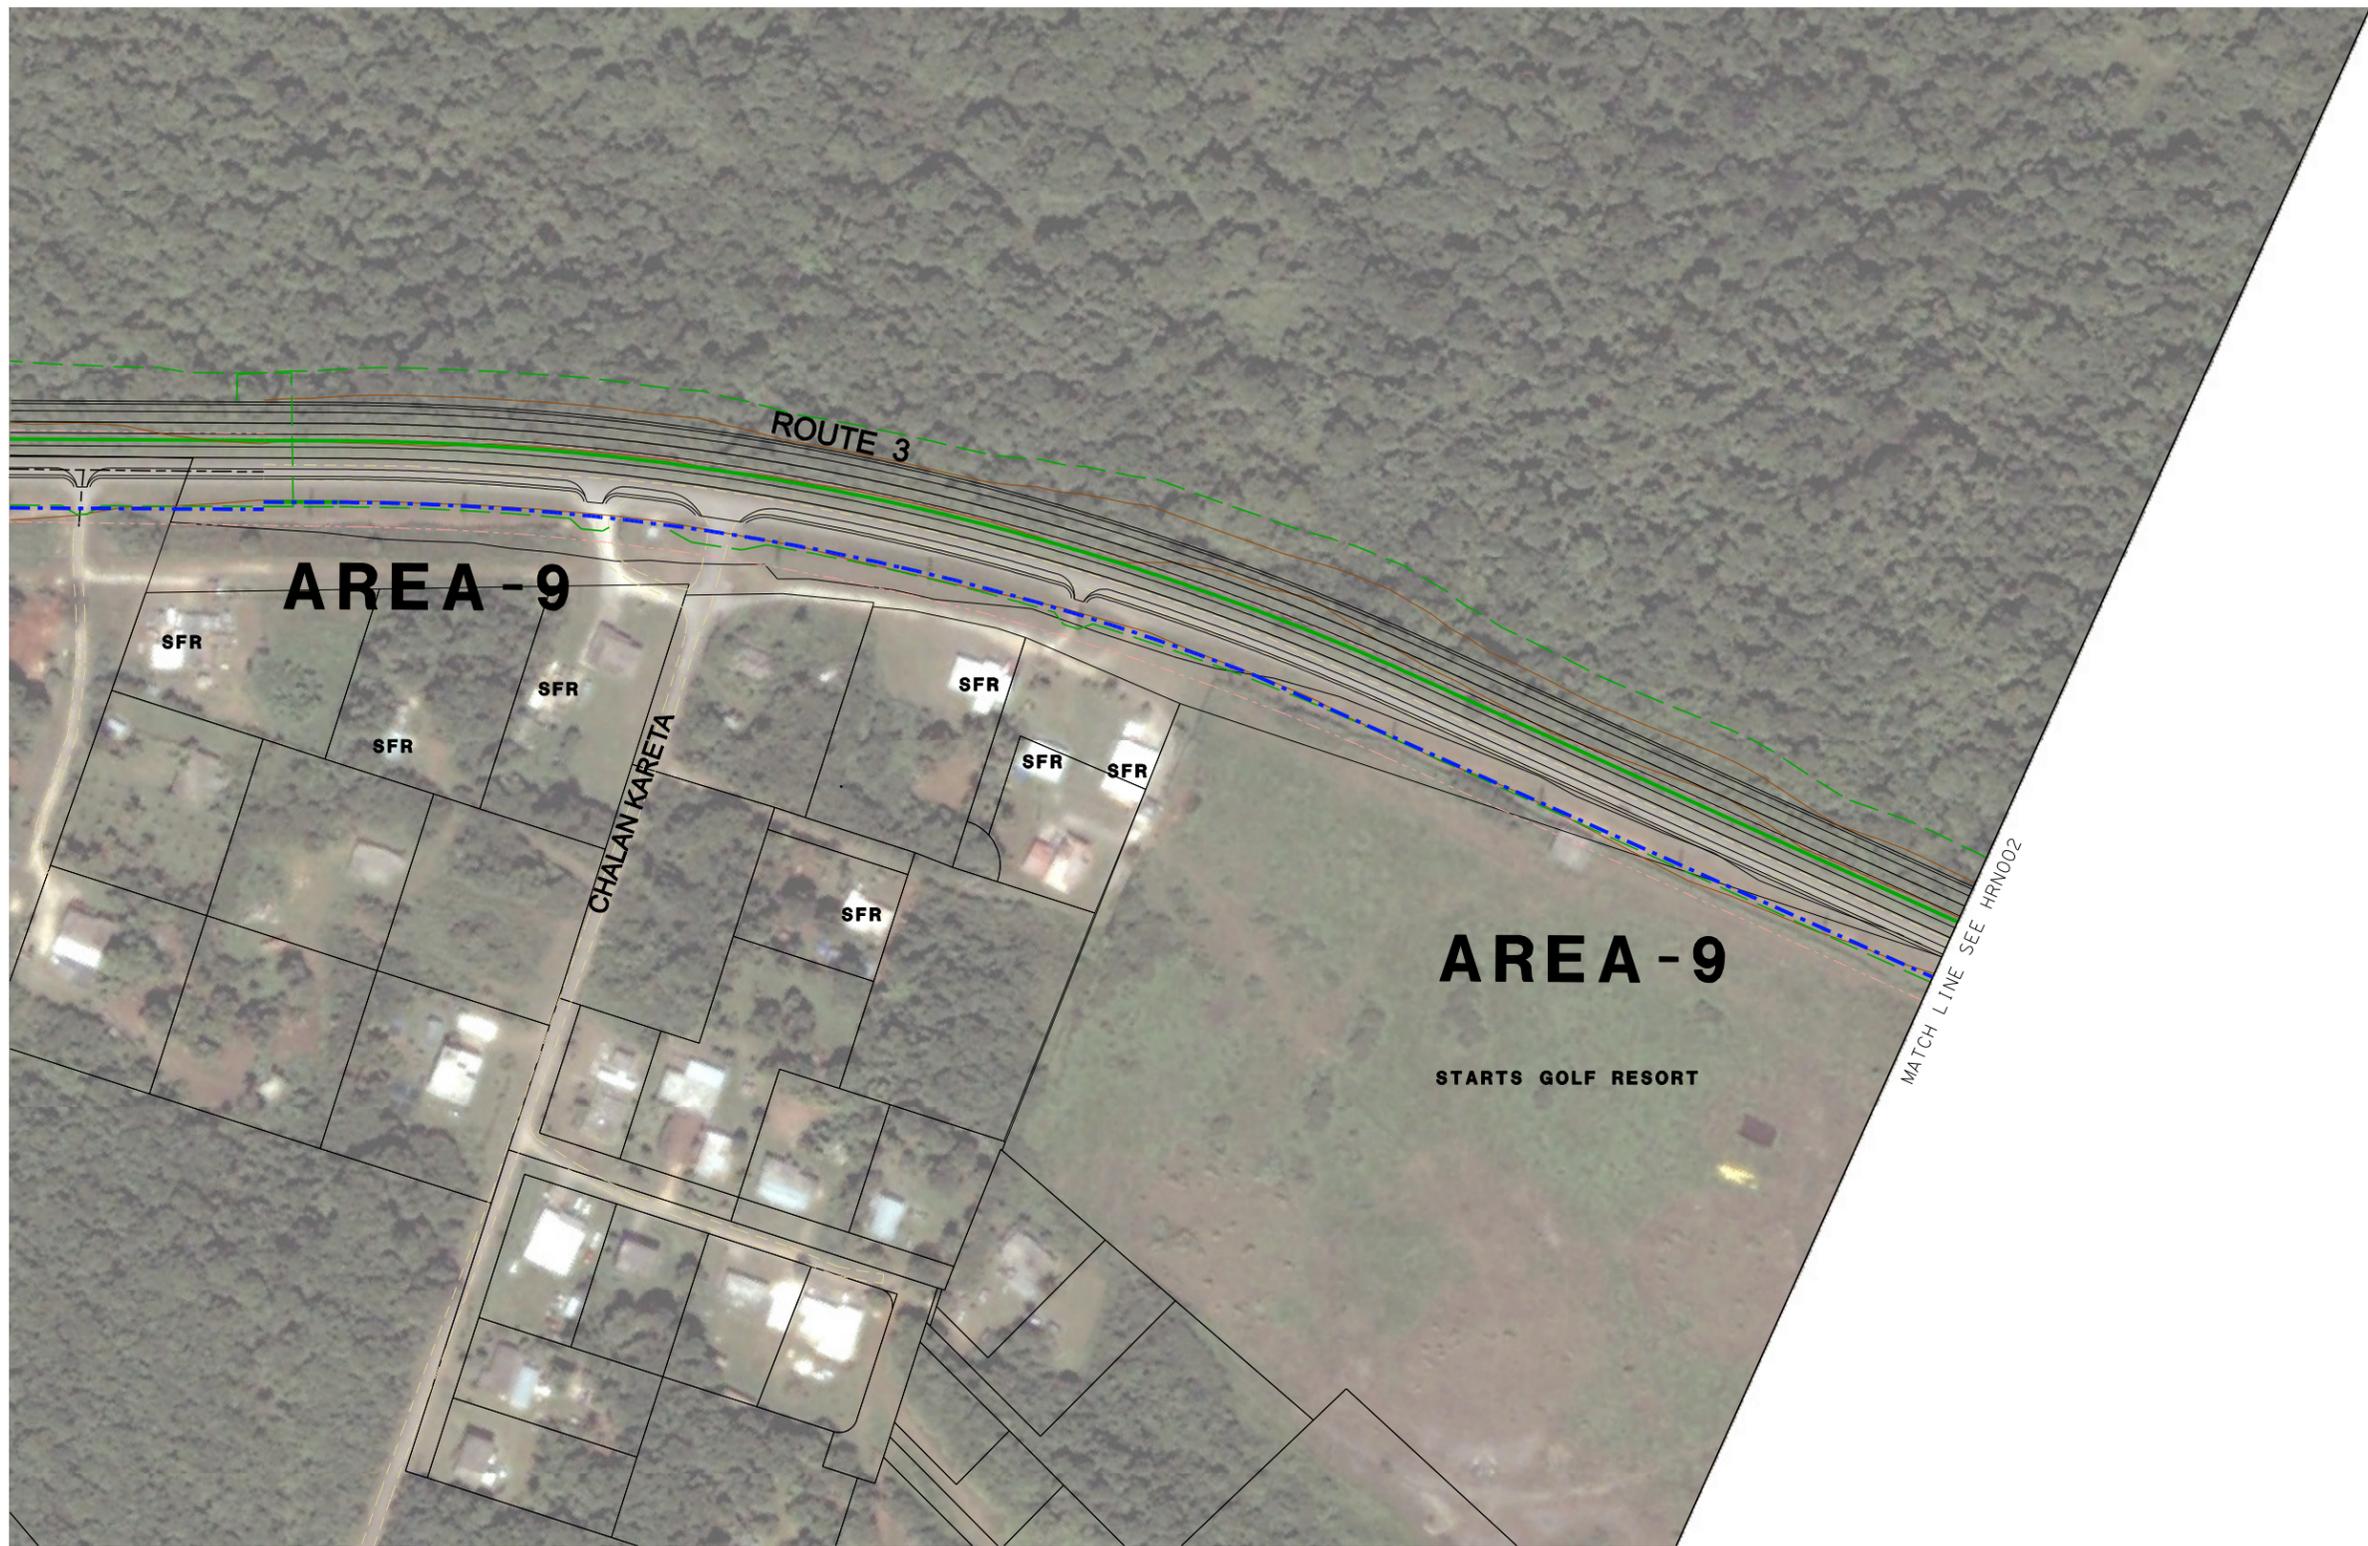
Scale 1"=200' Drawing HRN010 Sheet 10 of 69

**66 dBA NOISE  
IMPACT CONTOUR LINE  
FOR NON ABATEMENT**

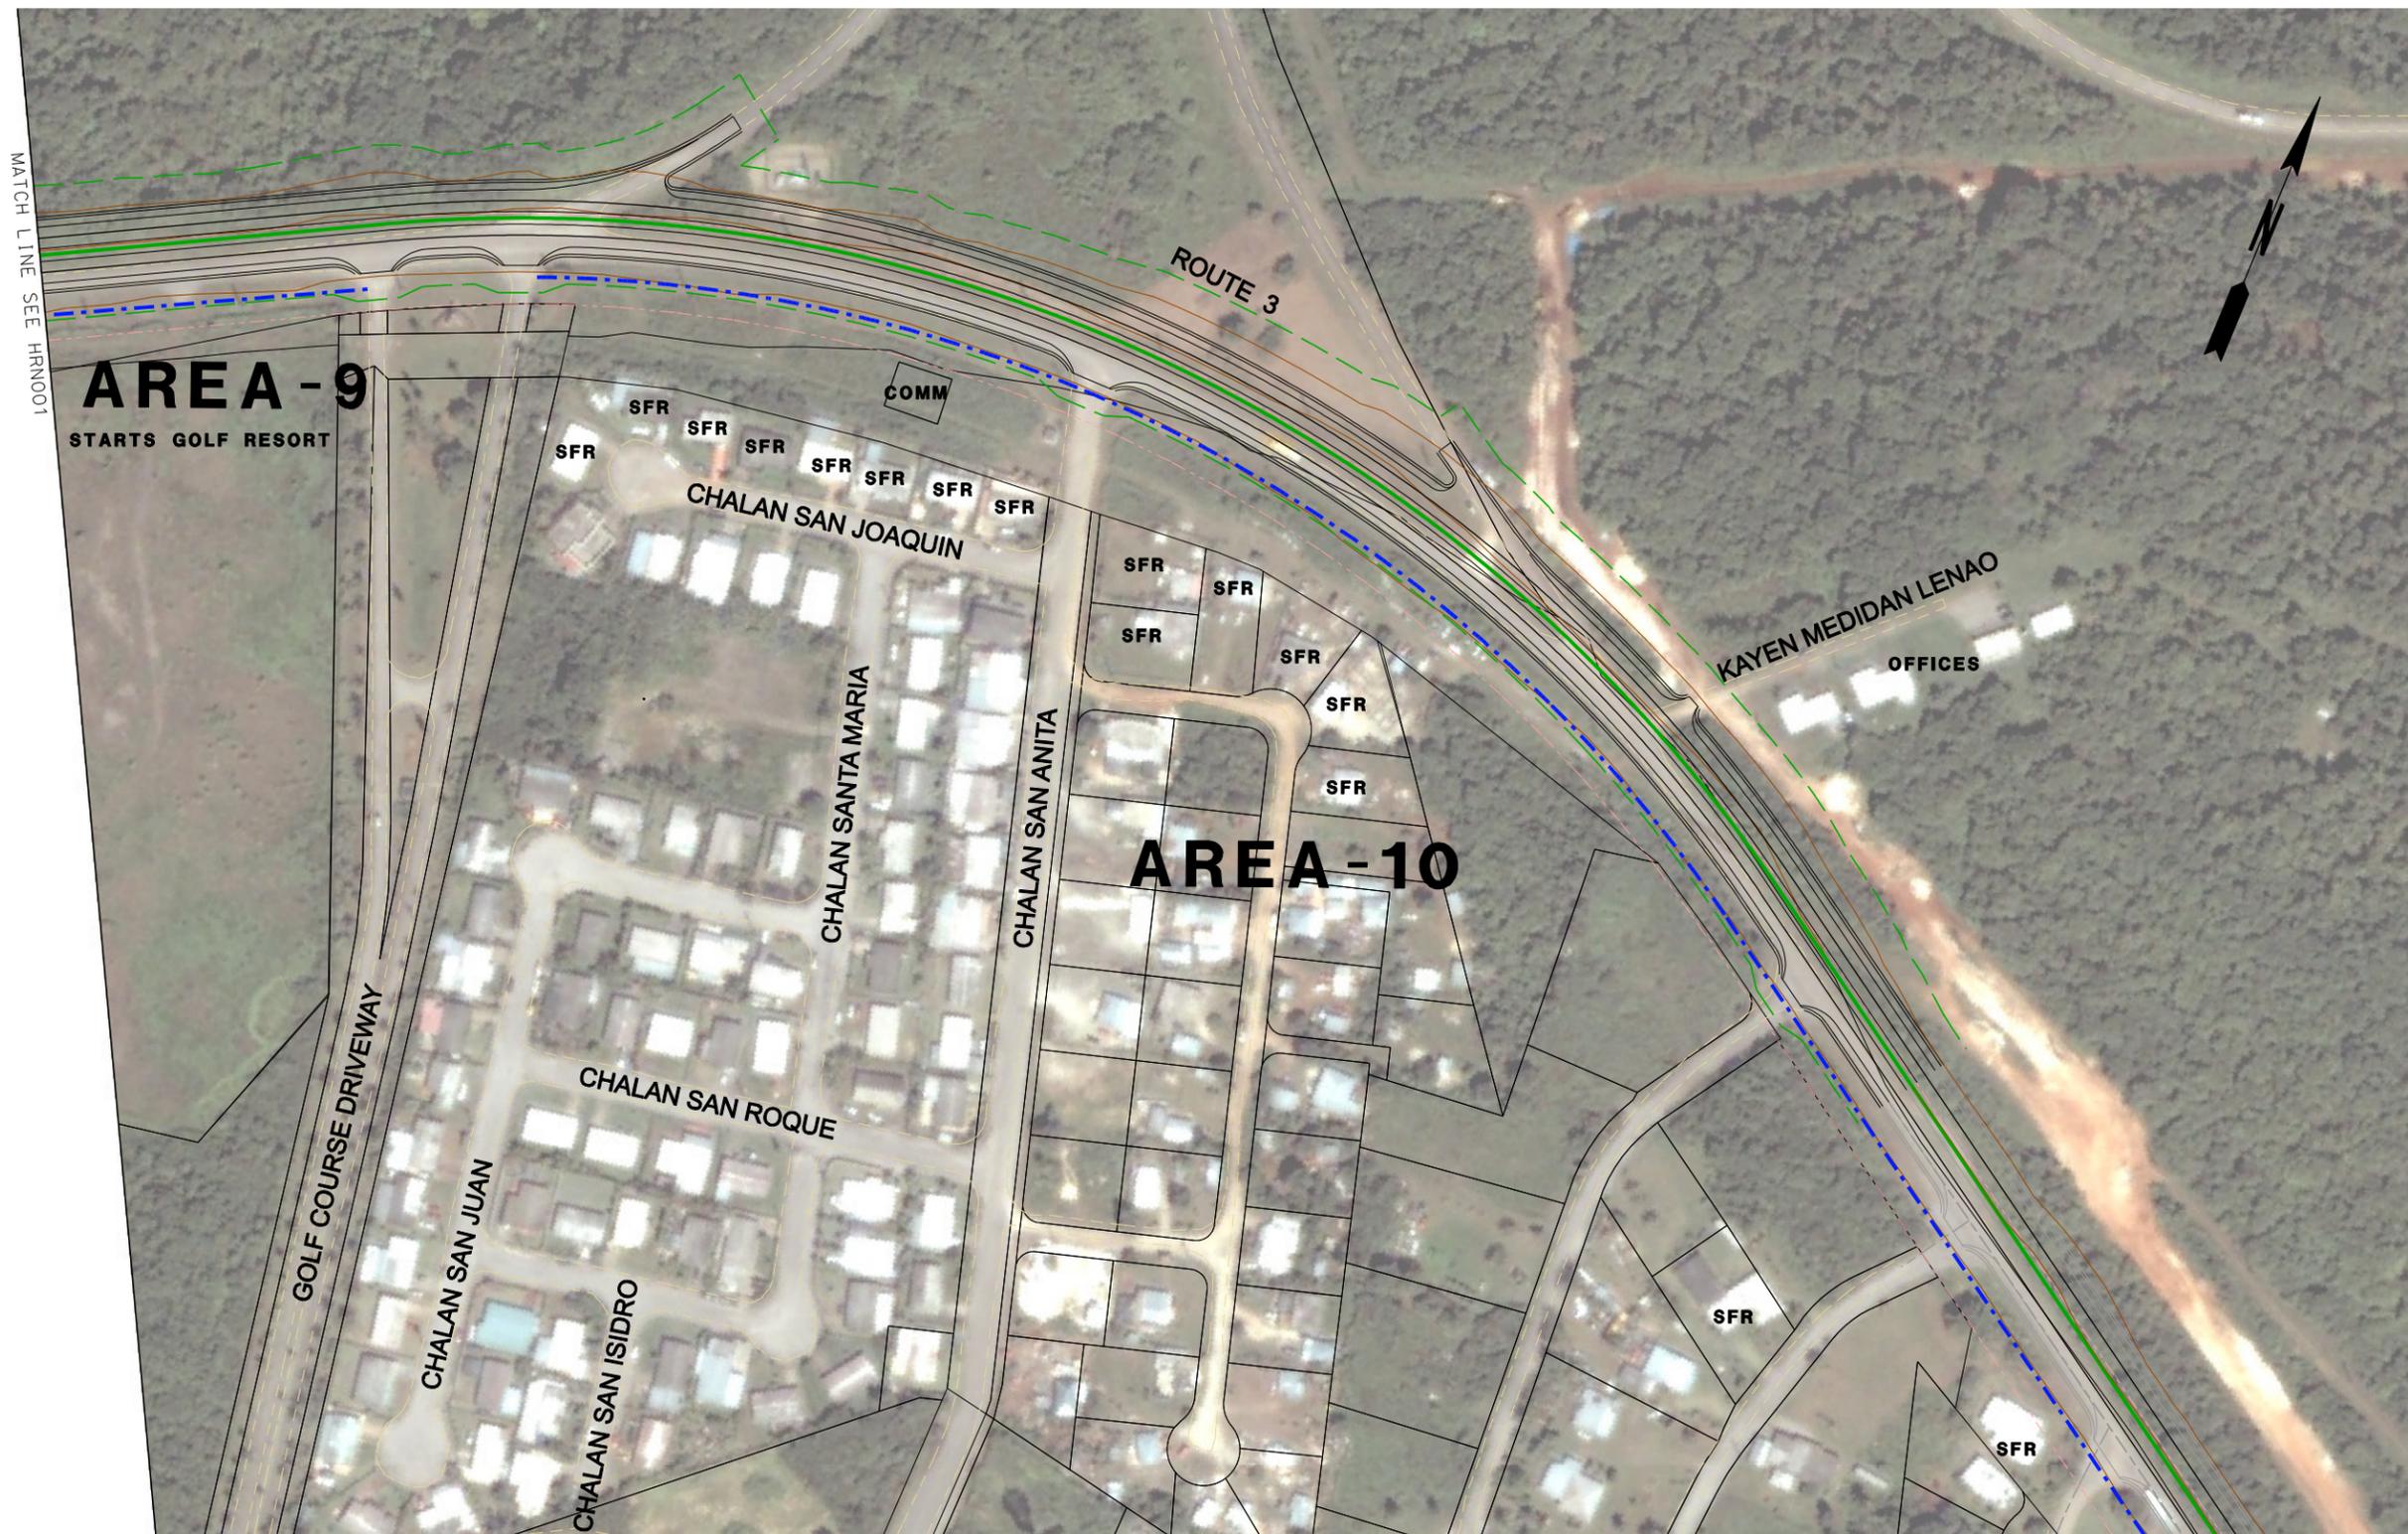
Scale 1"=200' Drawing HRN010 Sheet 11 of 69

**66 dBA NOISE  
IMPACT CONTOUR LINE  
FOR NON ABATEMENT**

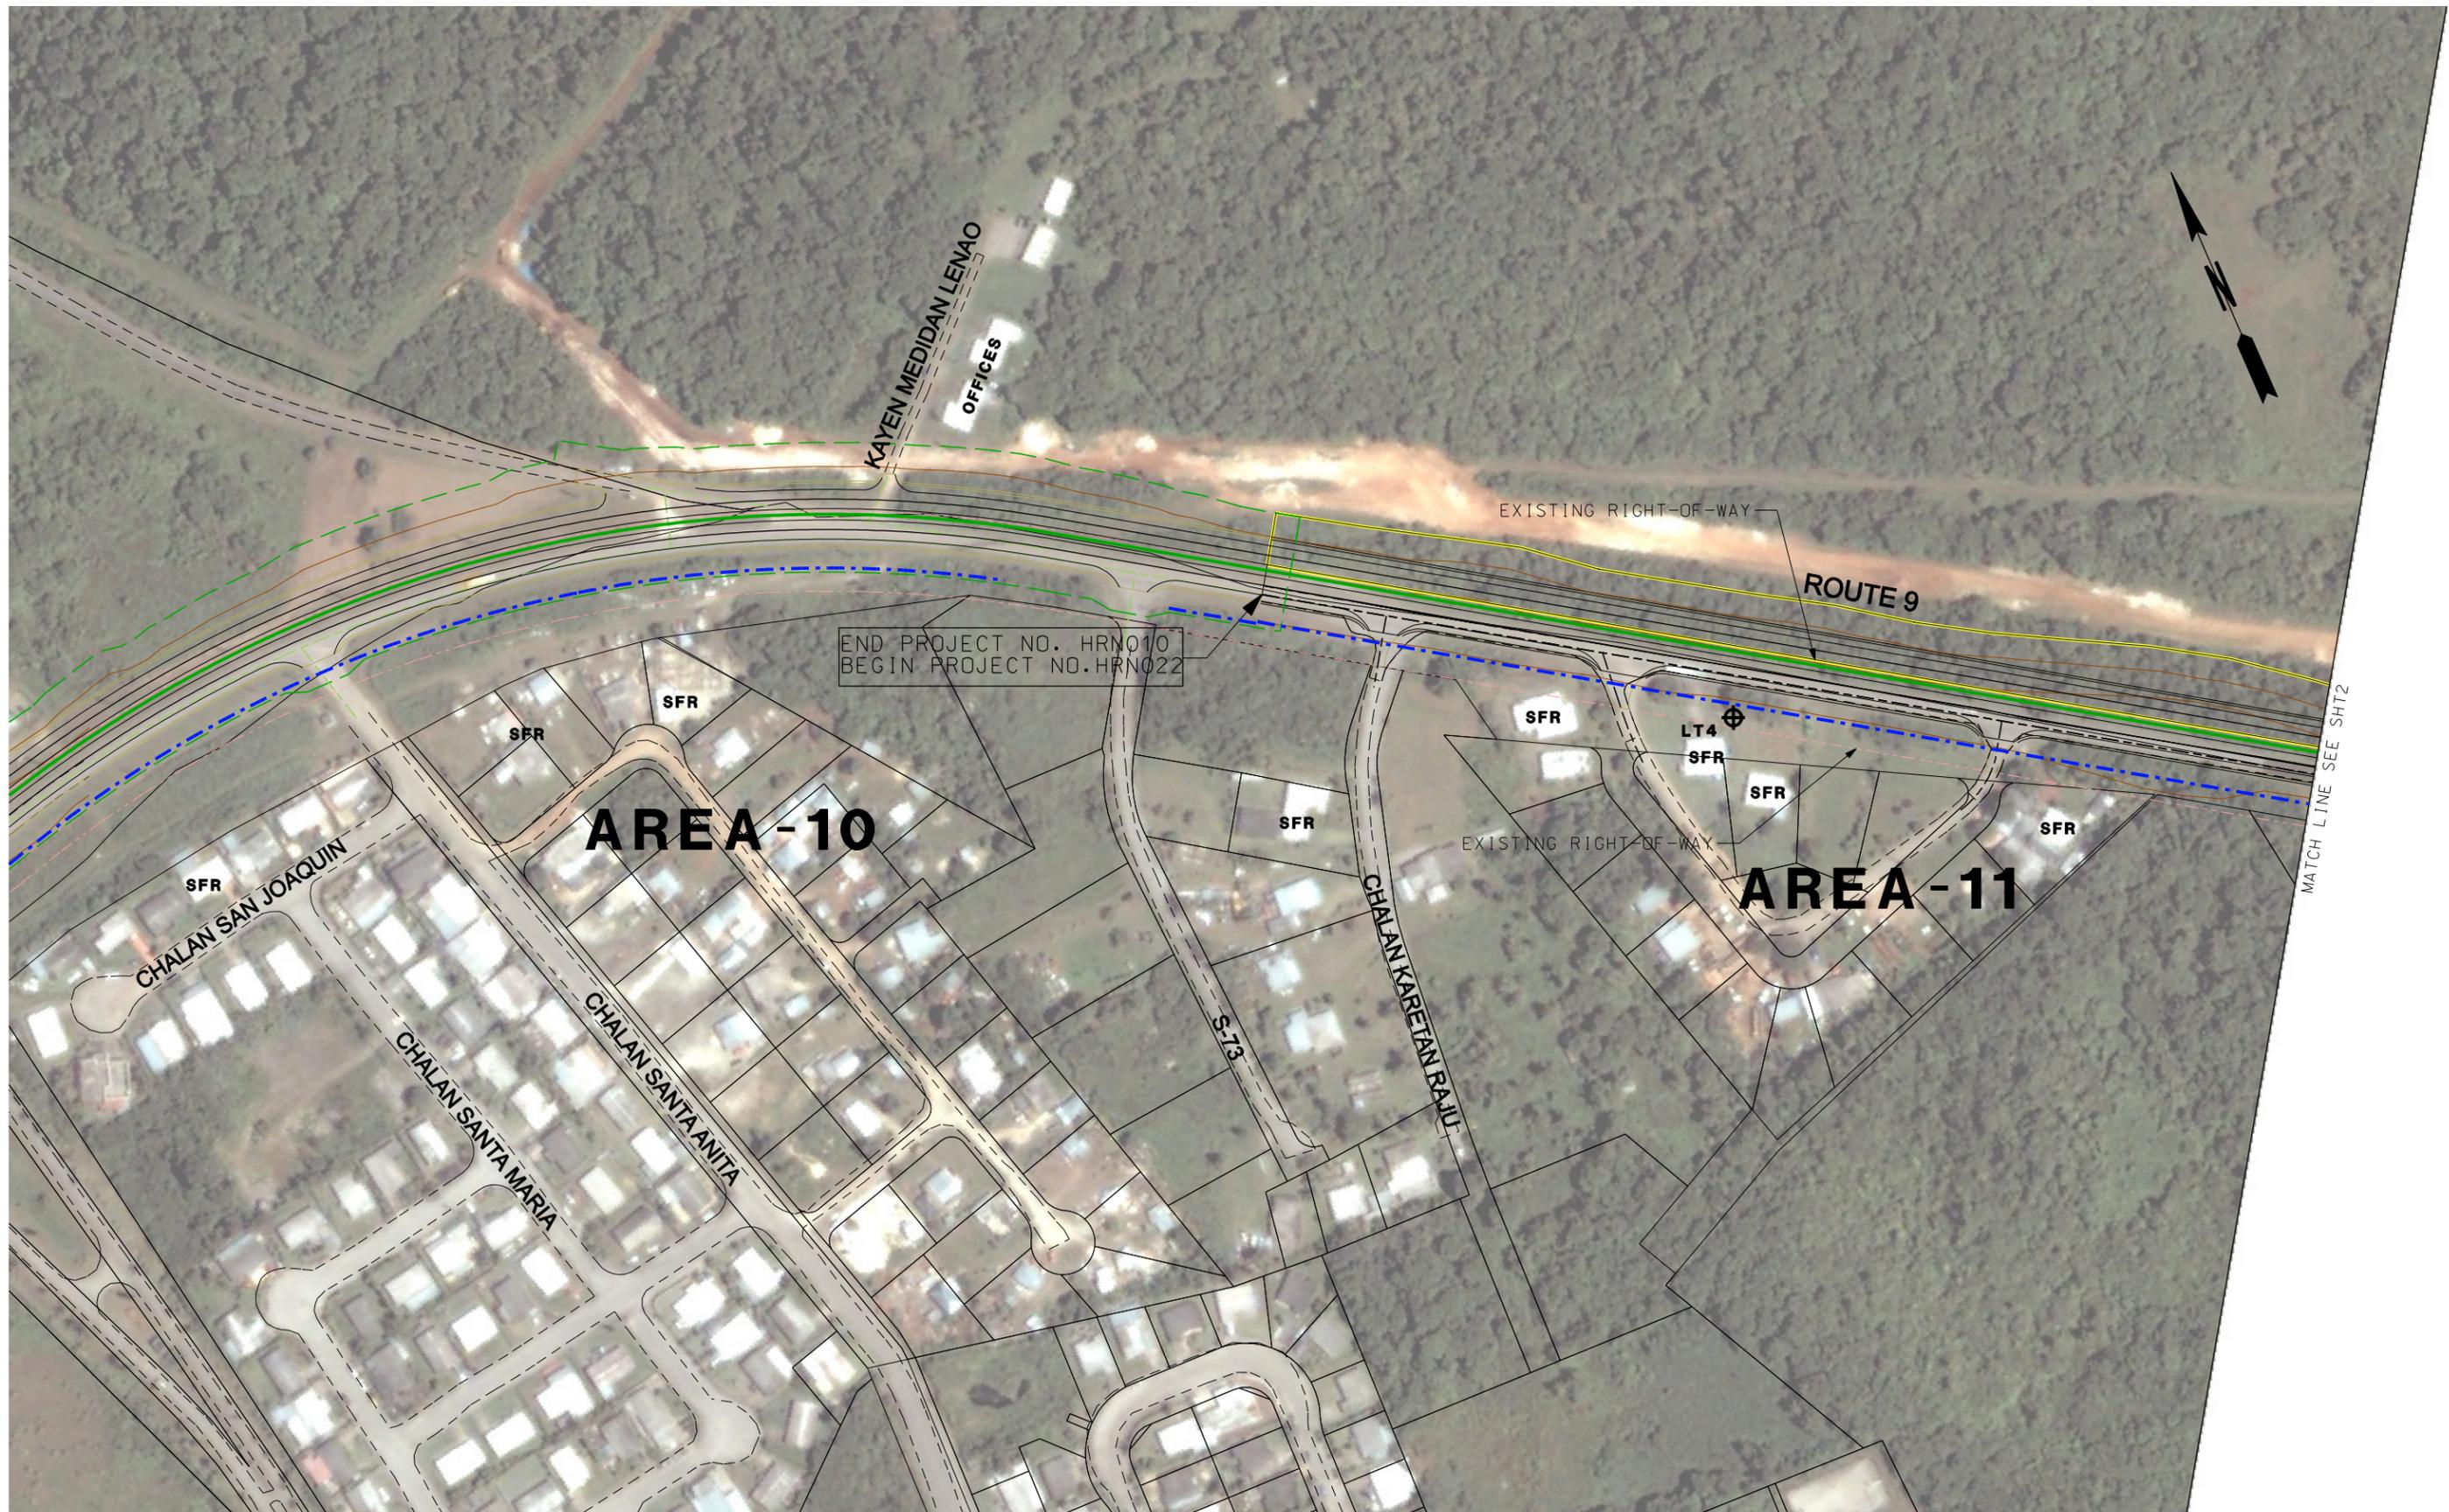
Scale 1"=200 Drawing HRN022 Sheet 12 of 69

**66 dBA NOISE  
 IMPACT CONTOUR LINE  
 FOR NON ABATEMENT**

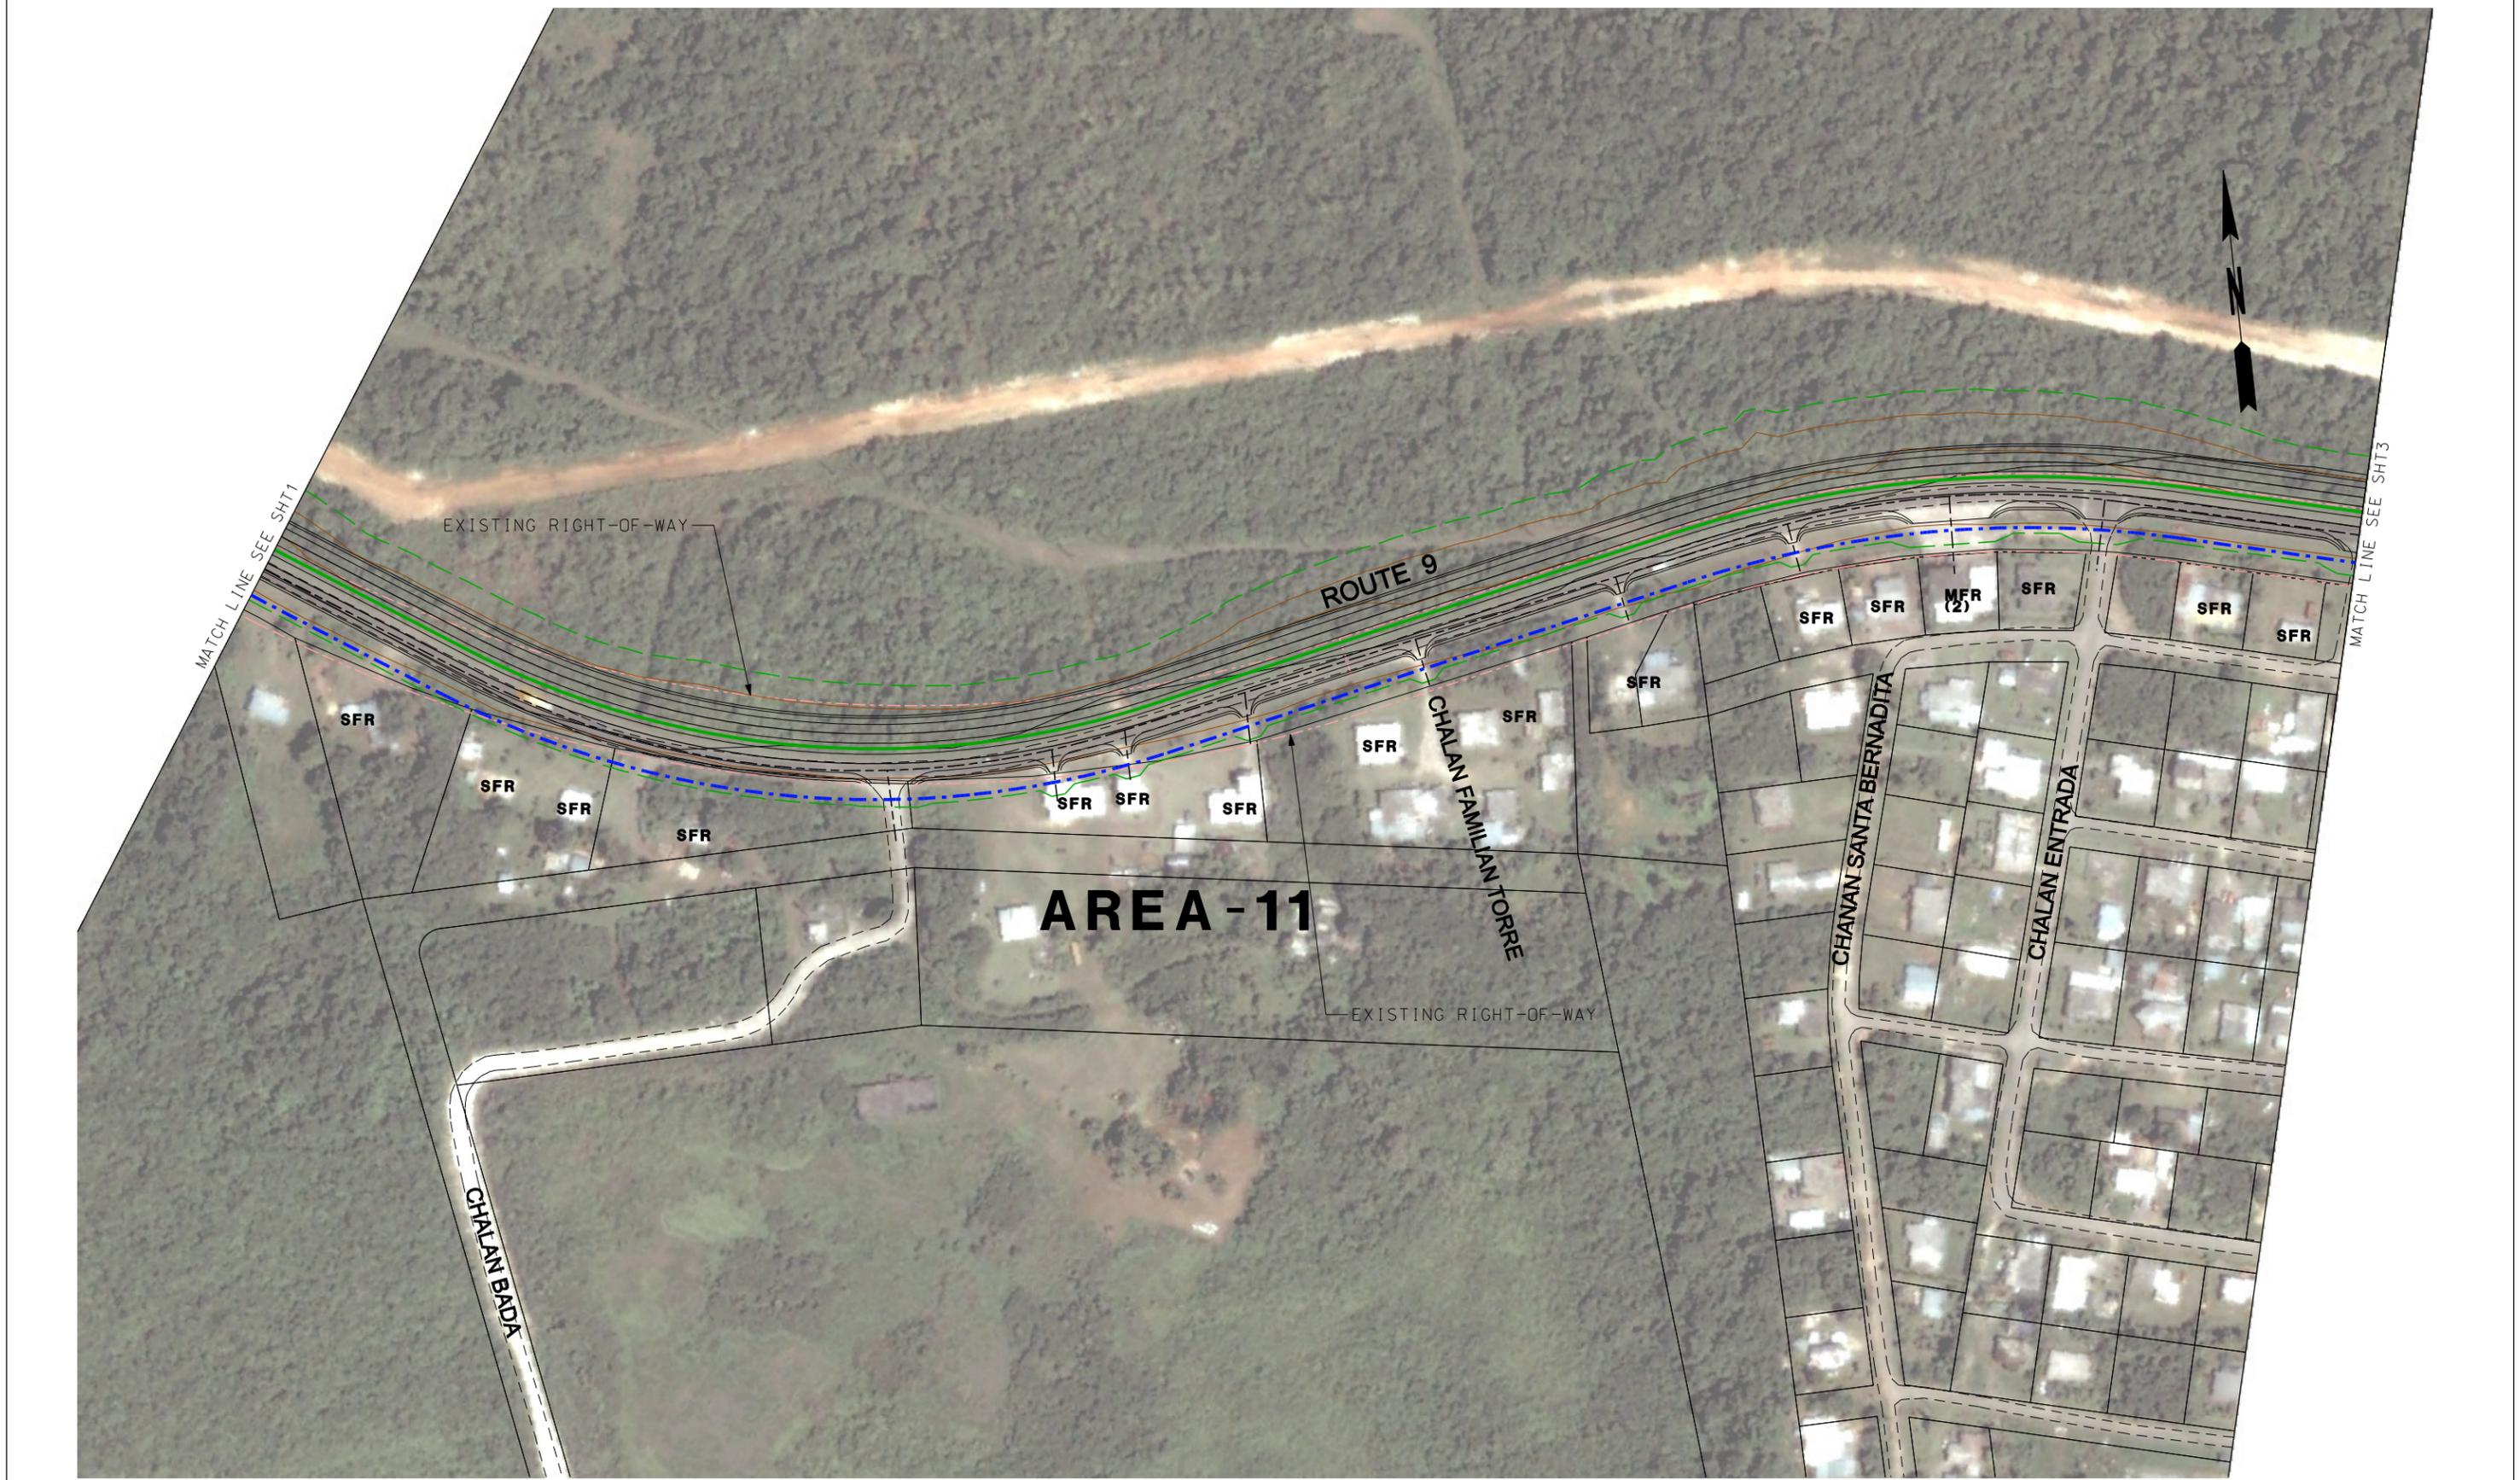
Scale 1"=200 Drawing HRN022 Sheet 13 of 69

**66 dBA NOISE  
IMPACT CONTOUR LINE  
FOR NON ABATEMENT**
