## Appendix G

### EIS Resource Technical Appendix

# Guam and CNMI Military Relocation EIS

## Volume 9: EIS Resource Technical Appendix

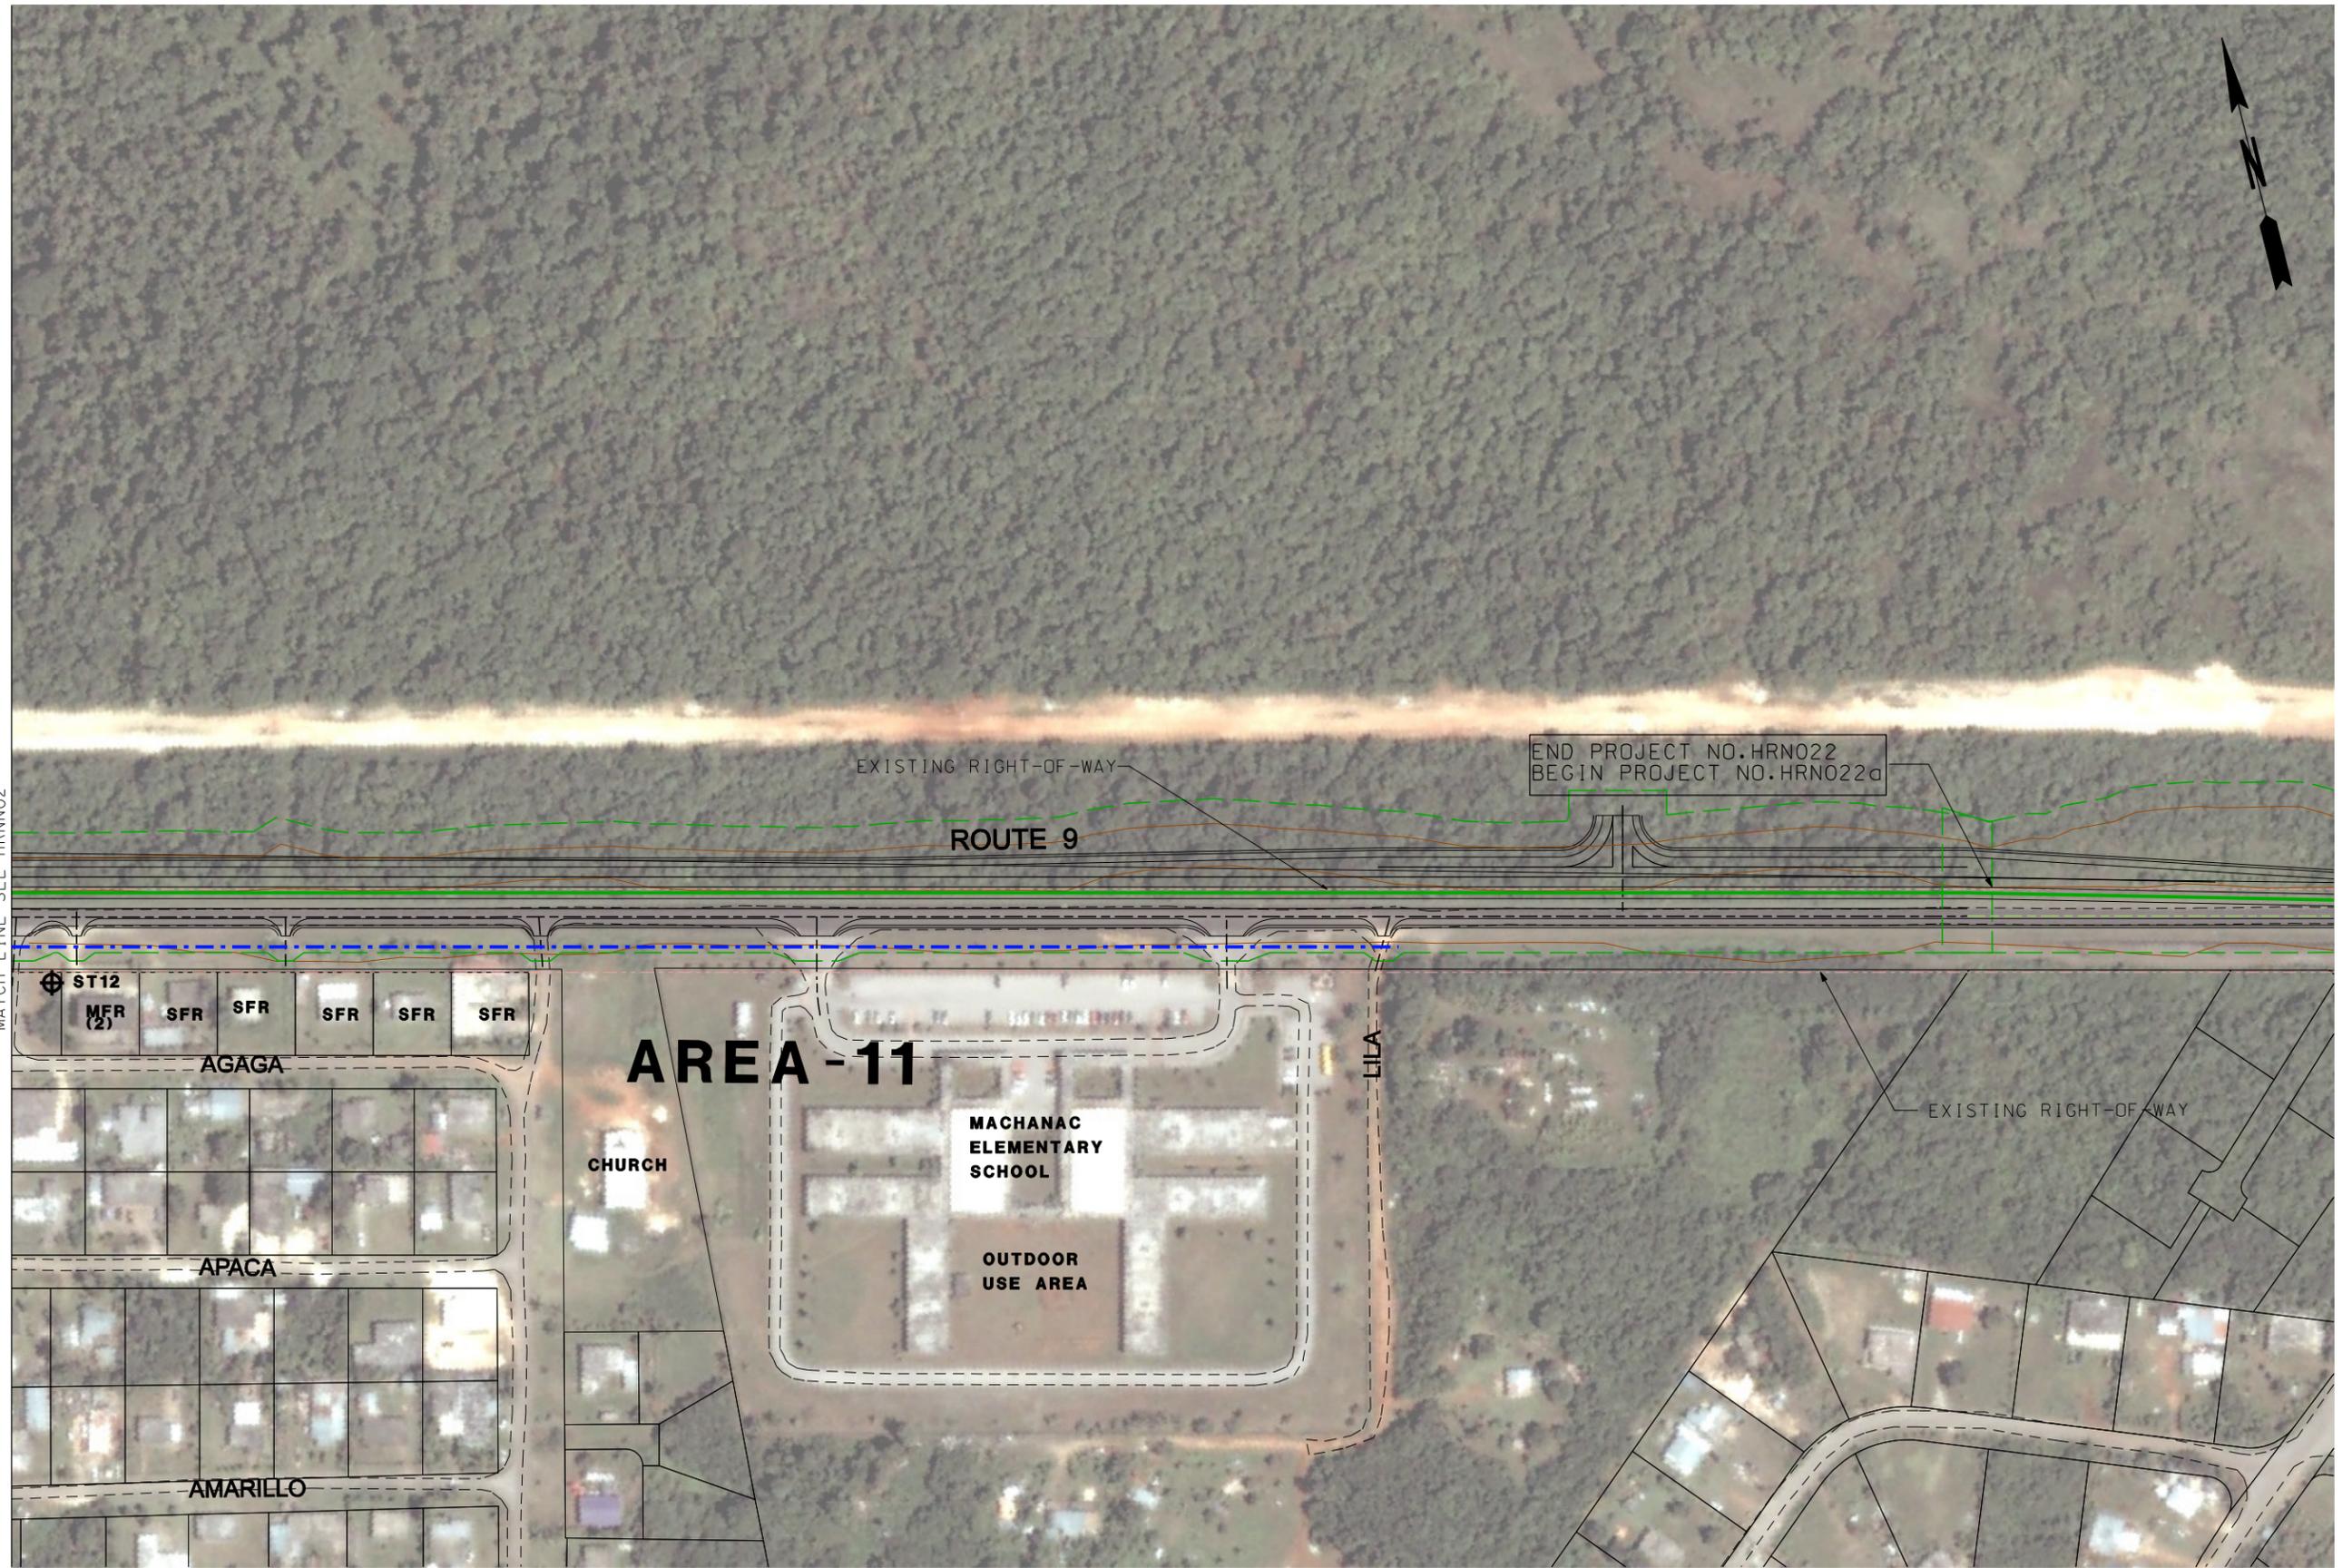
Scale 1"=200 Drawing HRN022 Sheet 14 of 69

**66 dBA NOISE  
IMPACT CONTOUR LINE  
FOR NON ABATEMENT**

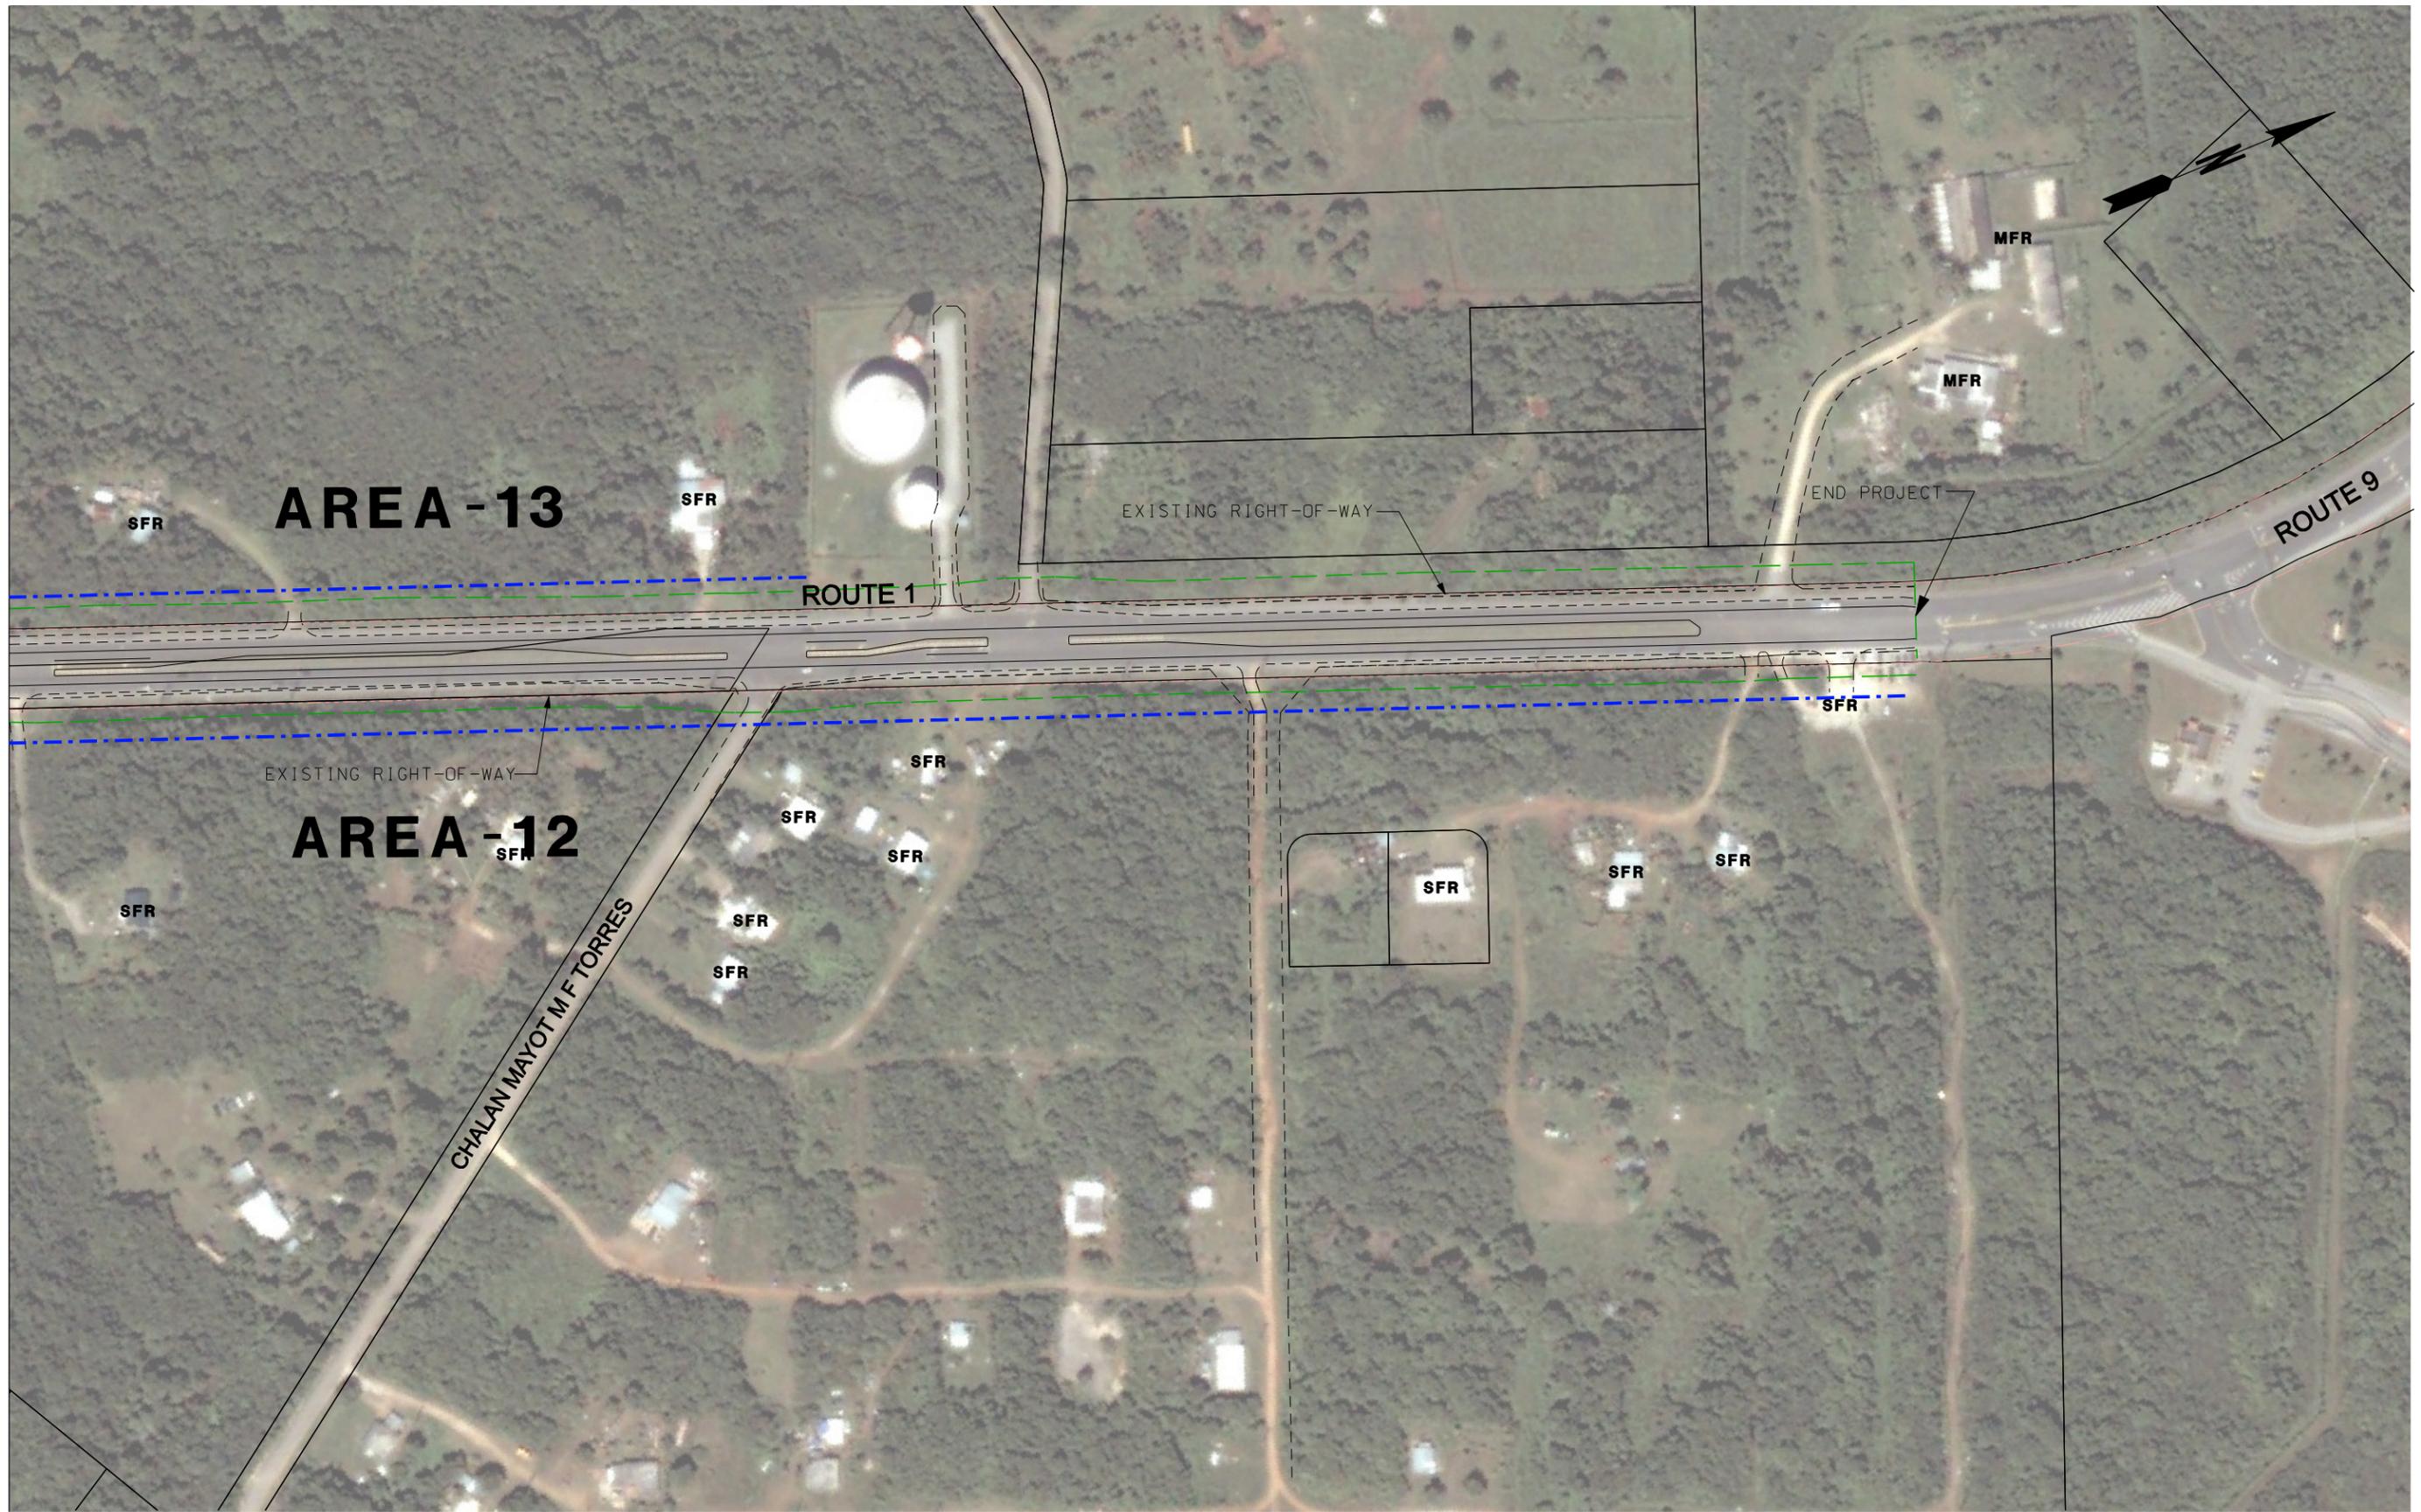
Scale 1"=200' Drawing HRN023 Sheet 15 of 69

**66 dBA NOISE IMPACT CONTOUR LINE FOR NON ABATEMENT**

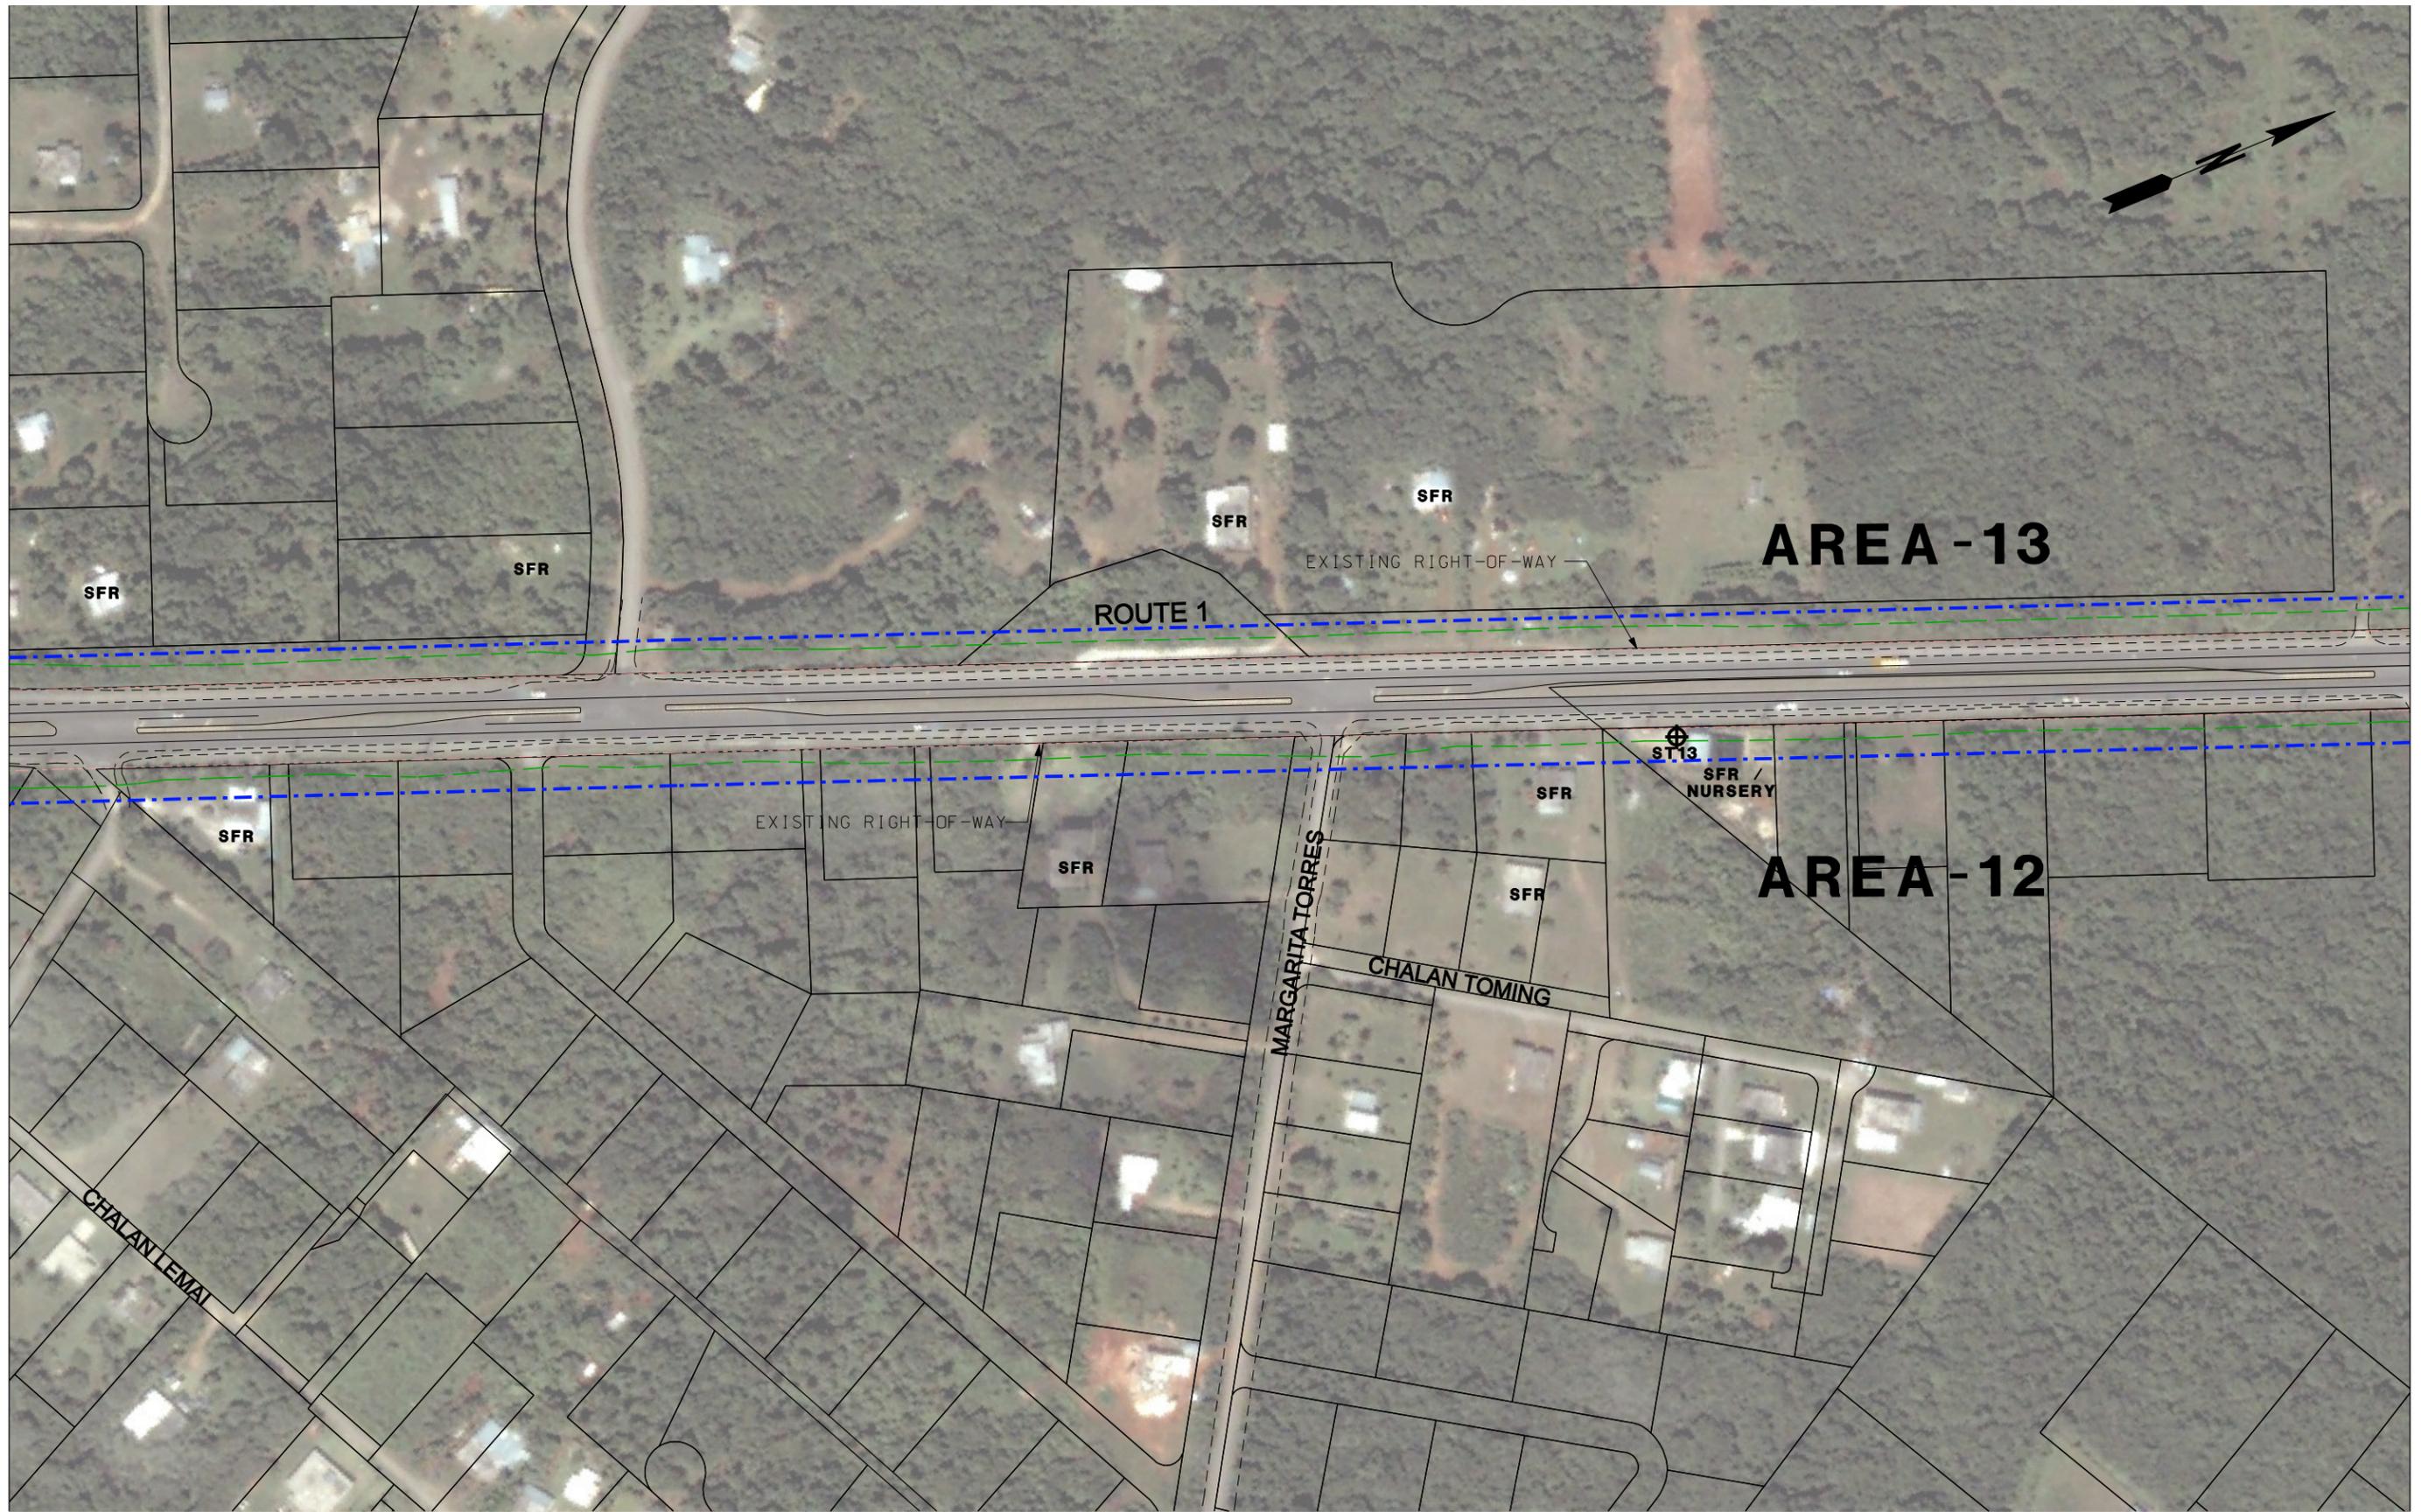
Scale 1"=200' Drawing HRN023 Sheet 16 of 69

**66 dBA NOISE  
IMPACT CONTOUR LINE  
FOR NON ABATEMENT**

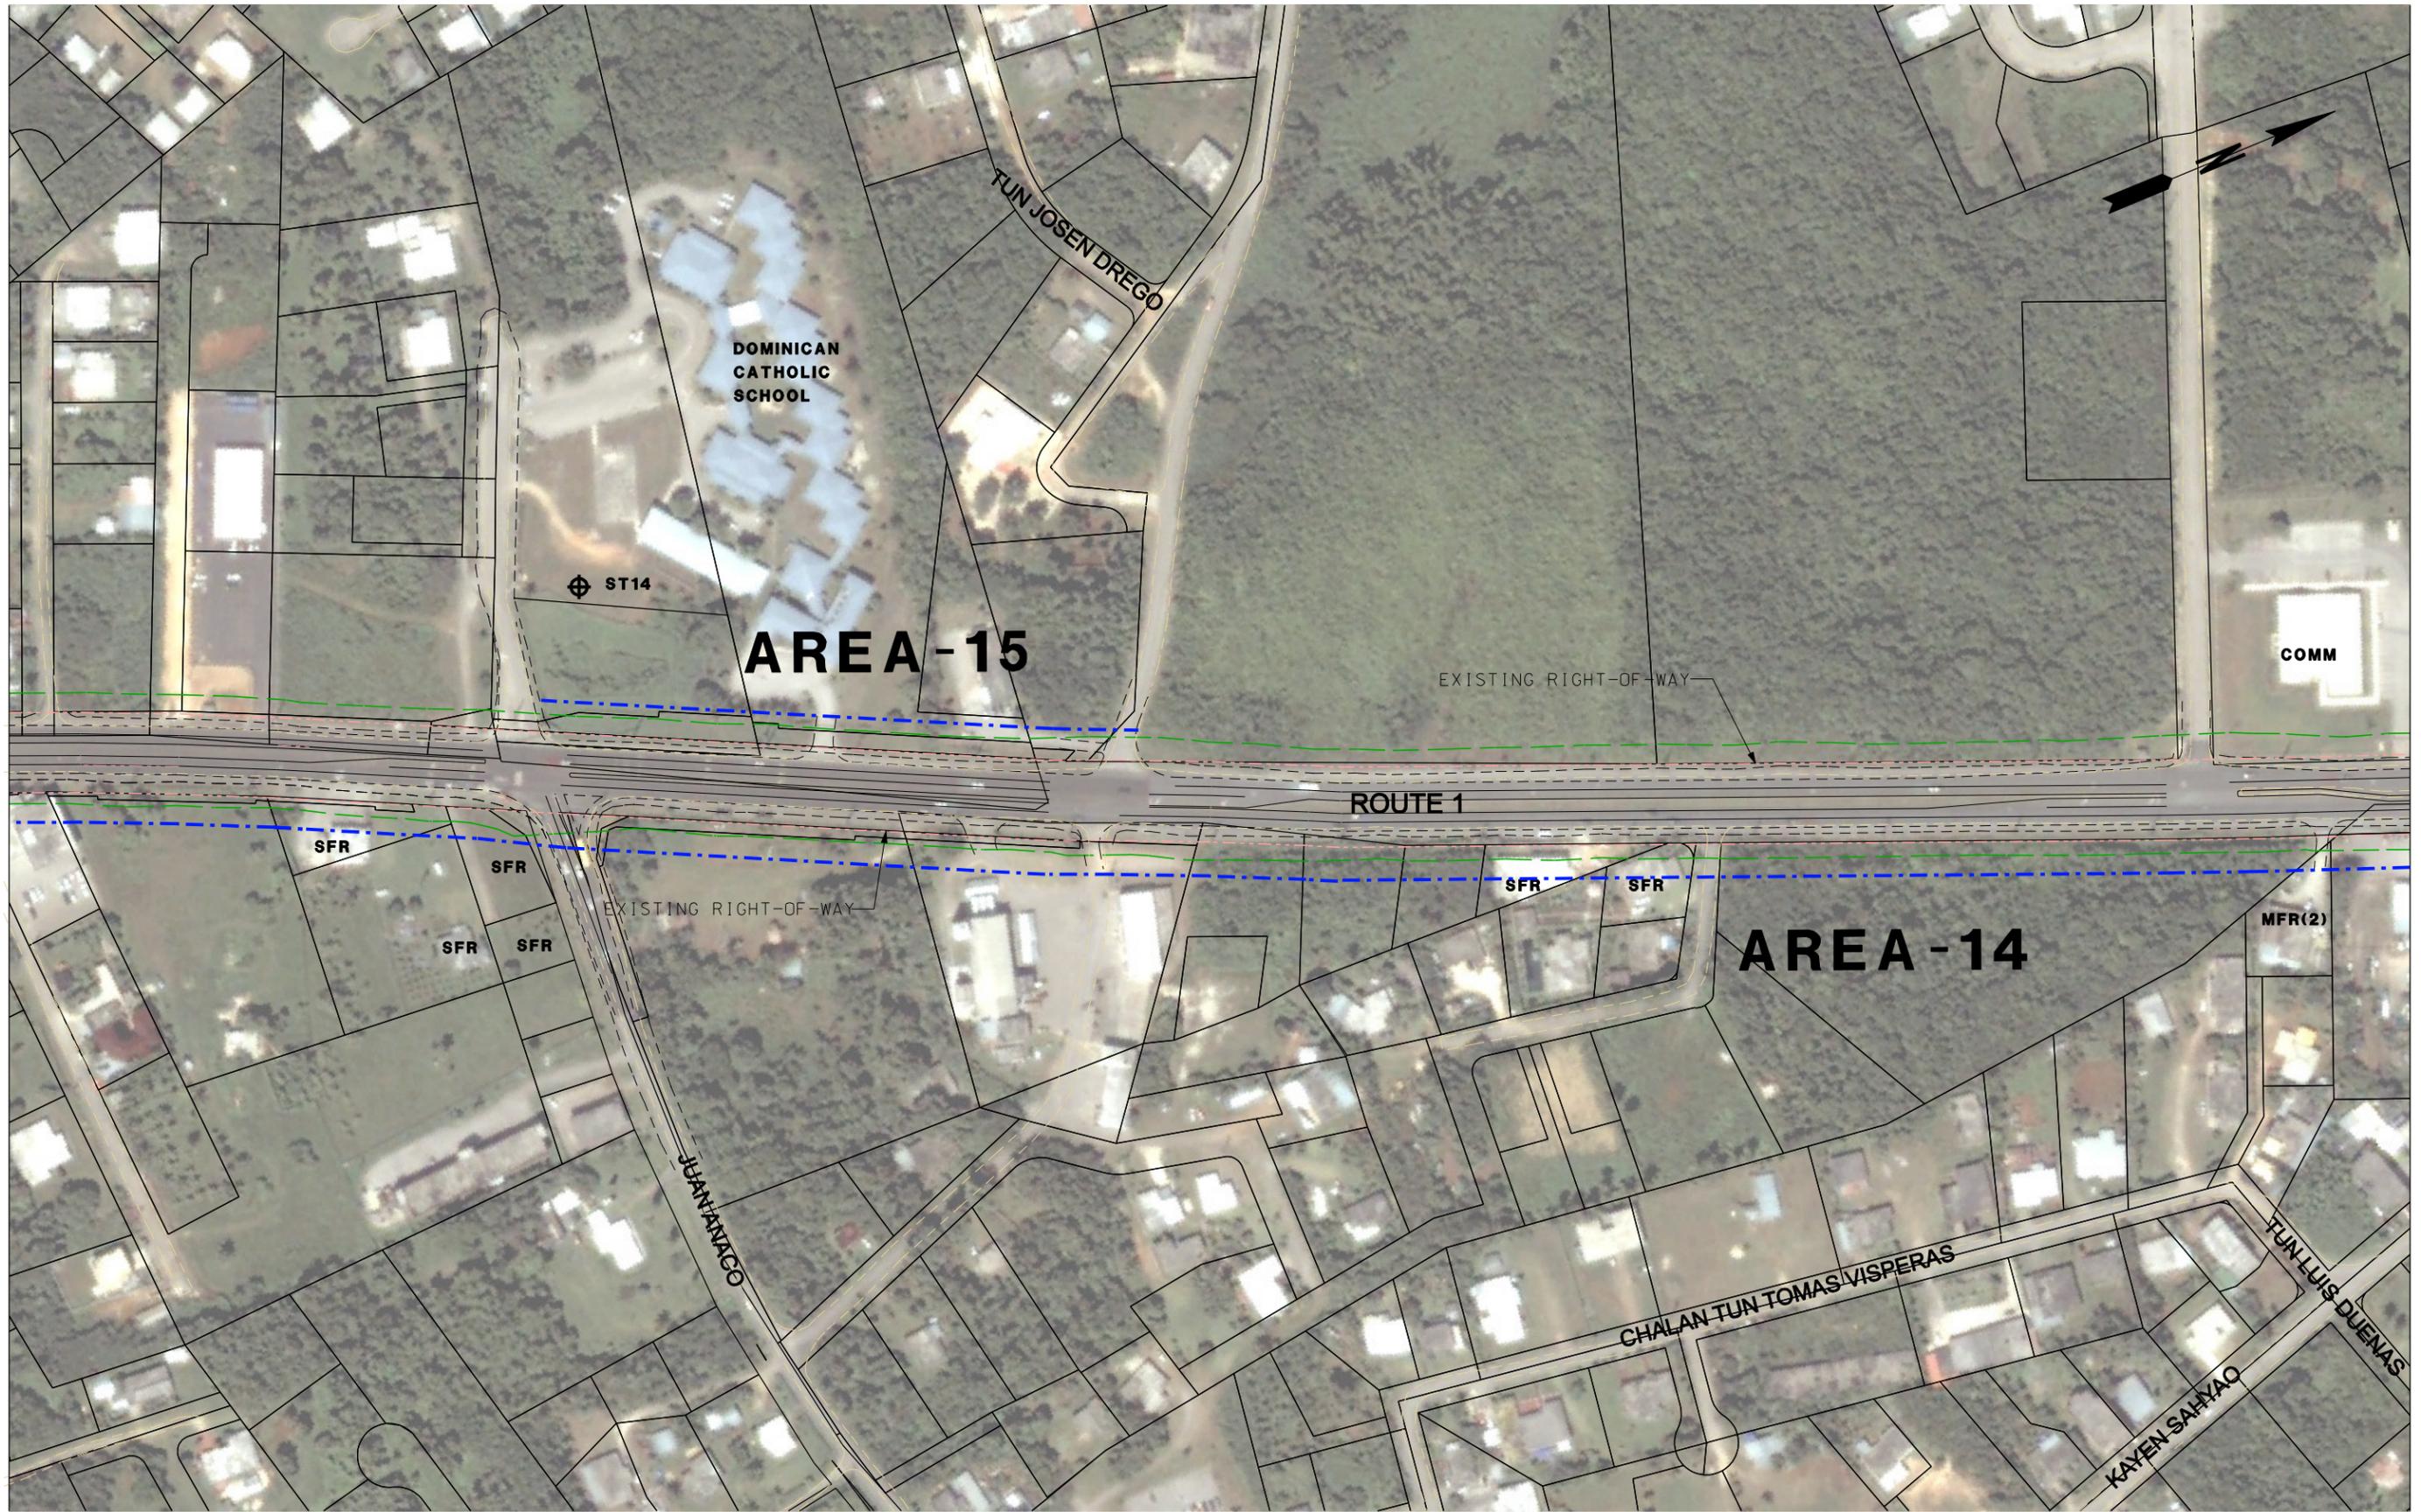
Scale 1"=200' Drawing HRN023 Sheet 18 of 69

**66 dBA NOISE  
IMPACT CONTOUR LINE  
FOR NON ABATEMENT**

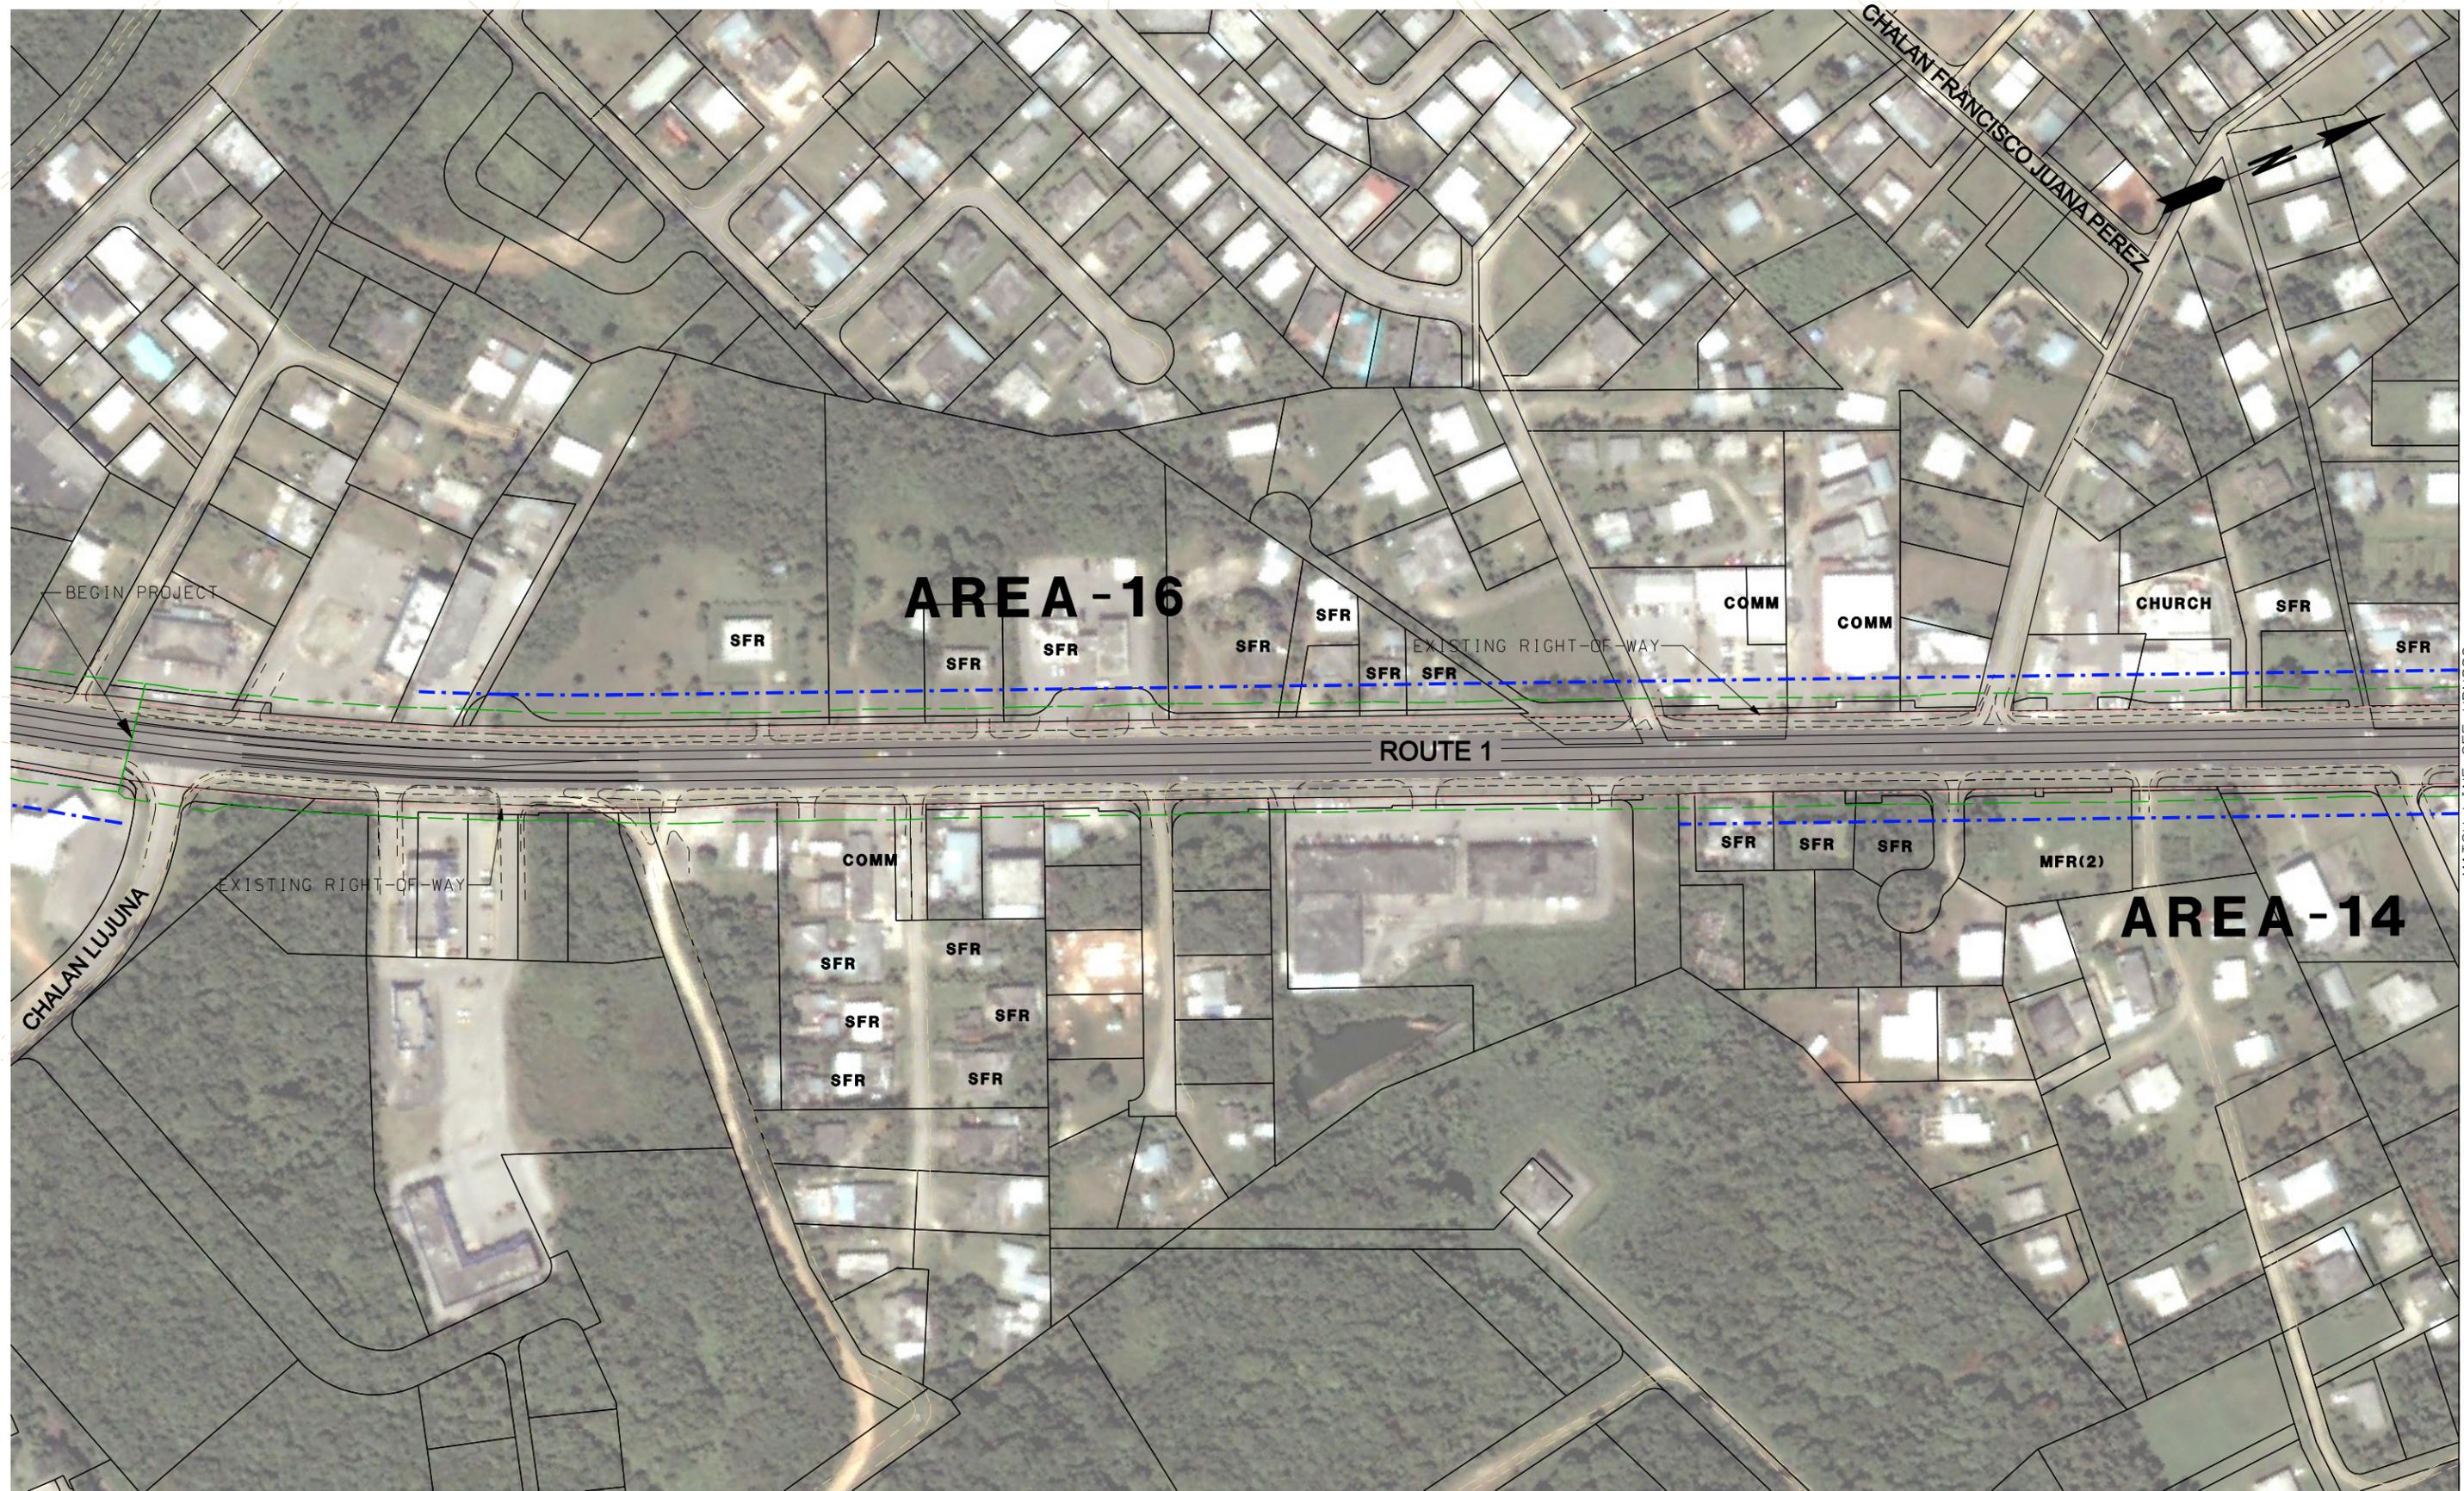
Scale 1"=200' Drawing HRN023 Sheet 19 of 69

**66 dBA NOISE  
IMPACT CONTOUR LINE  
FOR NON ABATEMENT**

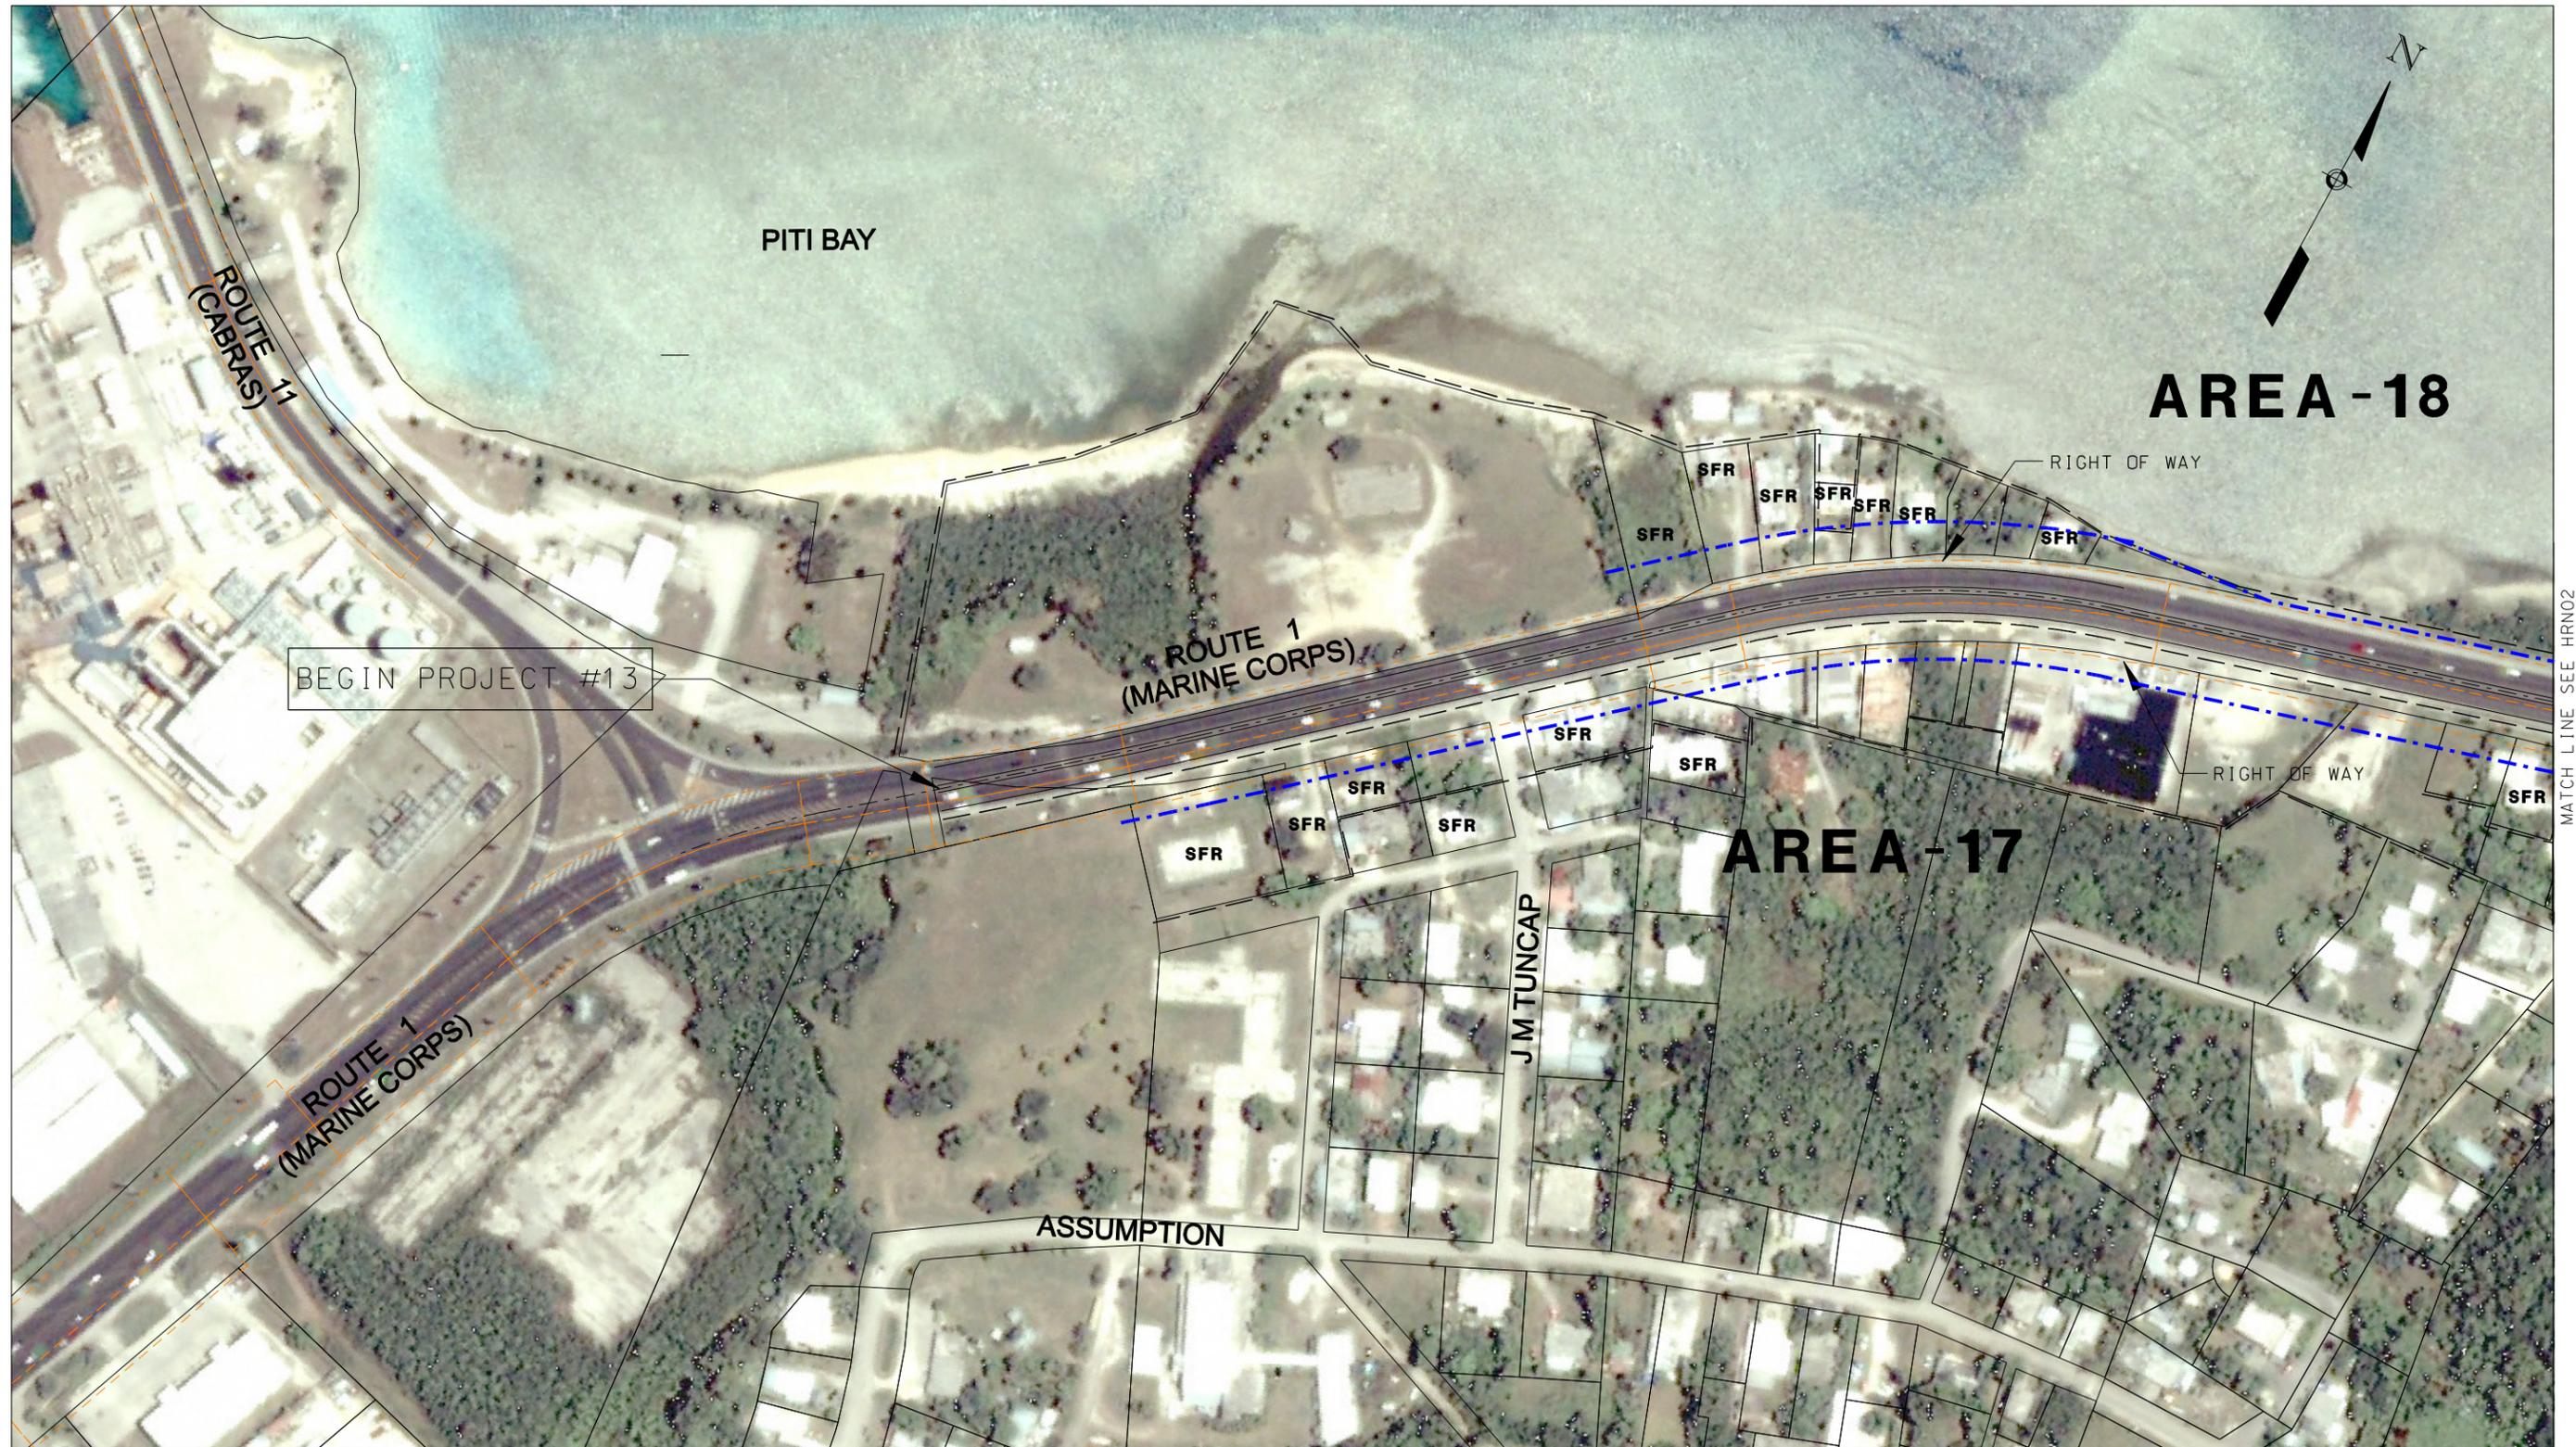
<b>66 dBA NOISE IMPACT CONTOUR LINE FOR NON ABATEMENT</b>	
Scale	1"=200'
Drawing	HRN013
Sheet	20 of 69
