## Appendix G

### EIS Resource Technical Appendix

# Guam and CNMI Military Relocation EIS

## Volume 9: EIS Resource Technical Appendix

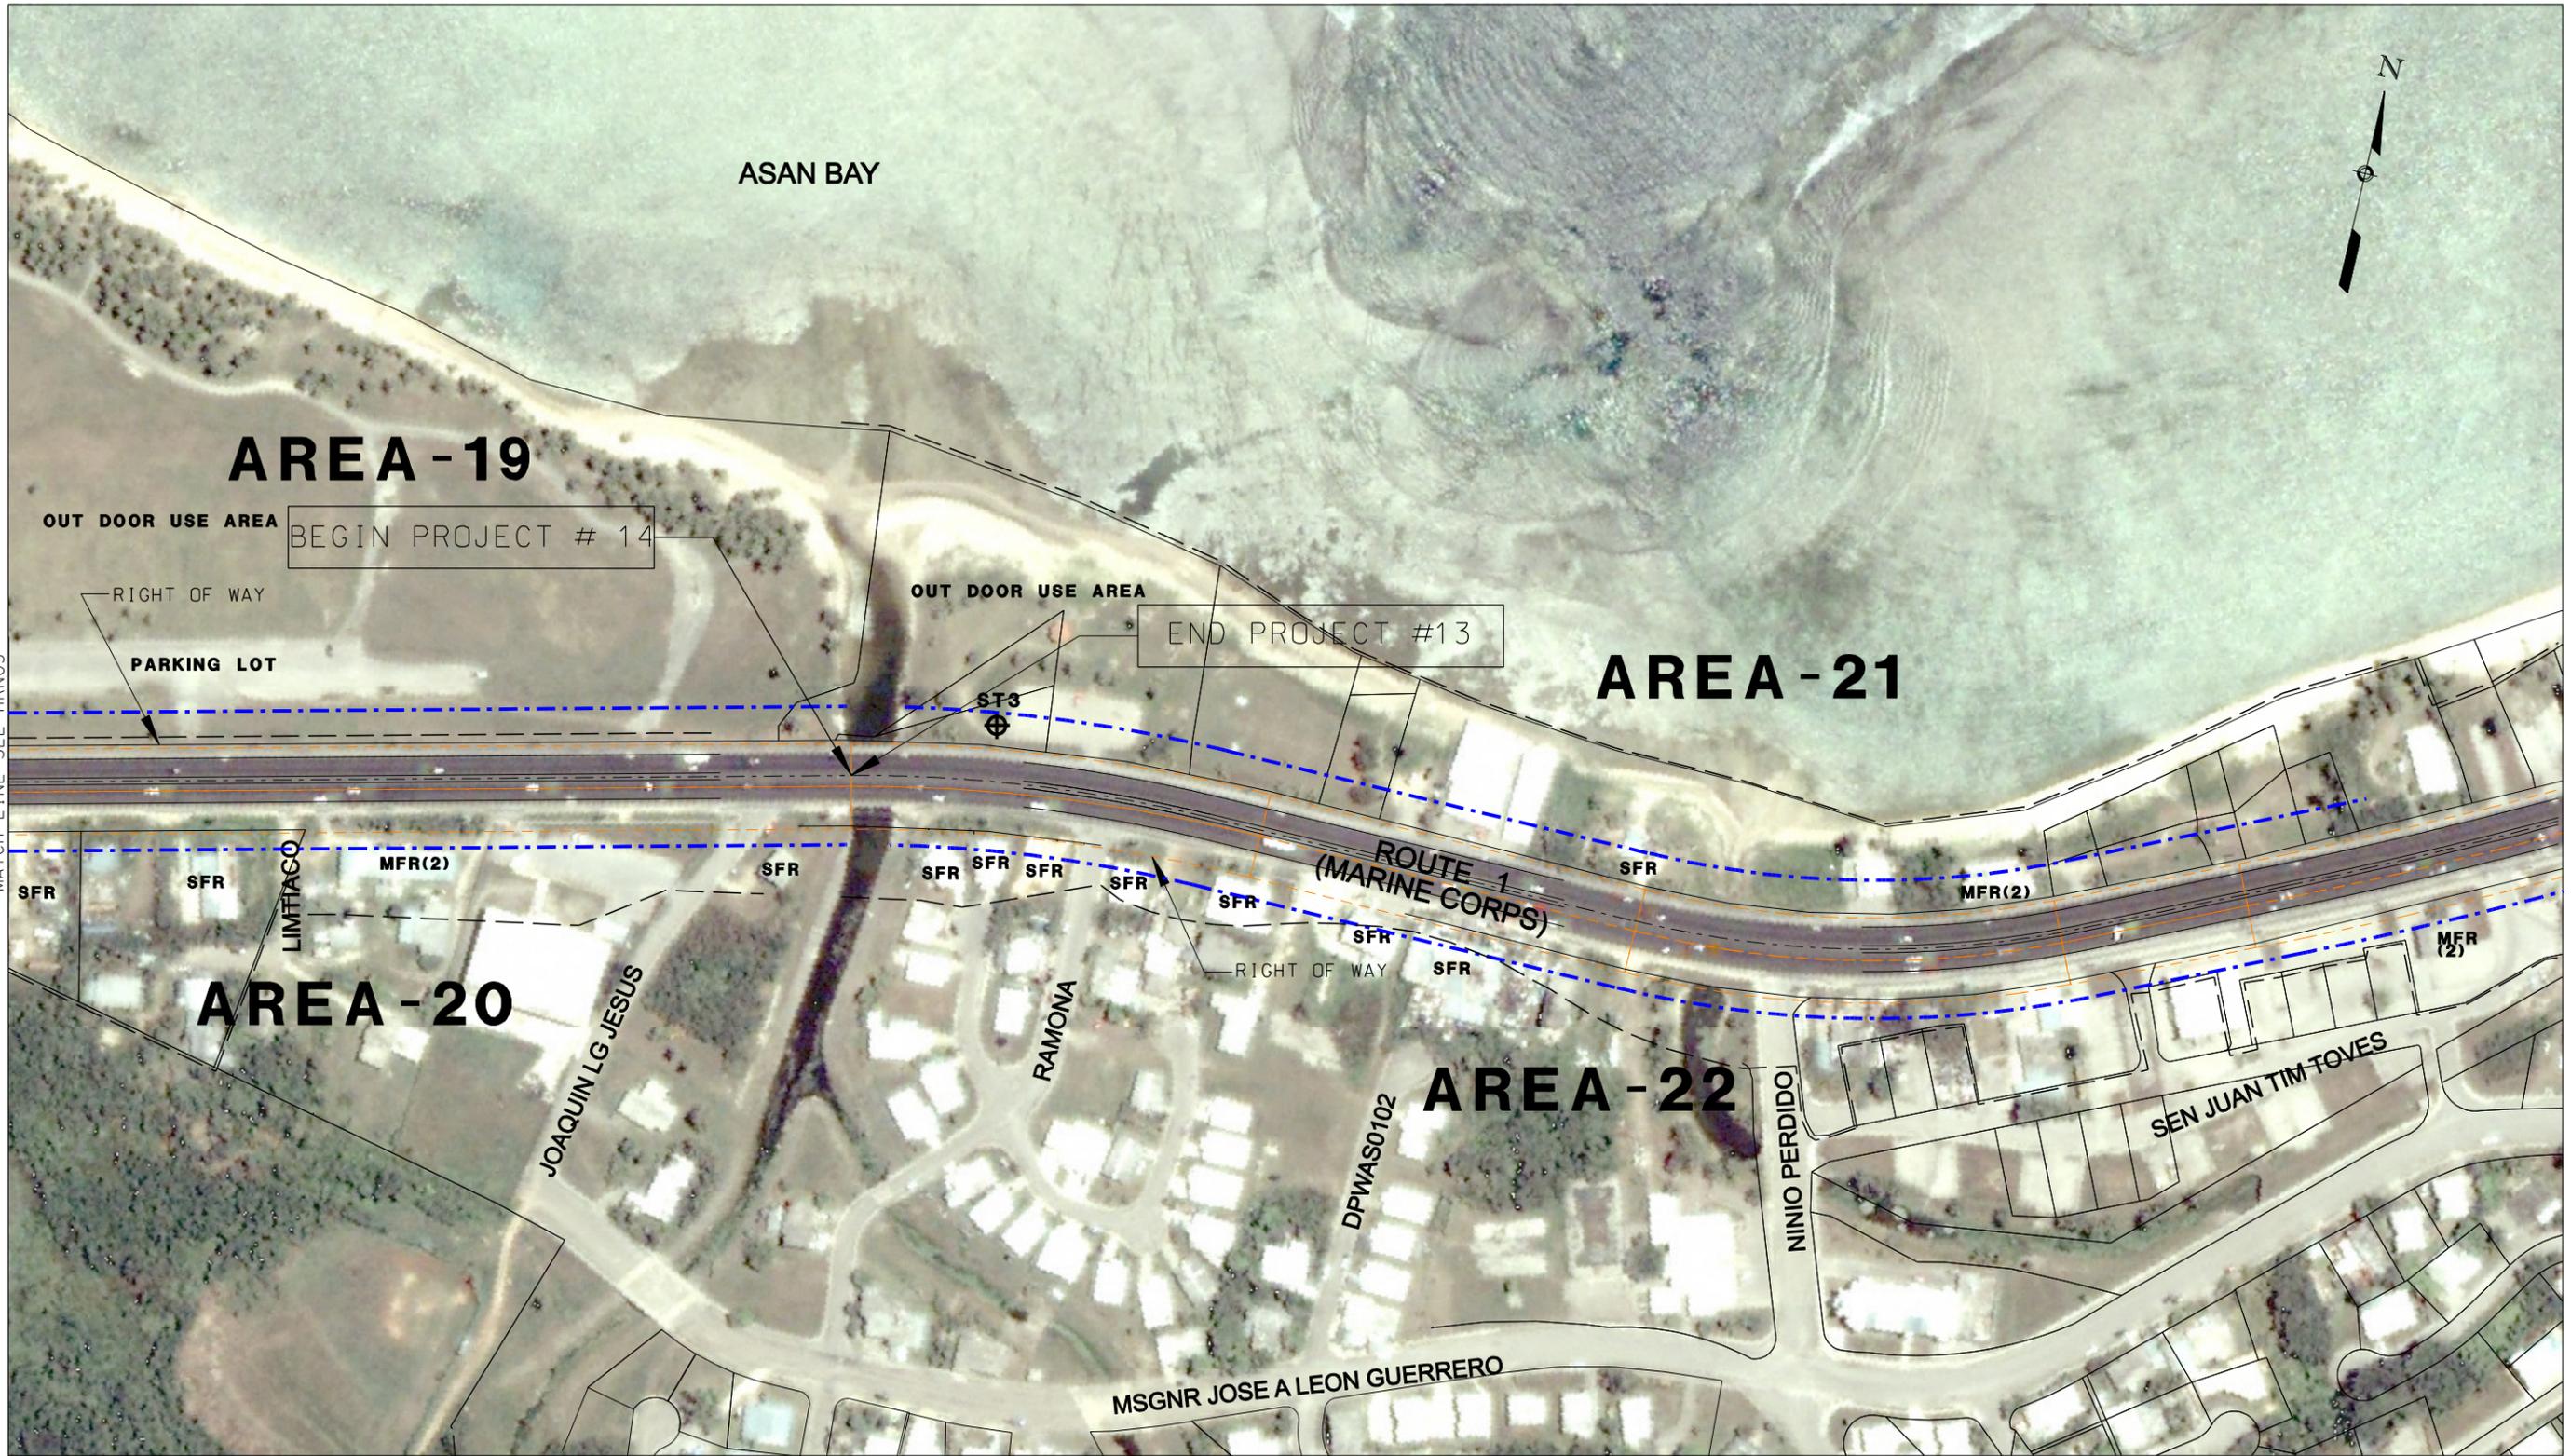
Scale 1"=200' Drawing HRN013 Sheet 23 of 69

**66 dBA NOISE  
IMPACT CONTOUR LINE  
FOR NON ABATEMENT**

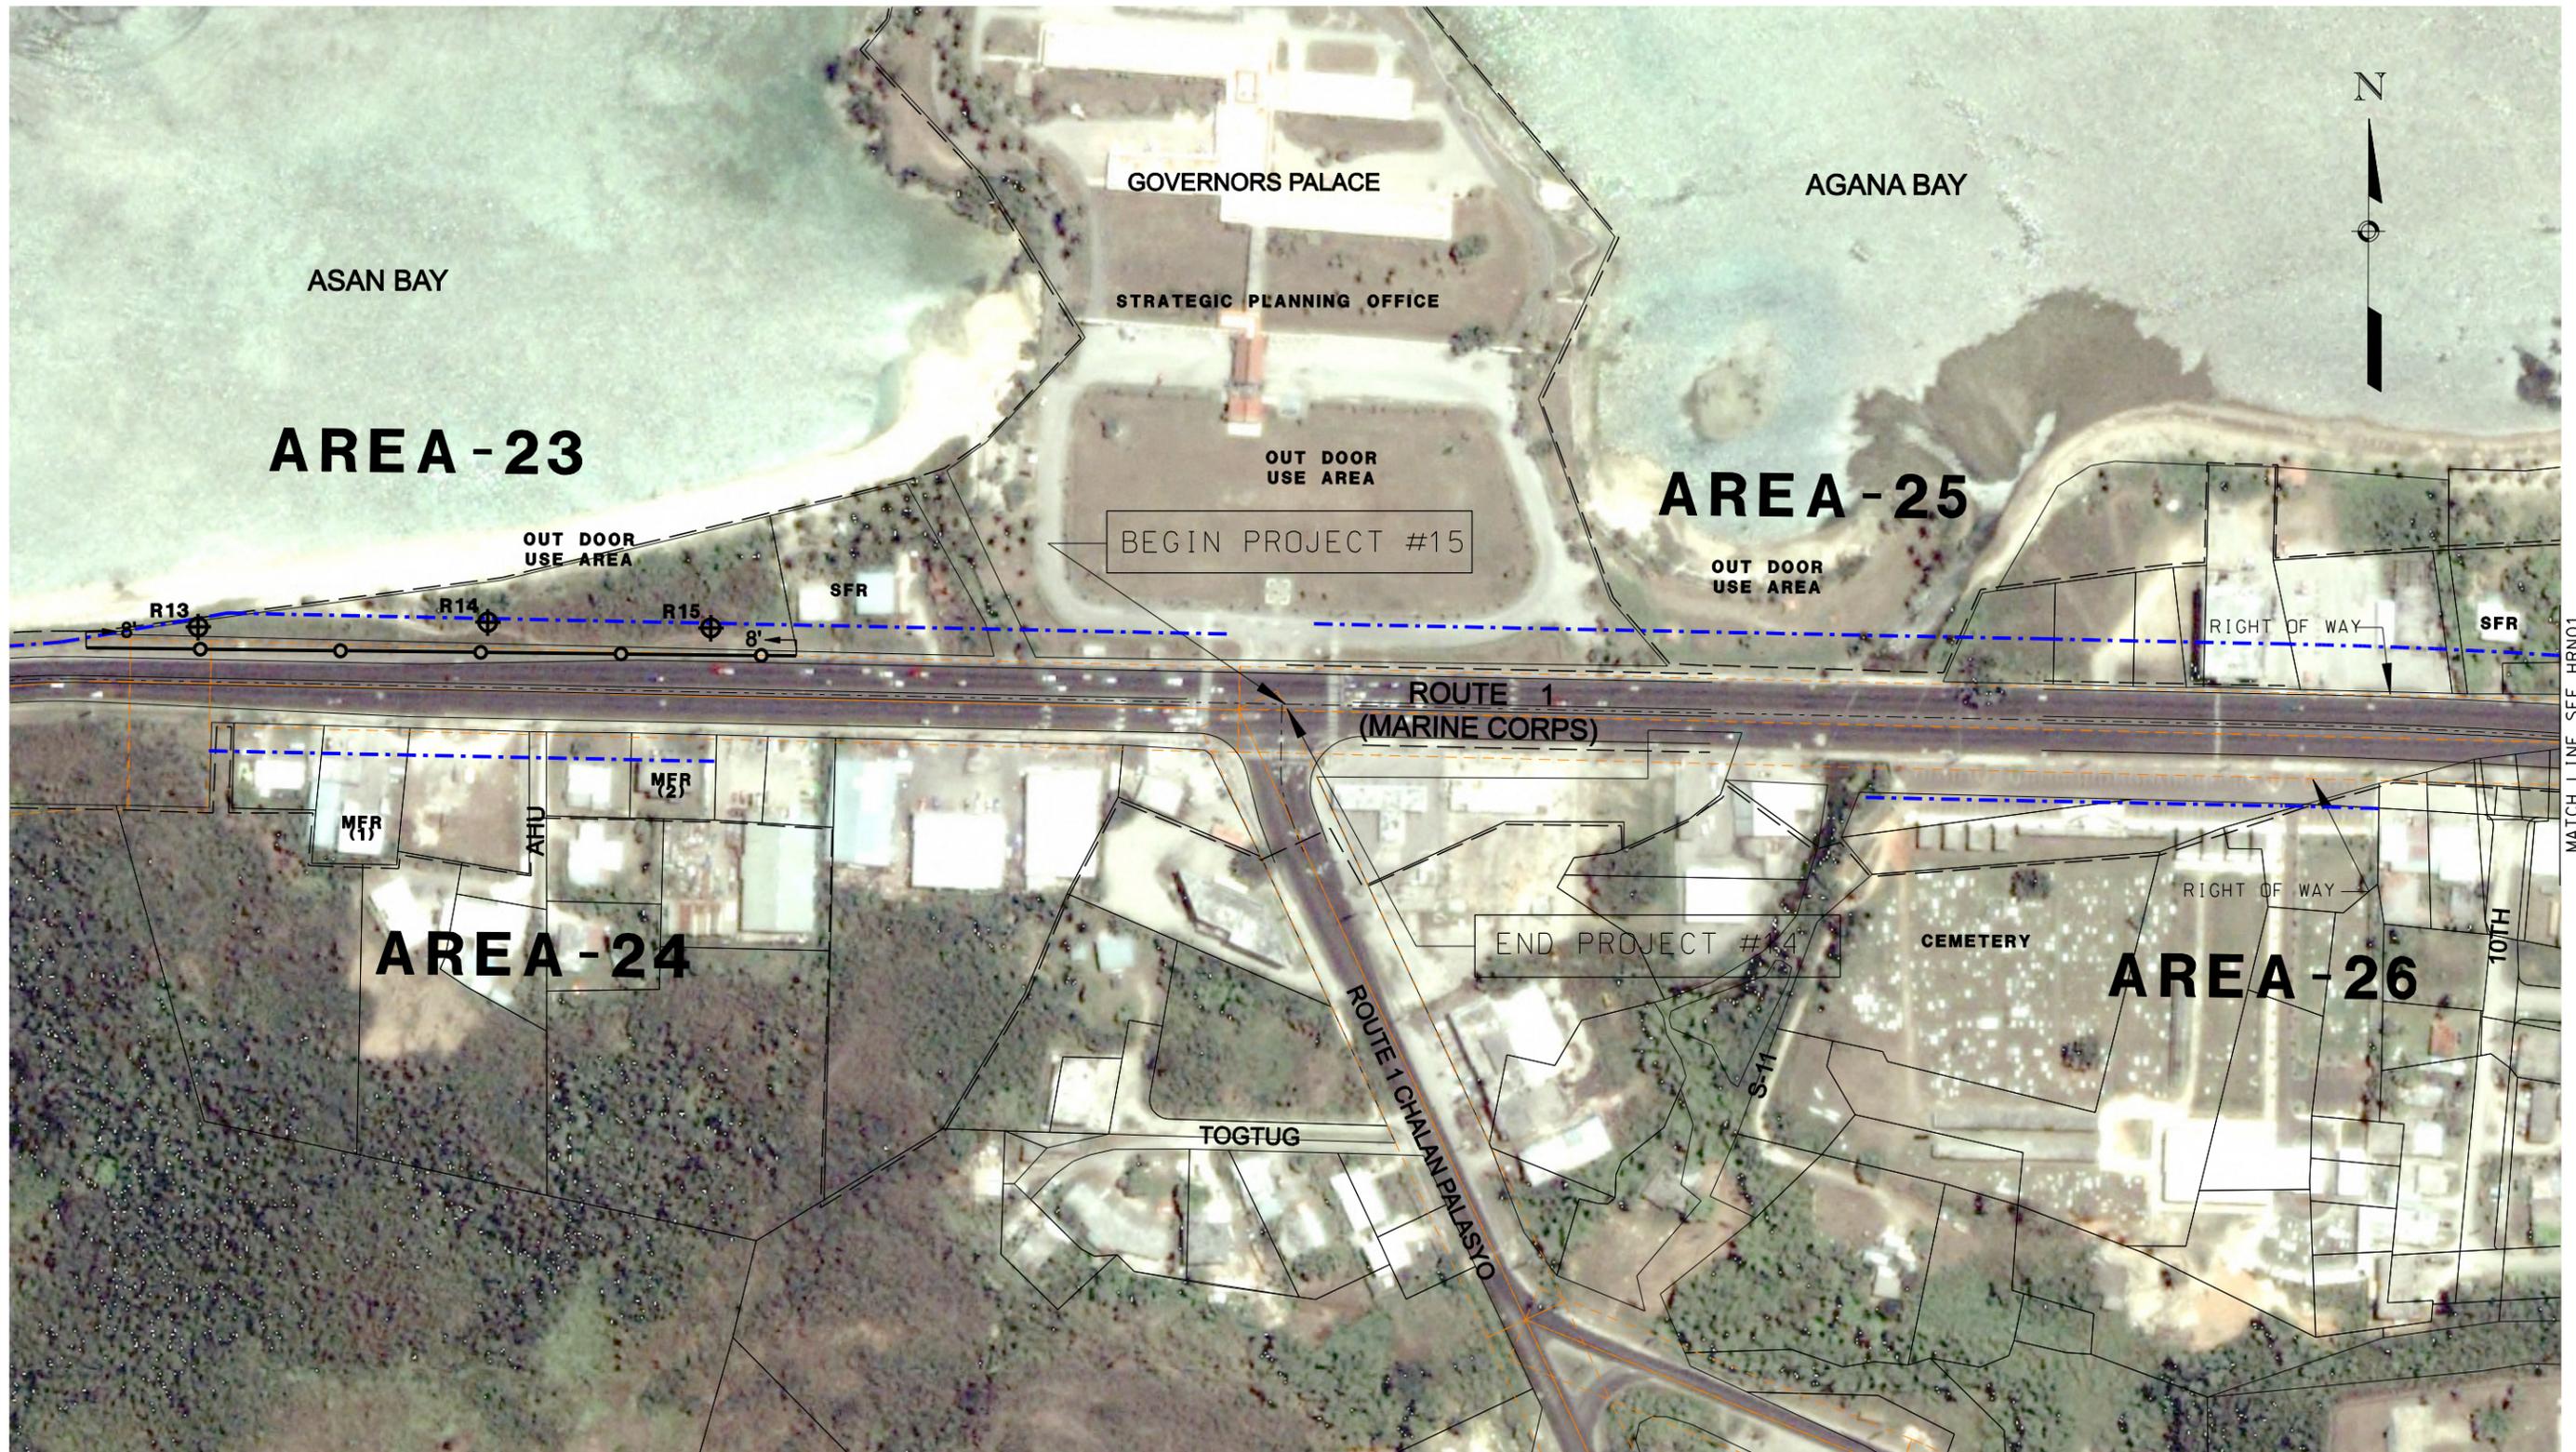
Scale 1"=200' Drawing HRN015 Sheet 25 of 69

**66 dBA NOISE  
IMPACT CONTOUR LINE  
FOR NON ABATEMENT**

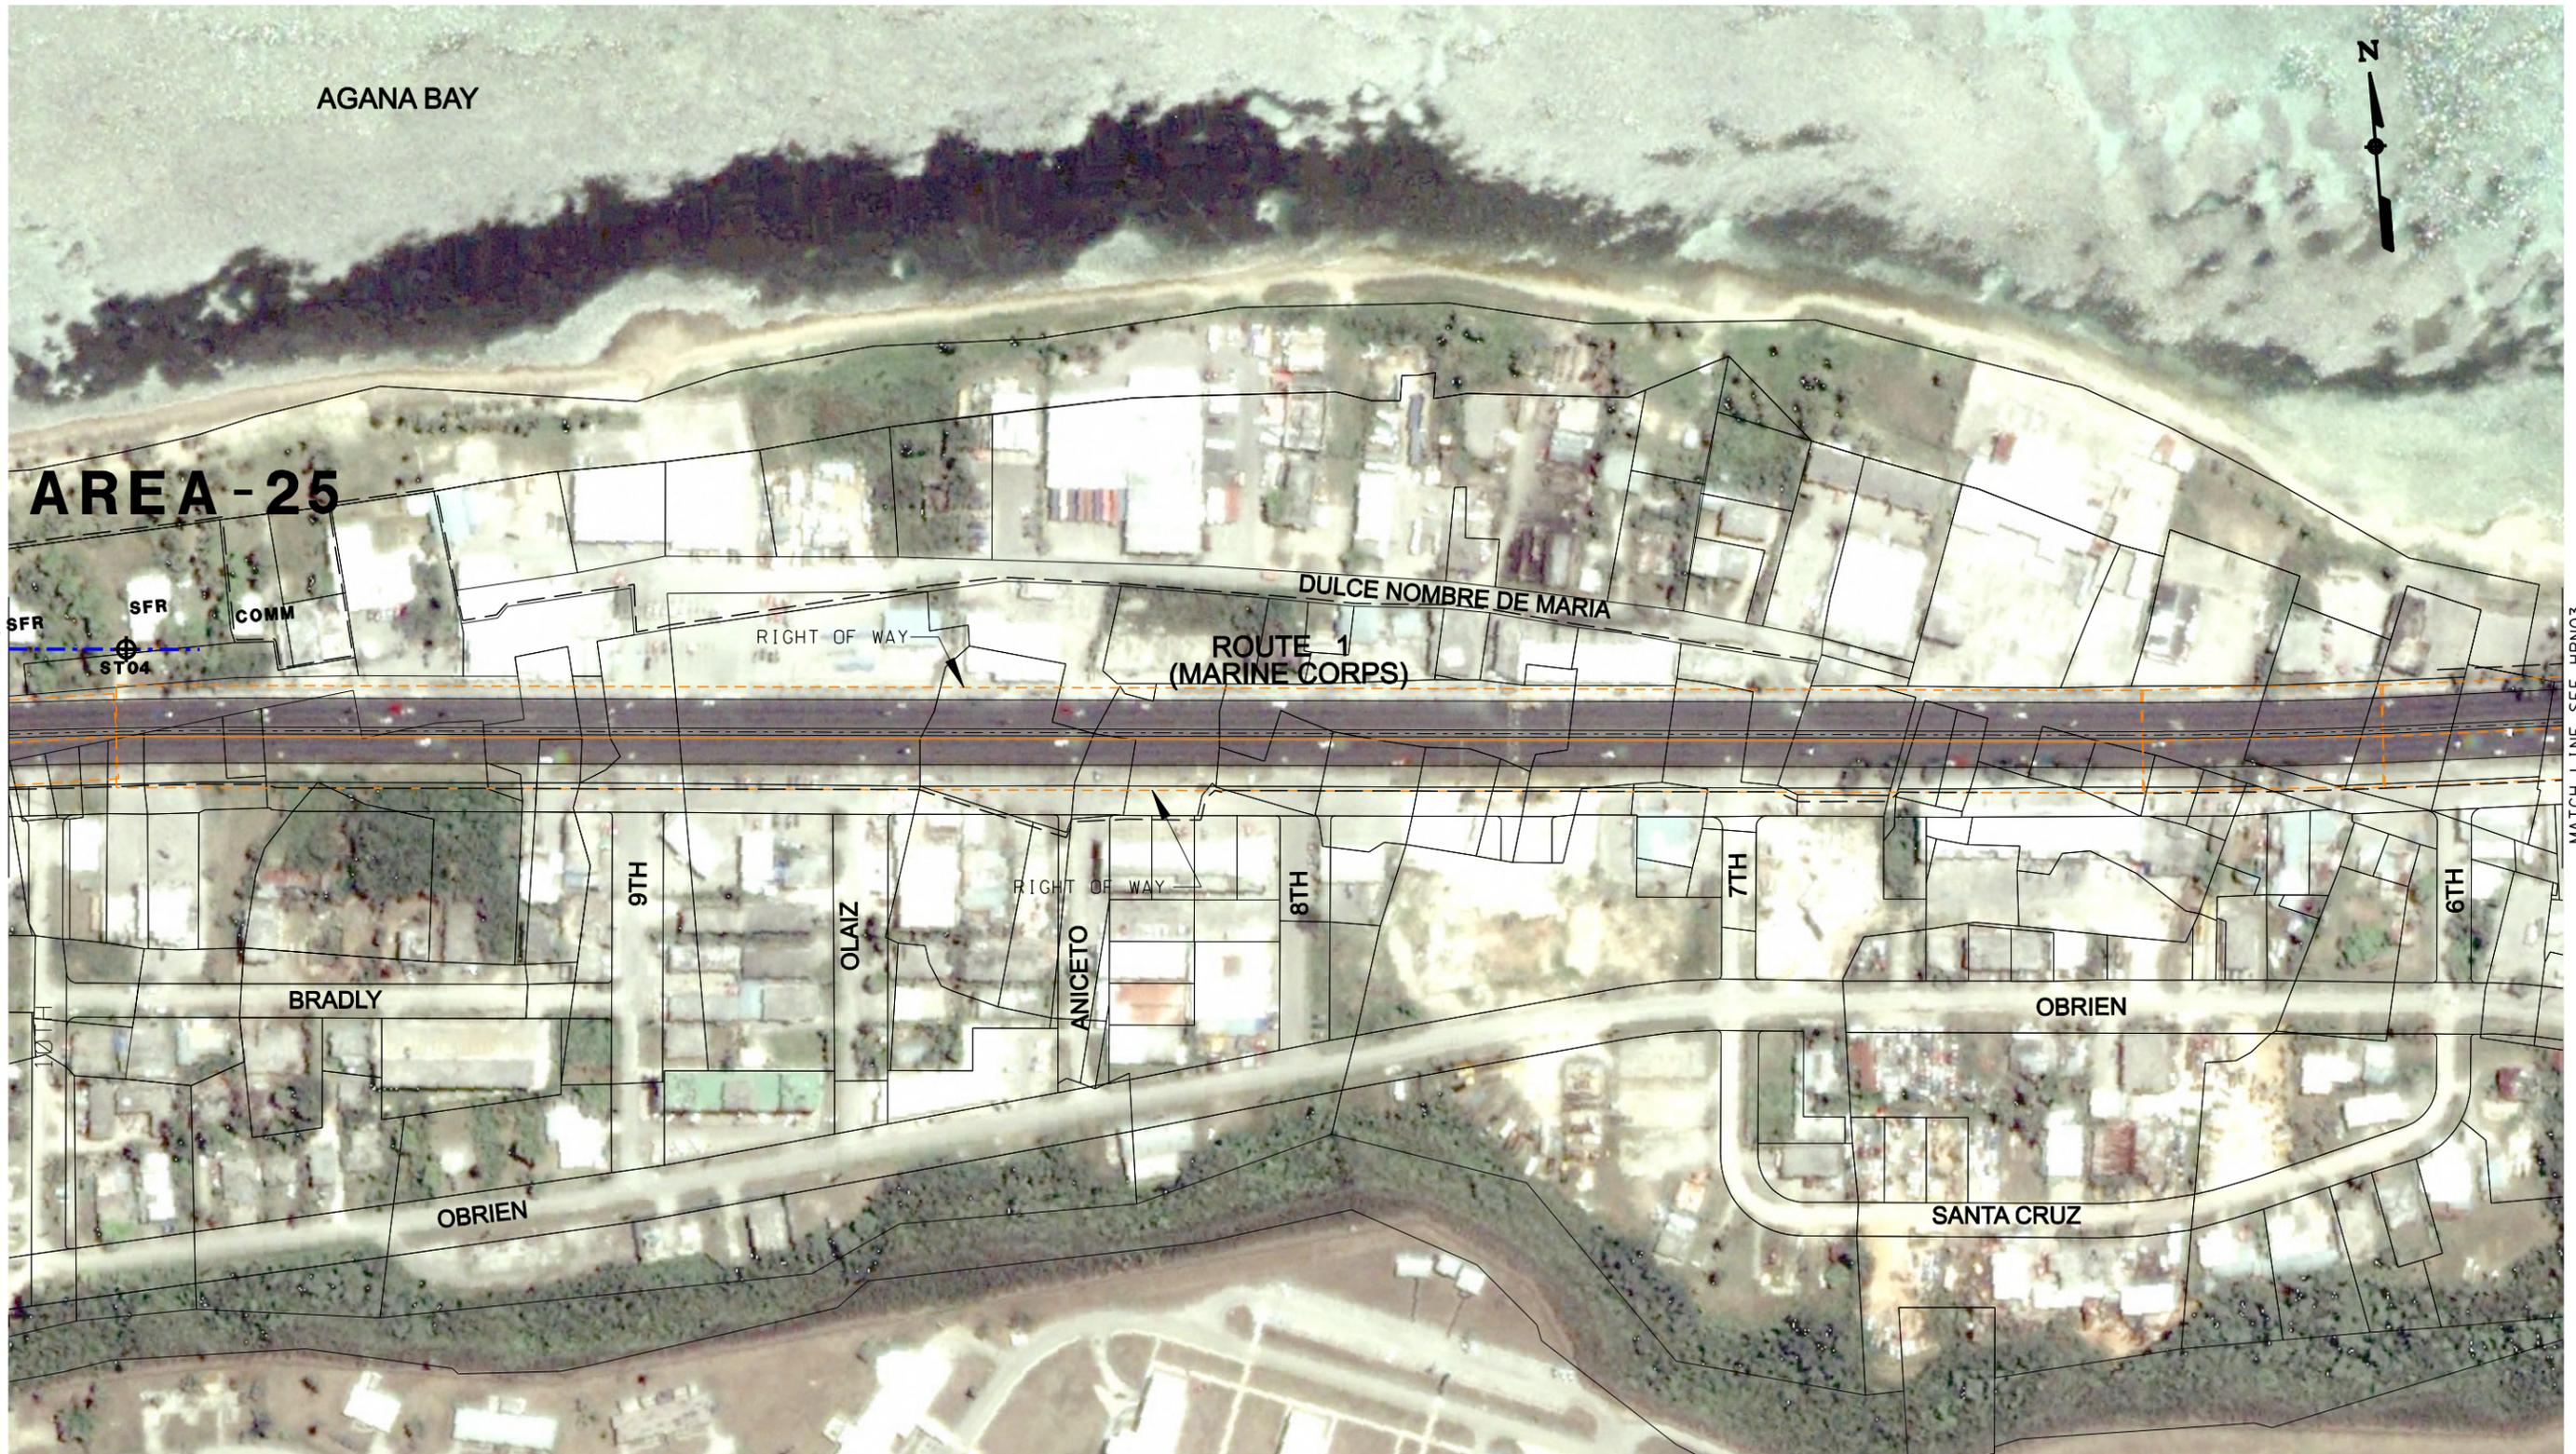
Scale 1"=200' Drawing HRN015 Sheet 26 of 69

**66 dBA NOISE  
IMPACT CONTOUR LINE  
FOR NON ABATEMENT**

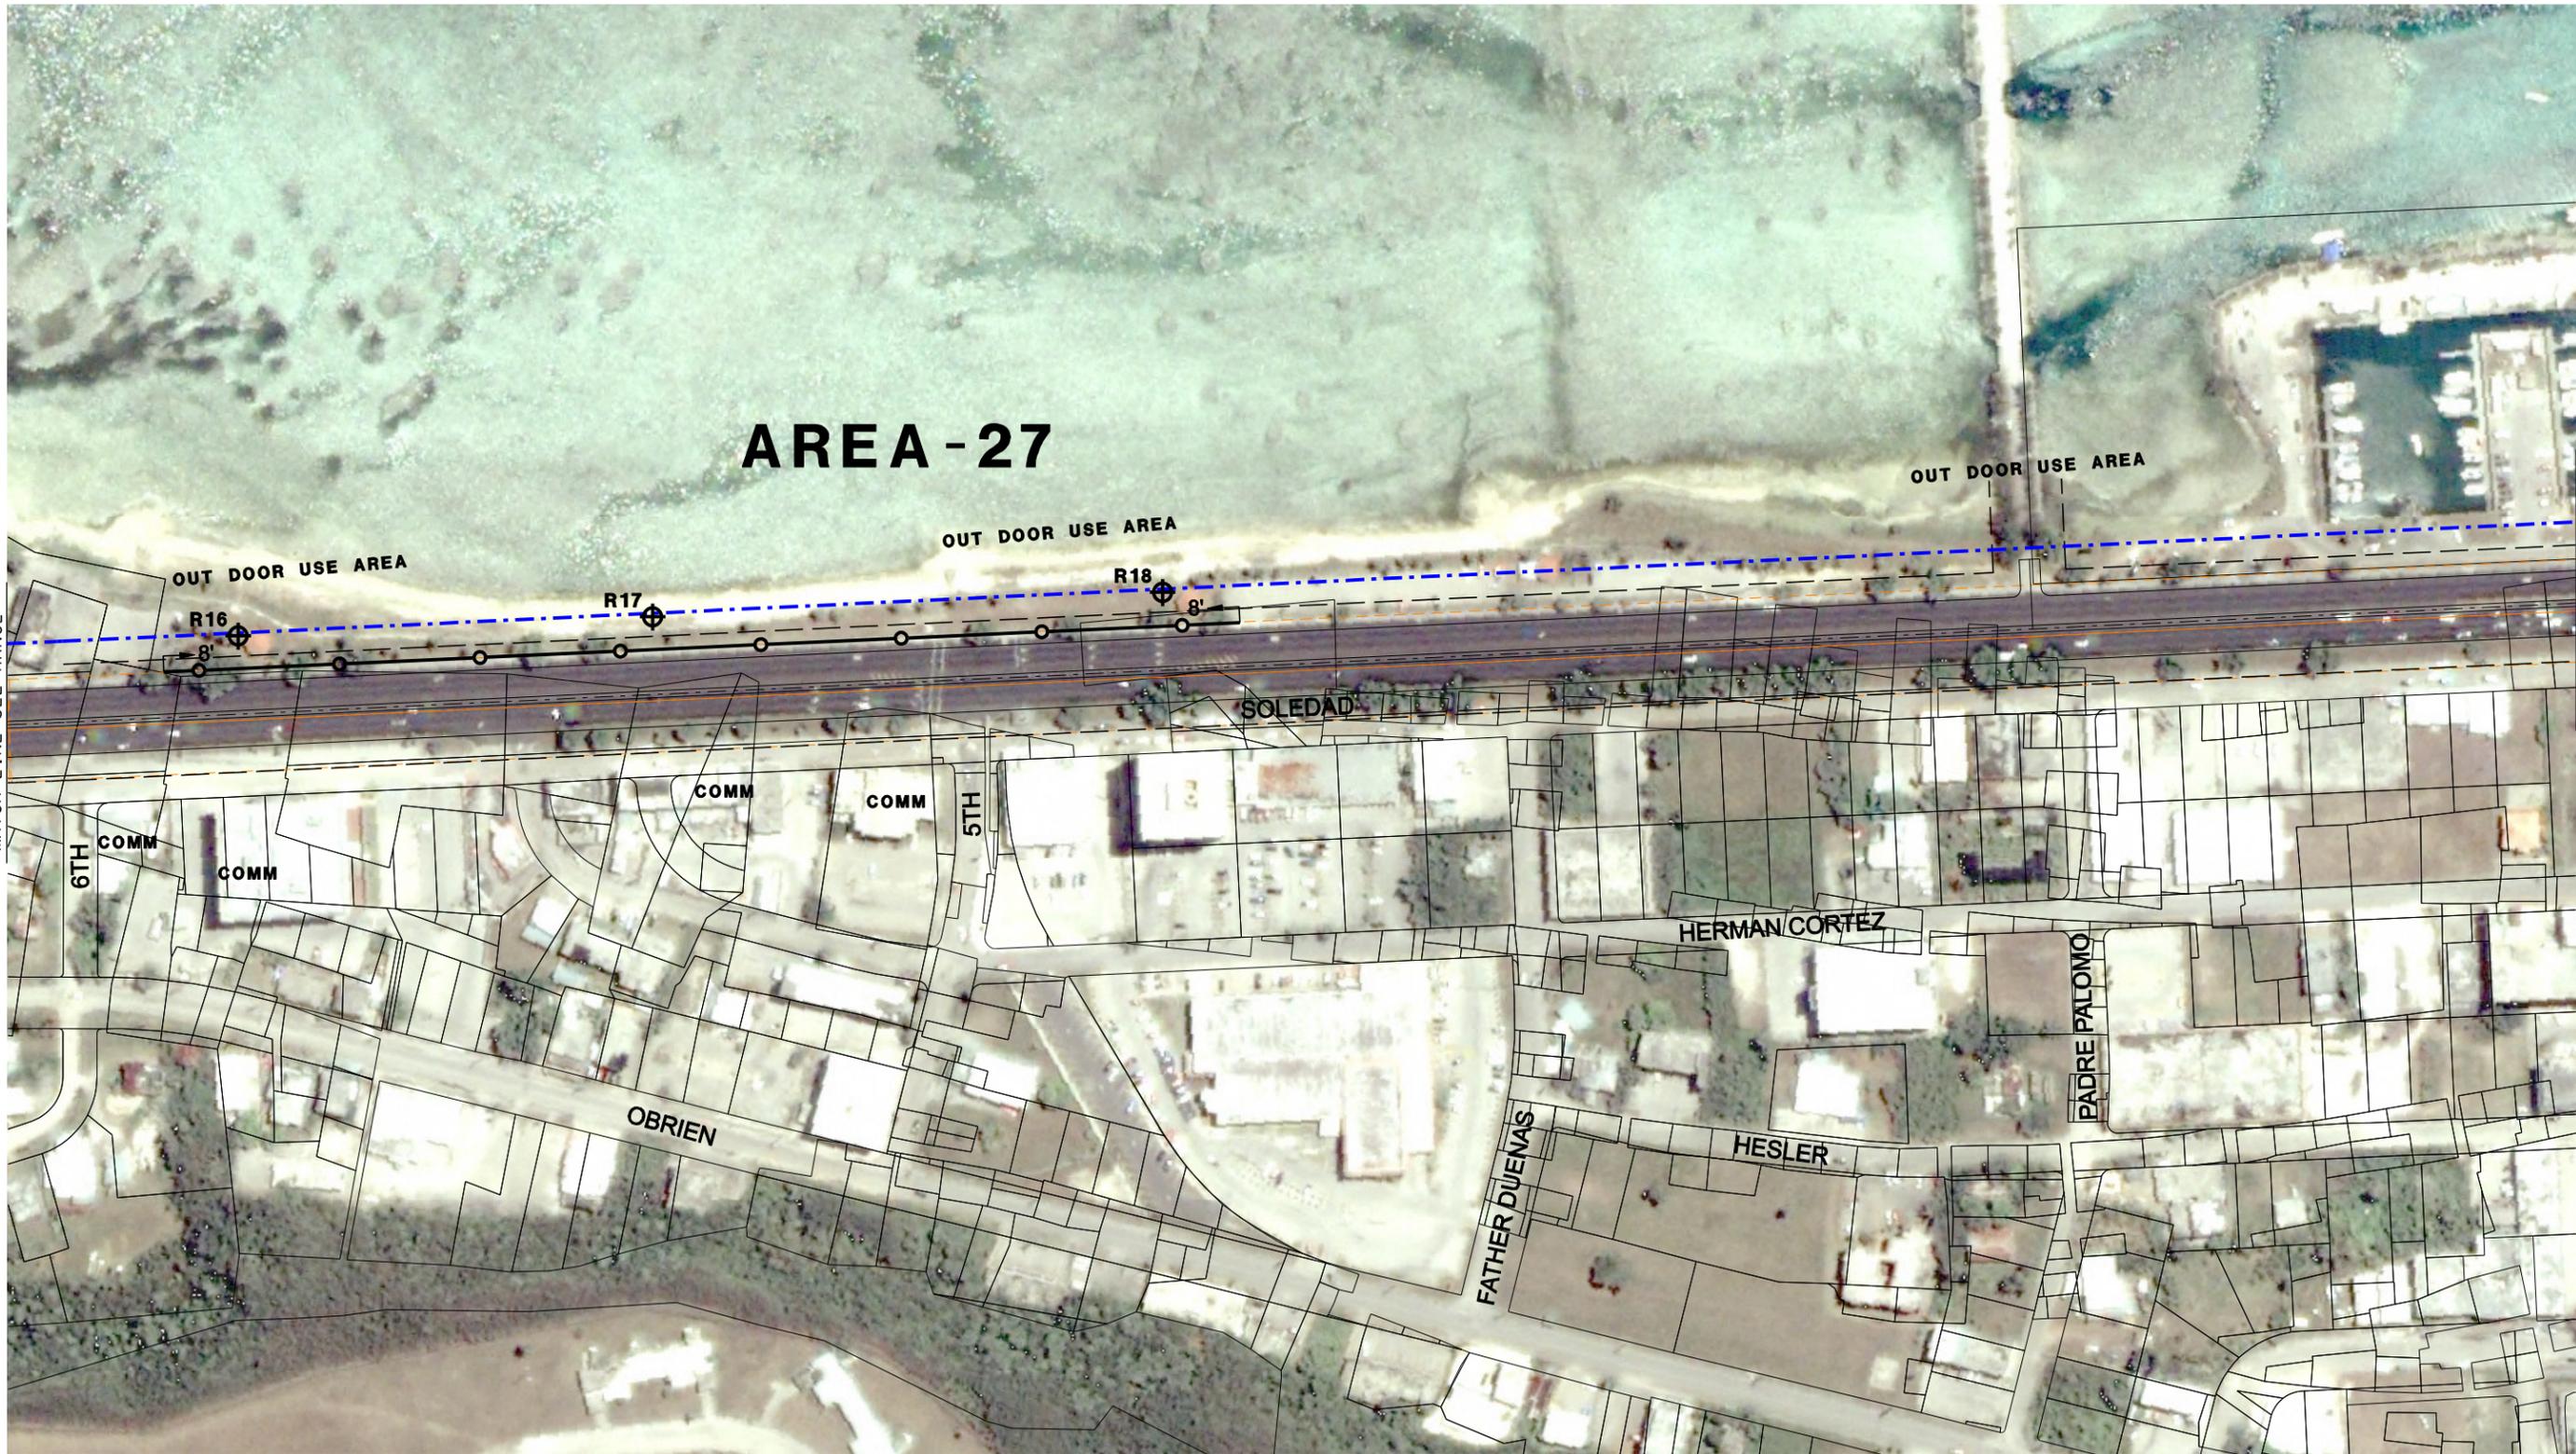
Scale 1"=200' Drawing HRN015 Sheet 27 of 69

**66 dBA NOISE**  
**IMPACT CONTOUR LINE**  
**FOR NON ABATEMENT**

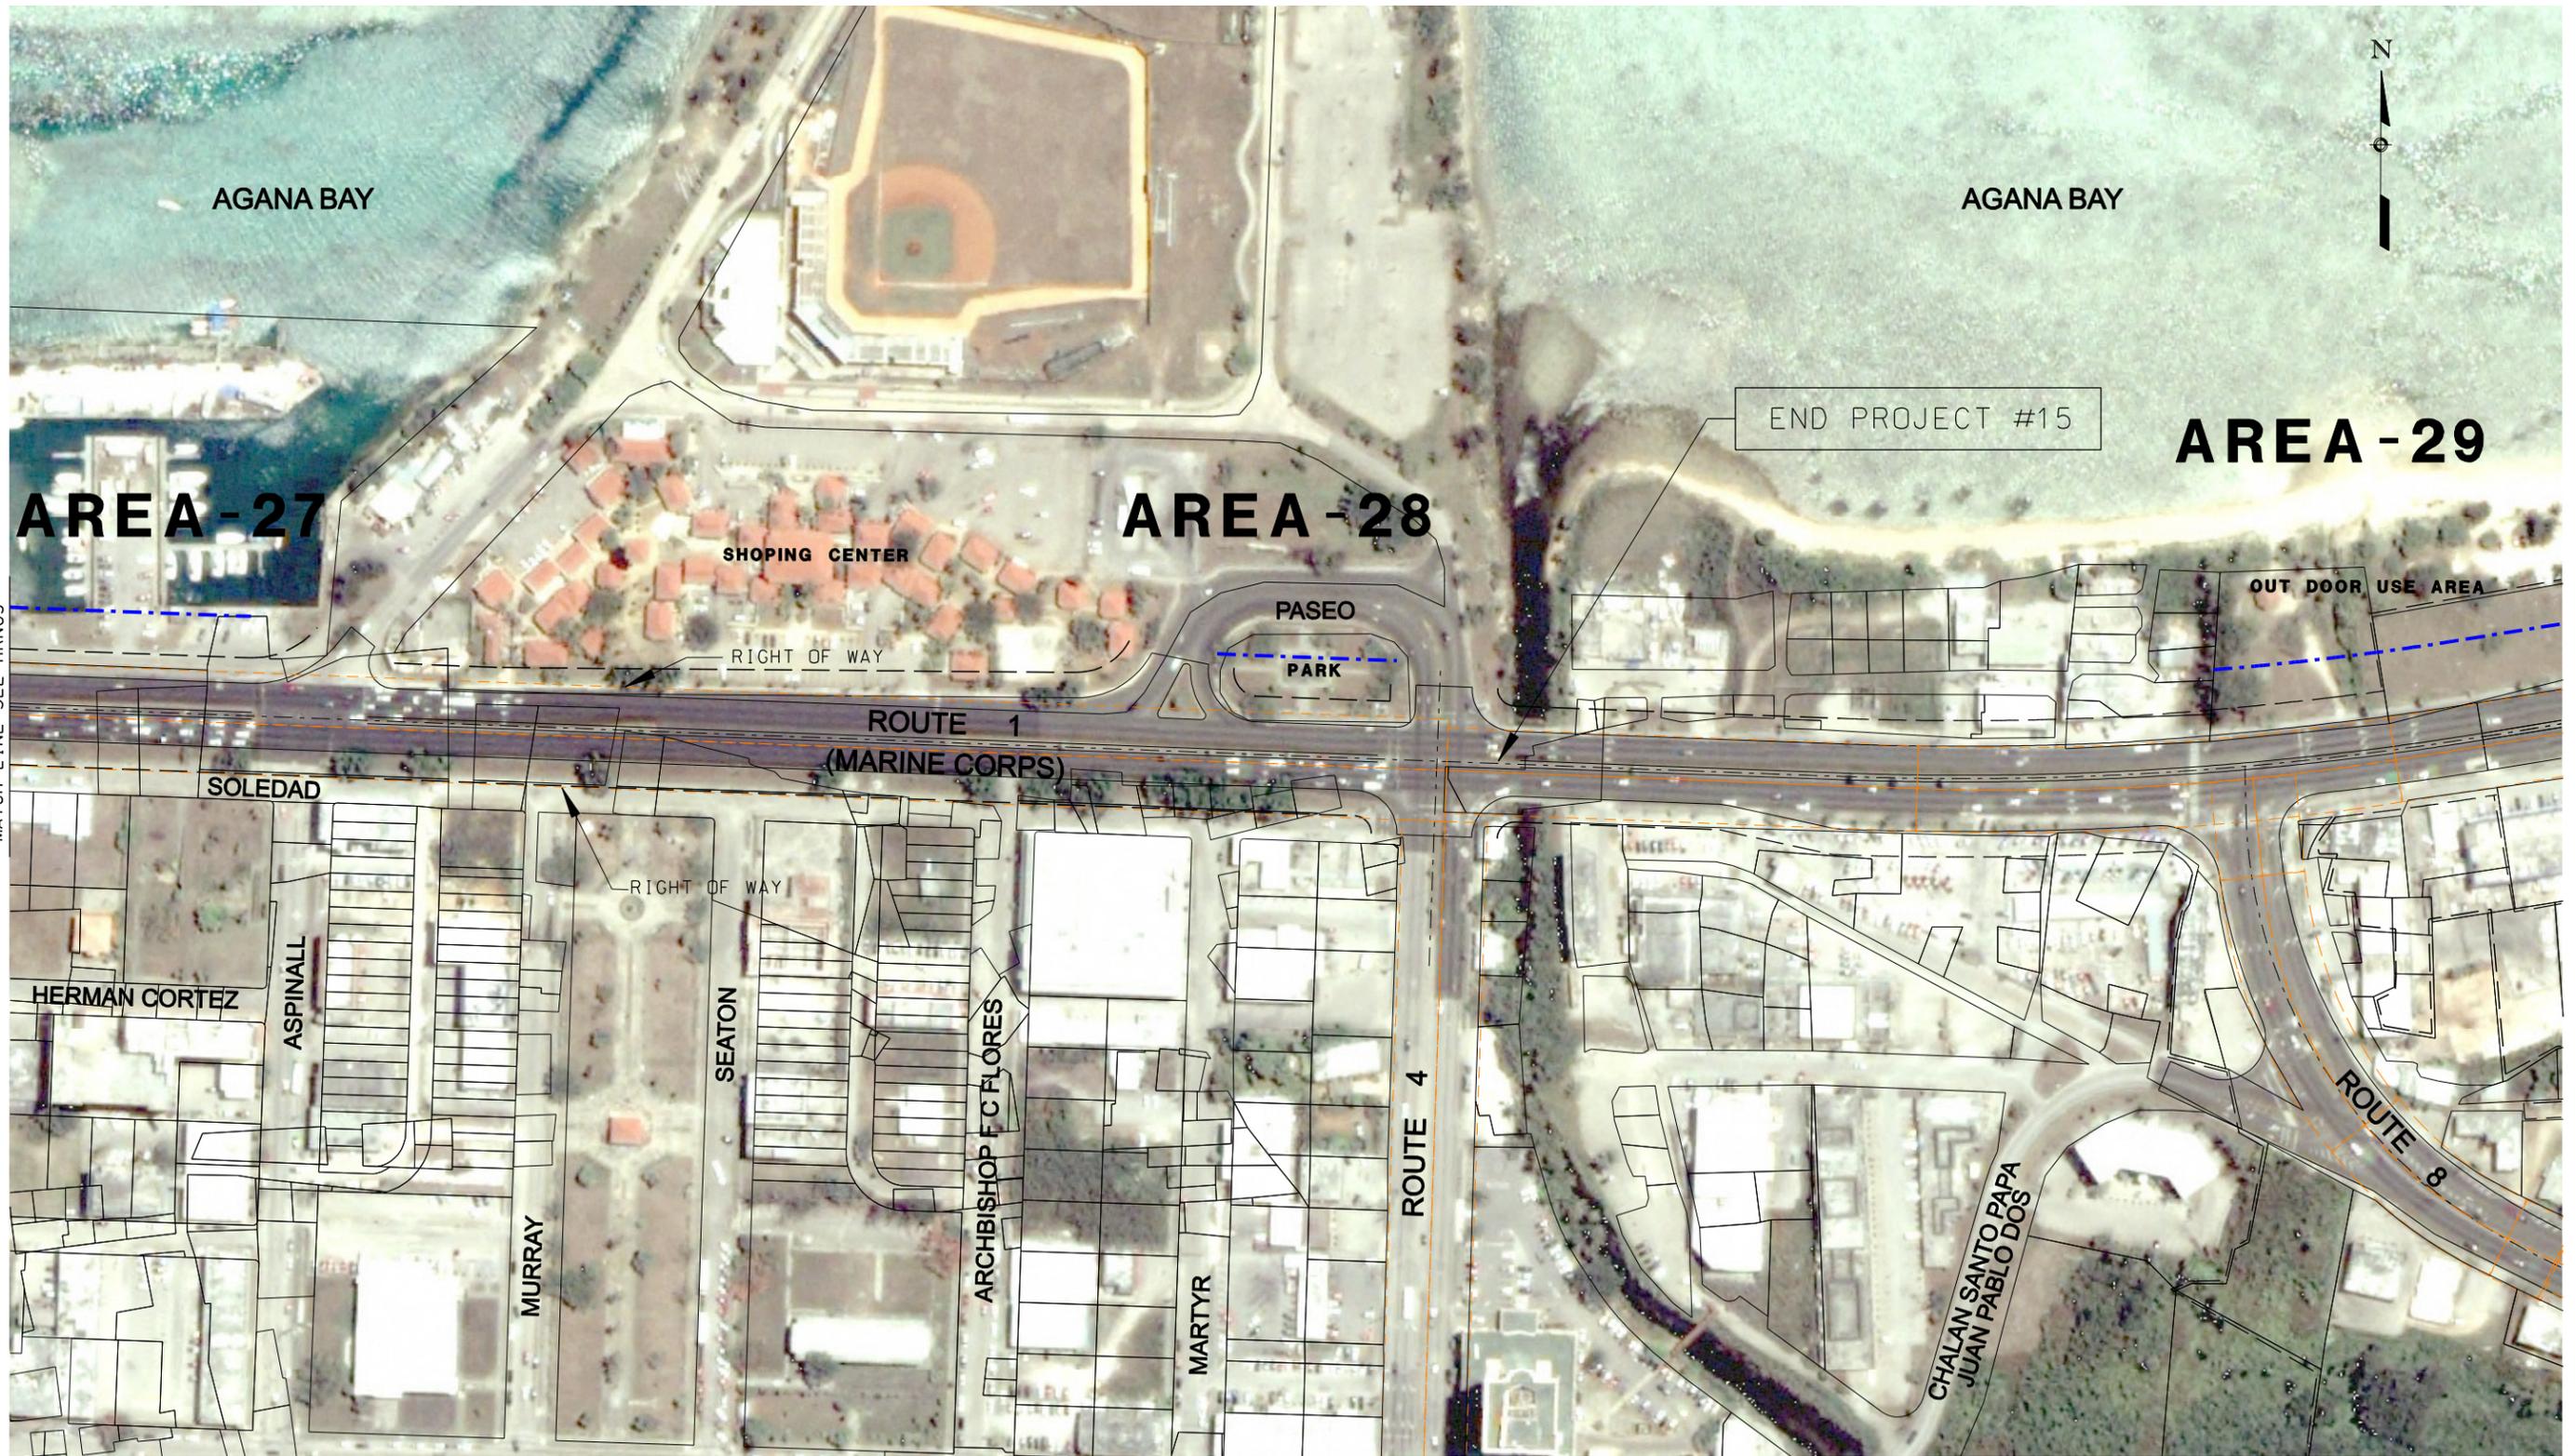
<b>66 dBA NOISE IMPACT CONTOUR LINE FOR NON ABATEMENT</b>		
Scale	1"=200'	Drawing HRN015 Sheet 28 of 69

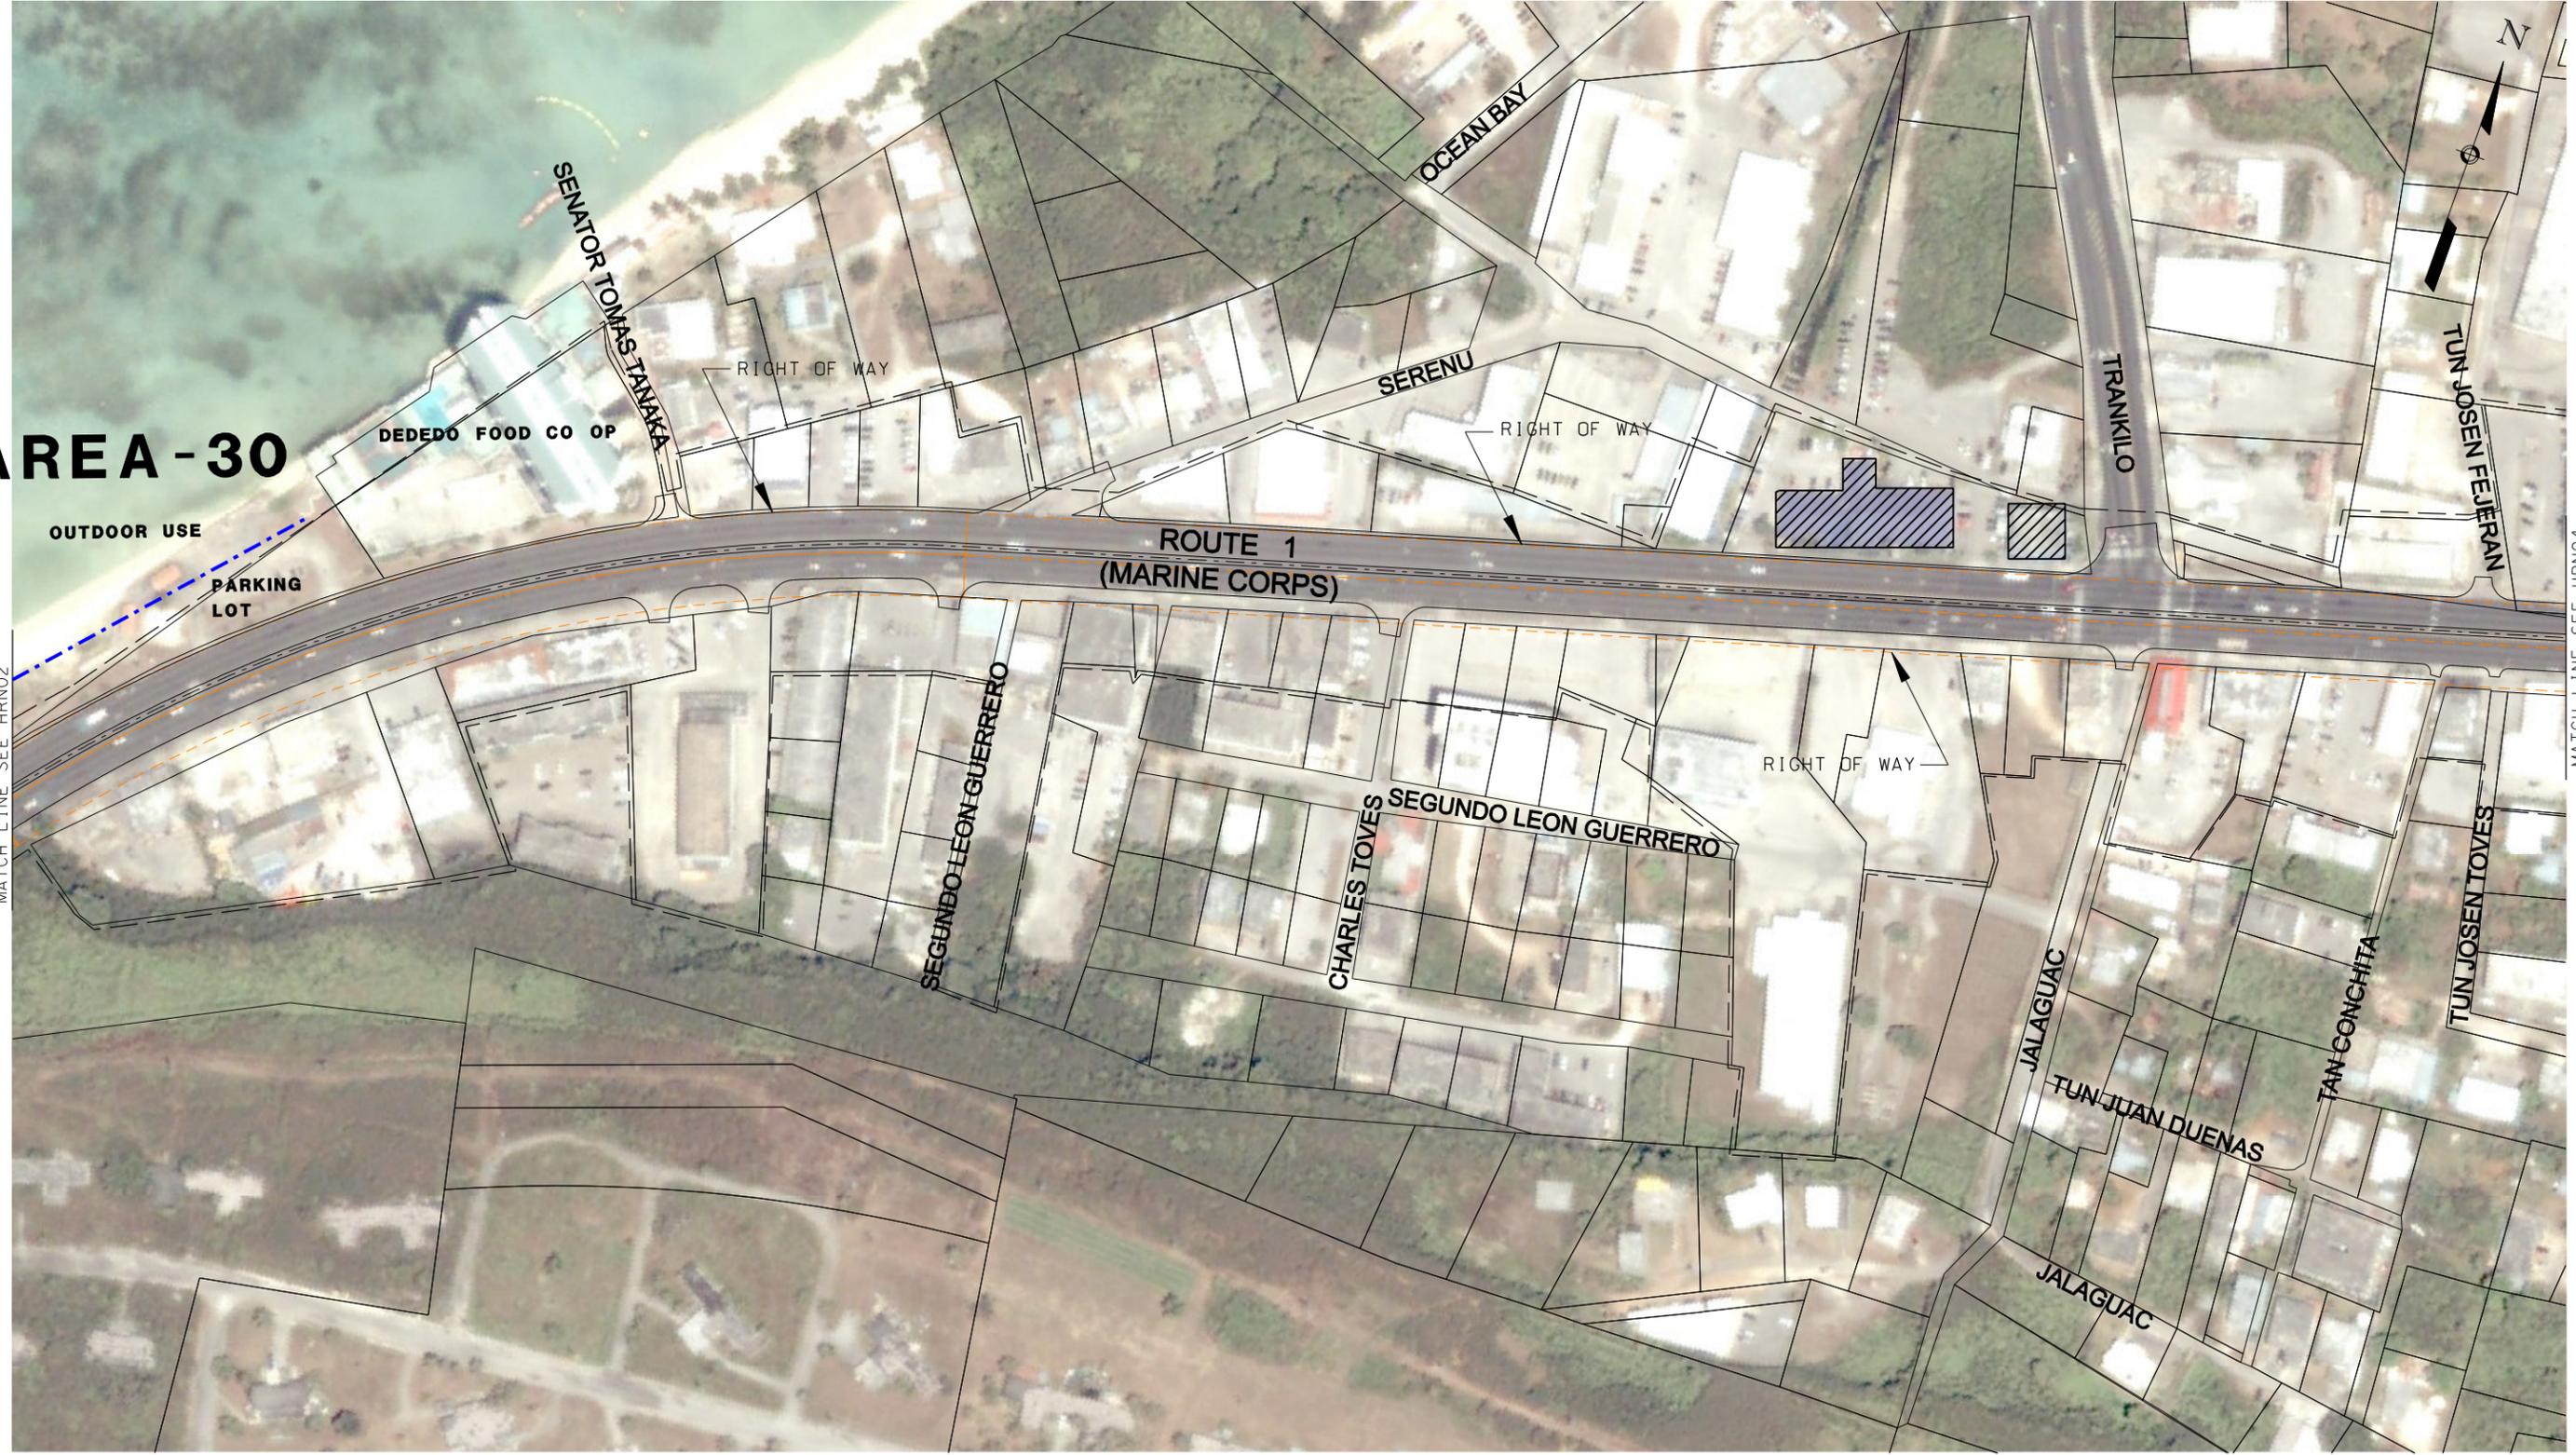
Scale 1"=200' Drawing HRN033 Sheet 30 of 69

# AREA - 30
