## Appendix G

### EIS Resource Technical Appendix

# Guam and CNMI Military Relocation EIS

## Volume 9: EIS Resource Technical Appendix

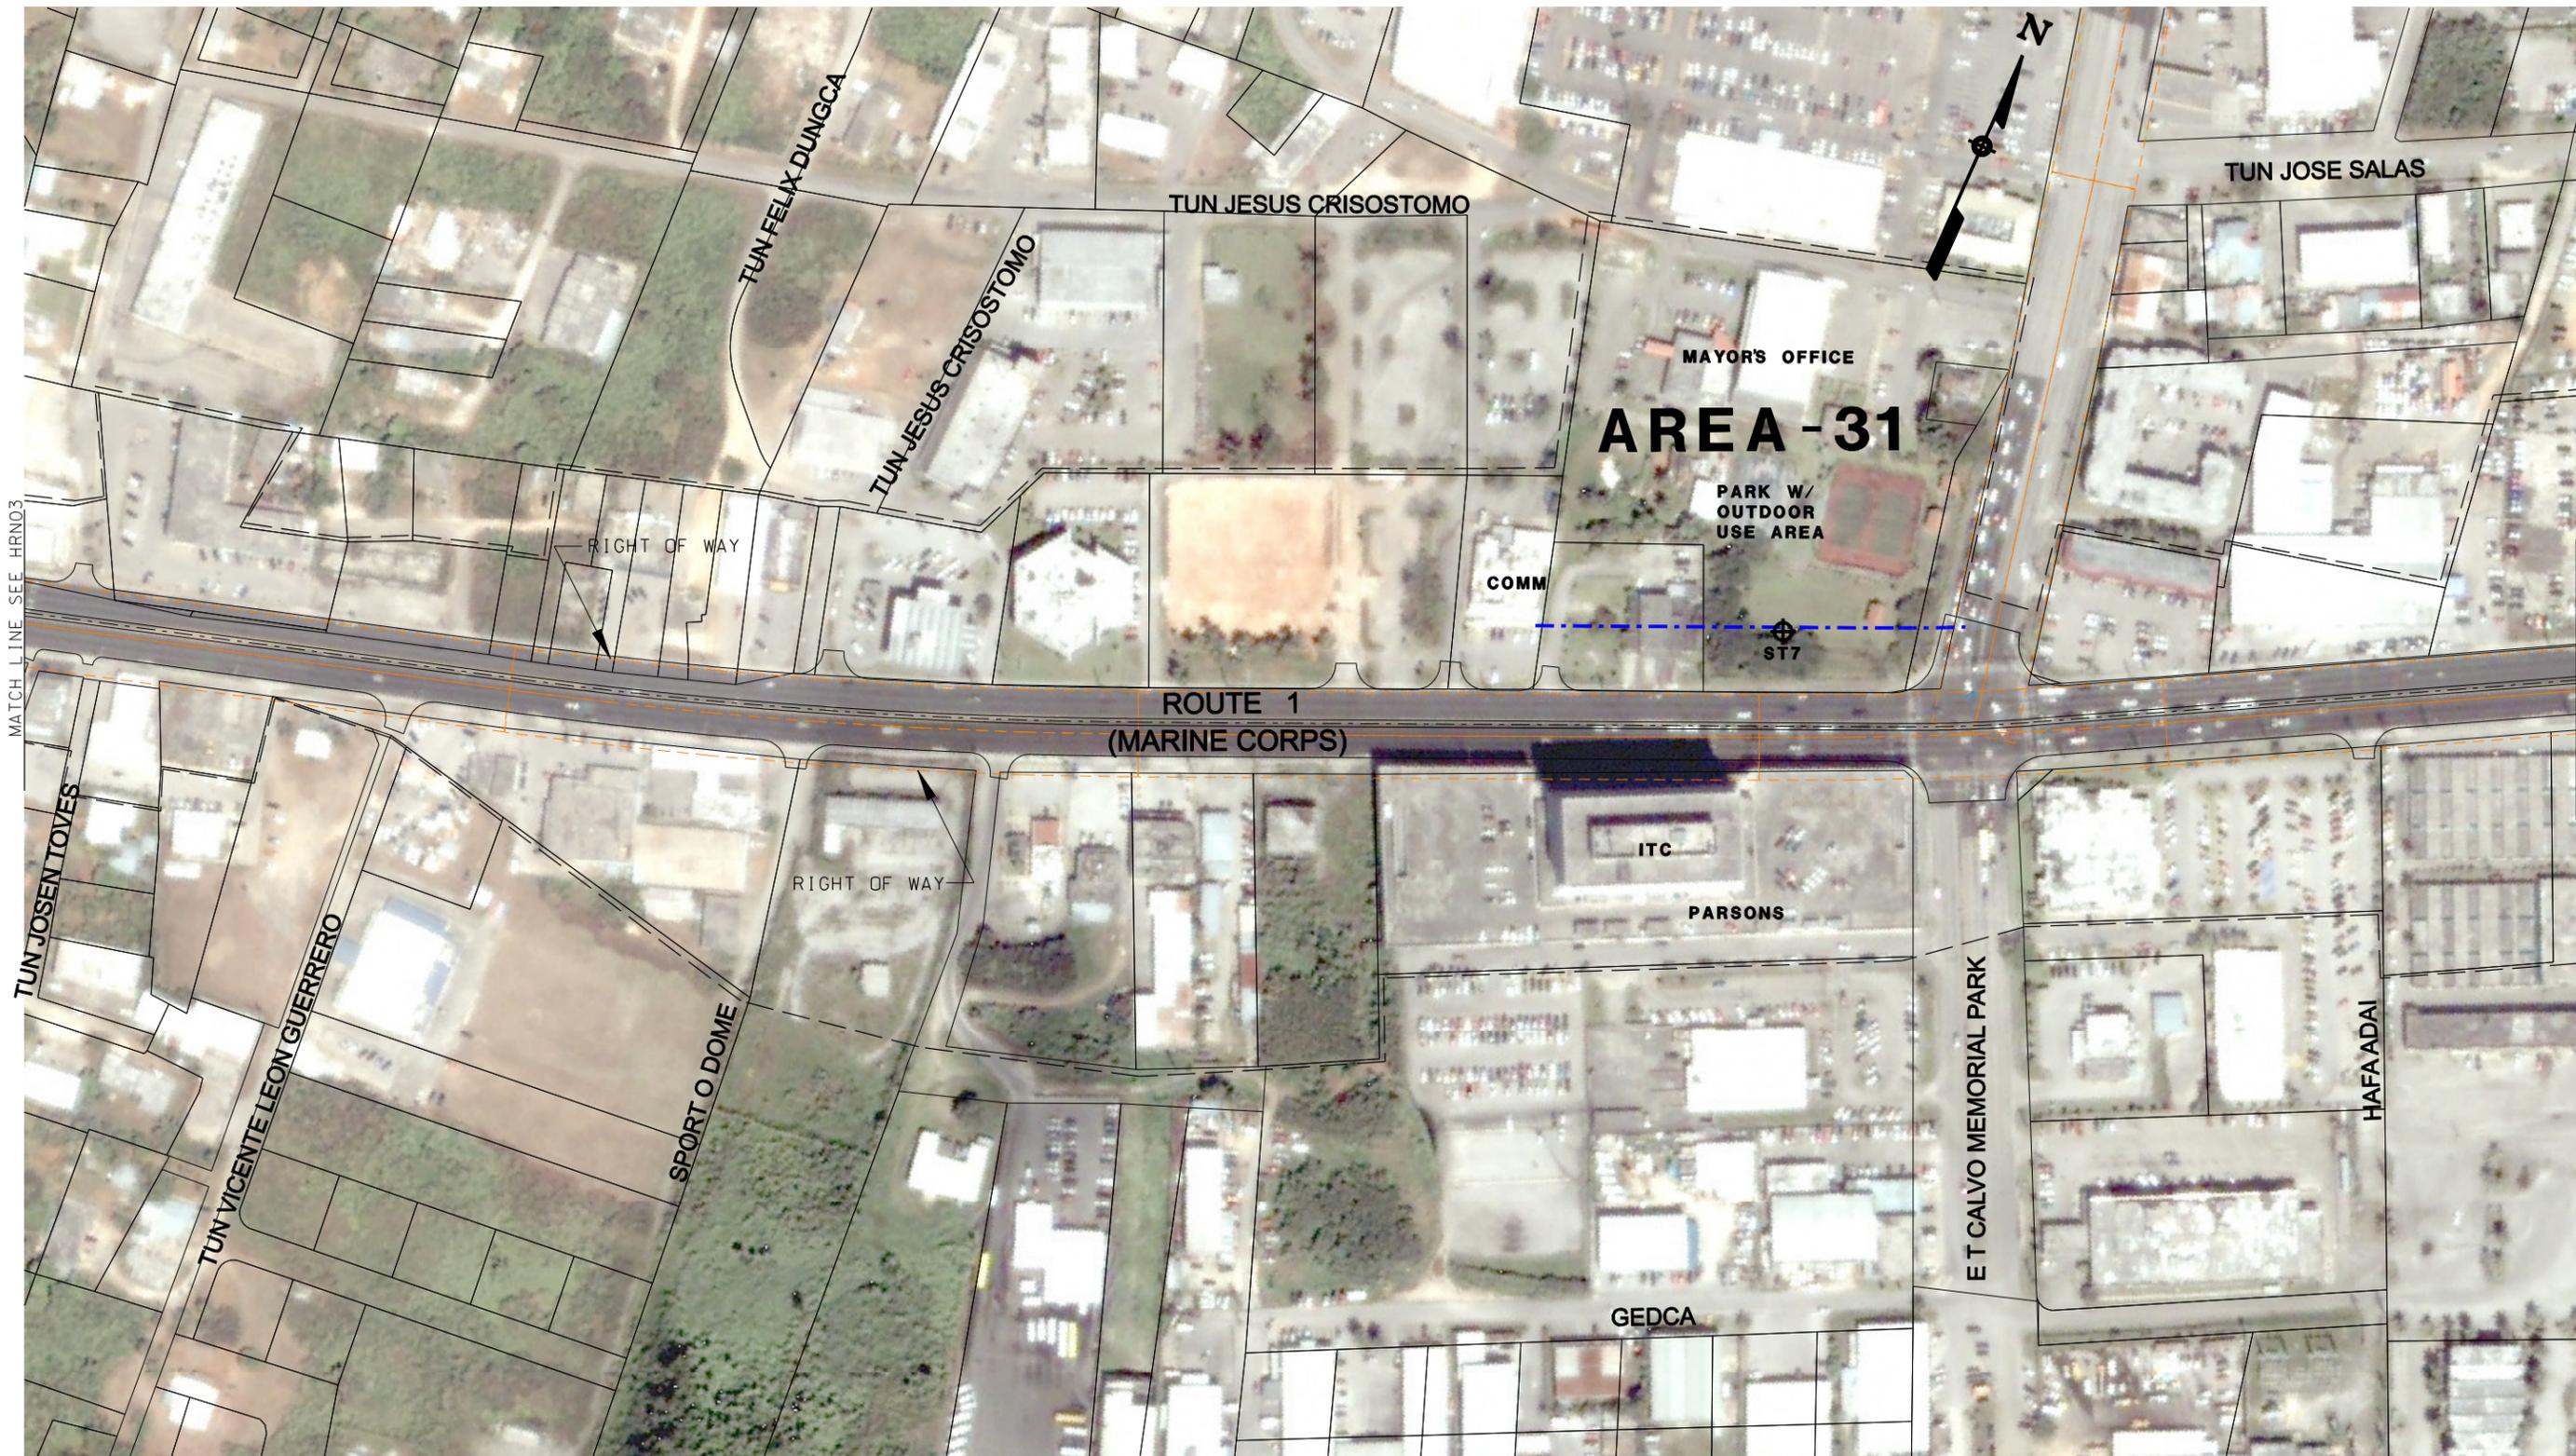
Scale 1"=200' Drawing HRN033 Sheet 31 of 69

**66 dBA NOISE  
IMPACT CONTOUR LINE  
FOR NON ABATEMENT**

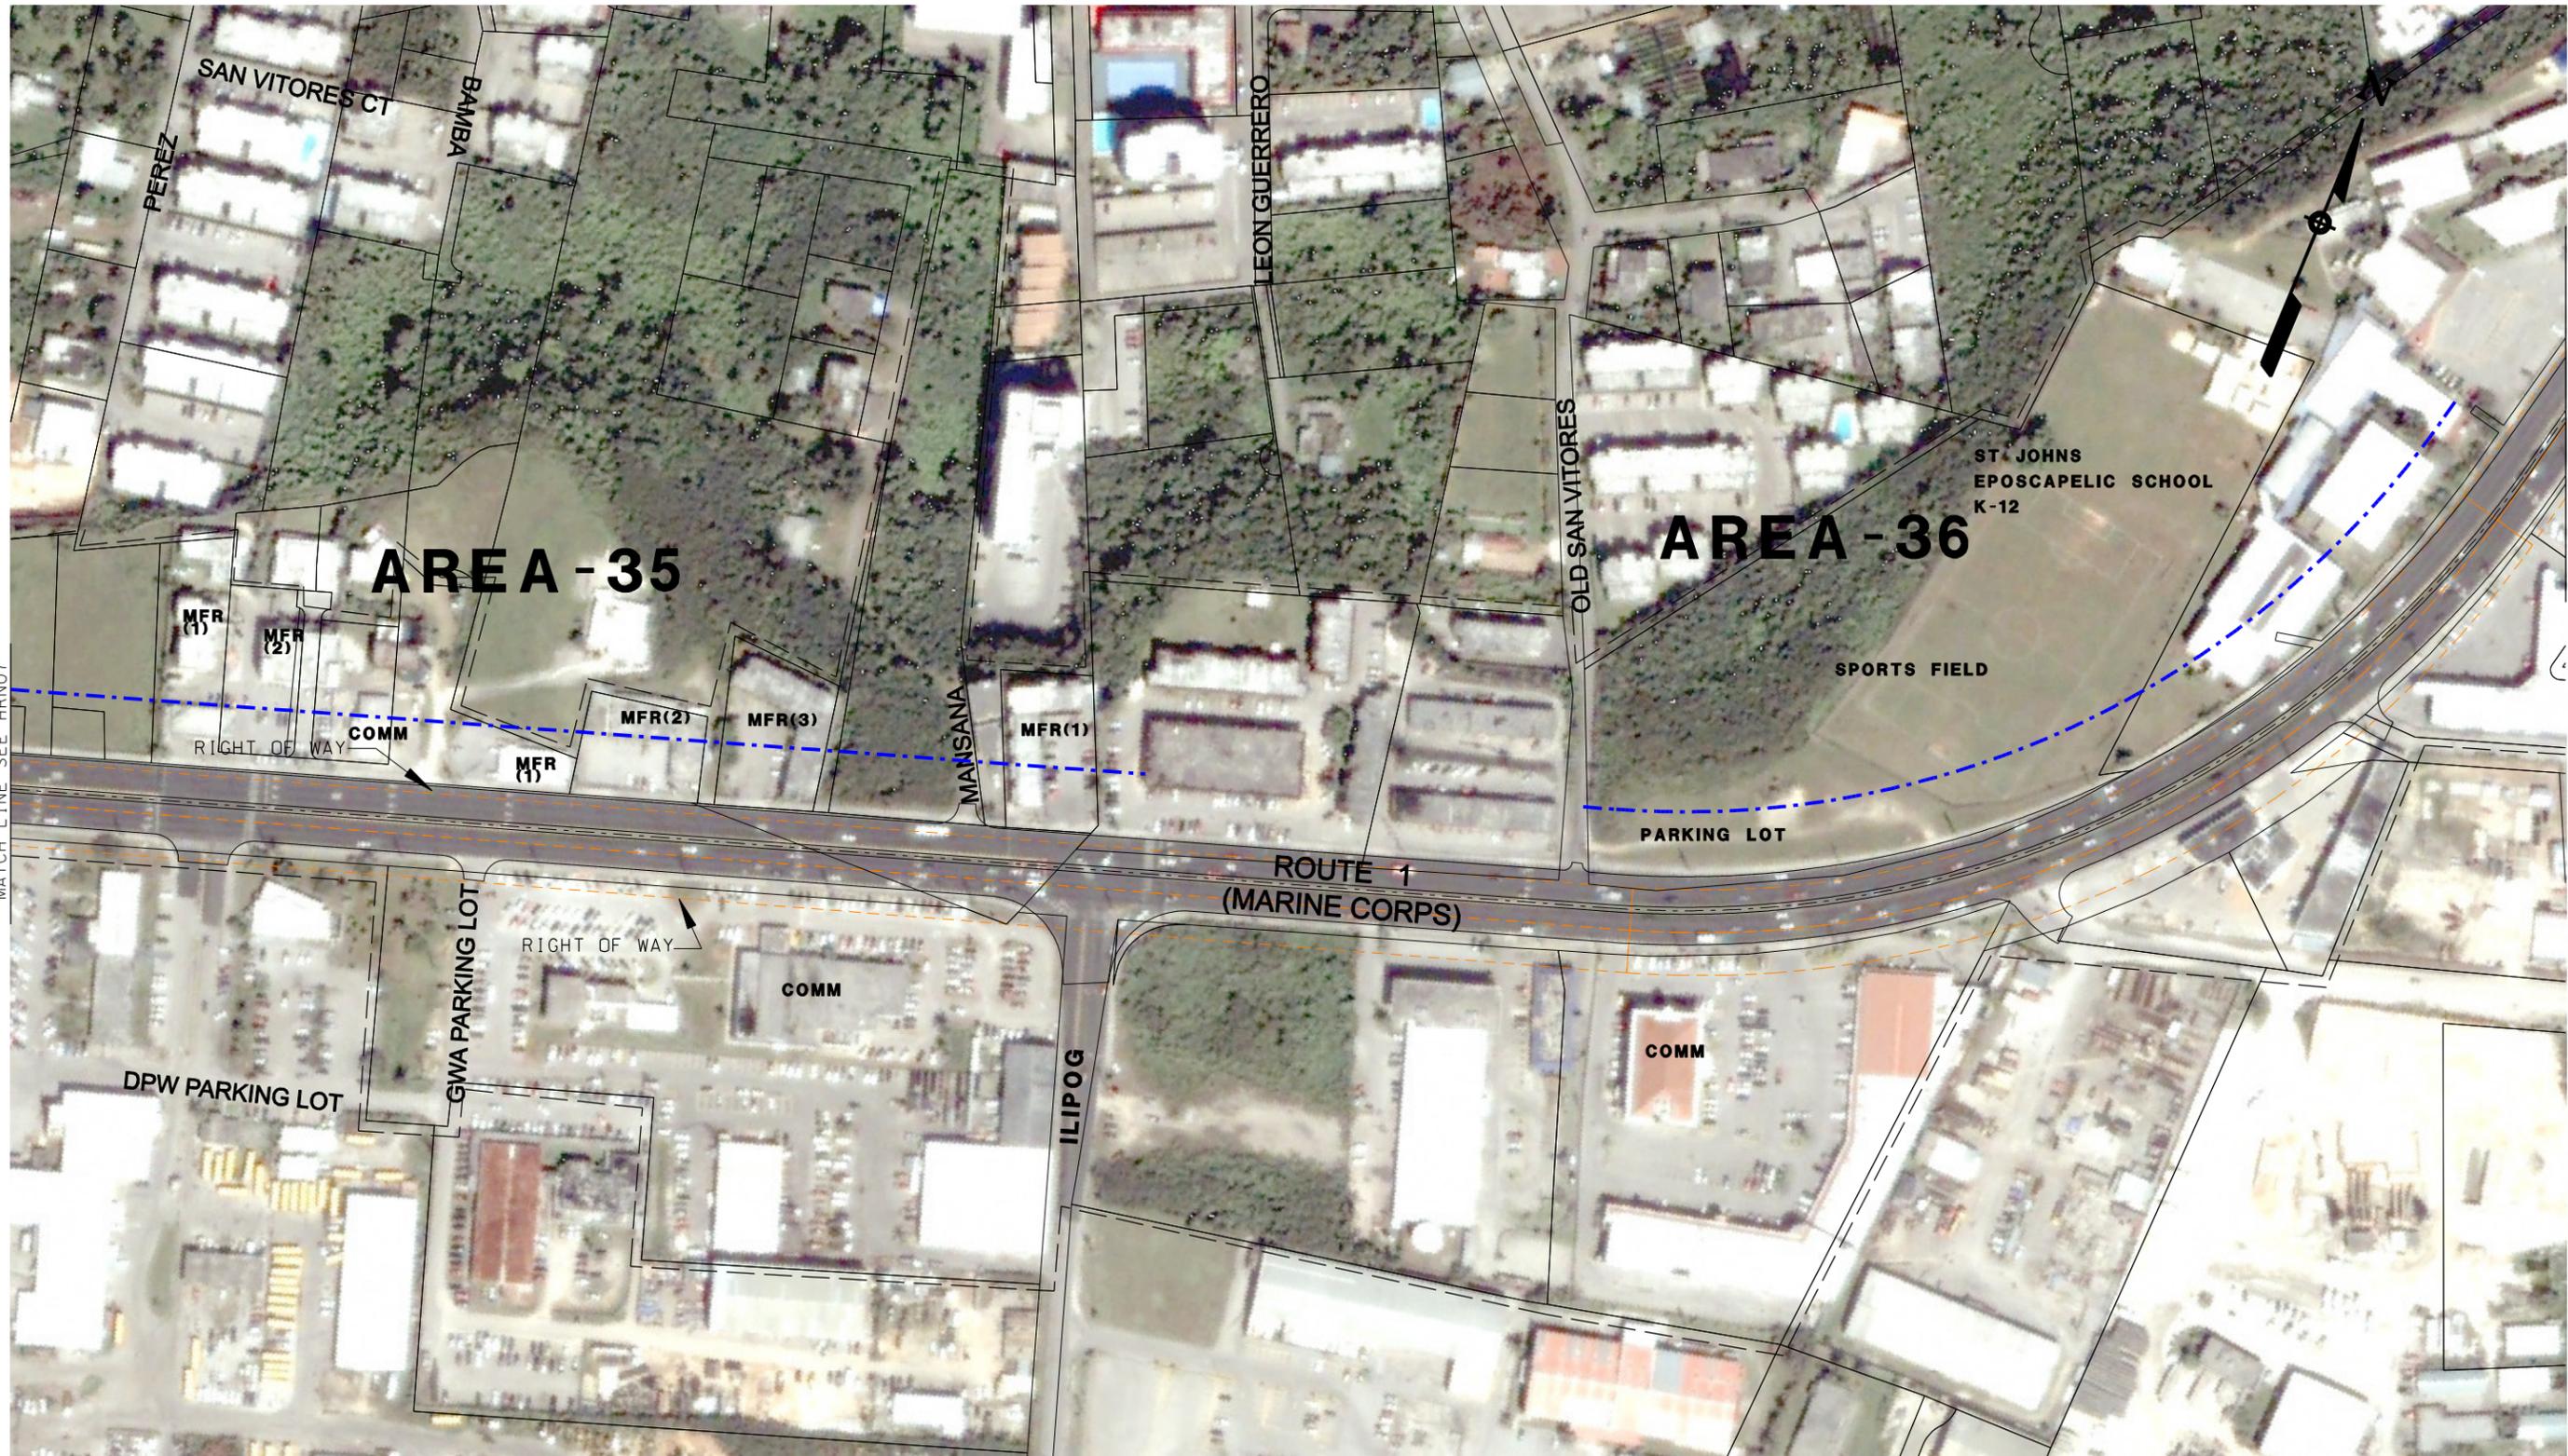
Scale 1"=200' Drawing HRN033 Sheet 35 of 69

**66 dBA NOISE**  
**IMPACT CONTOUR LINE**  
**FOR NON ABATEMENT**

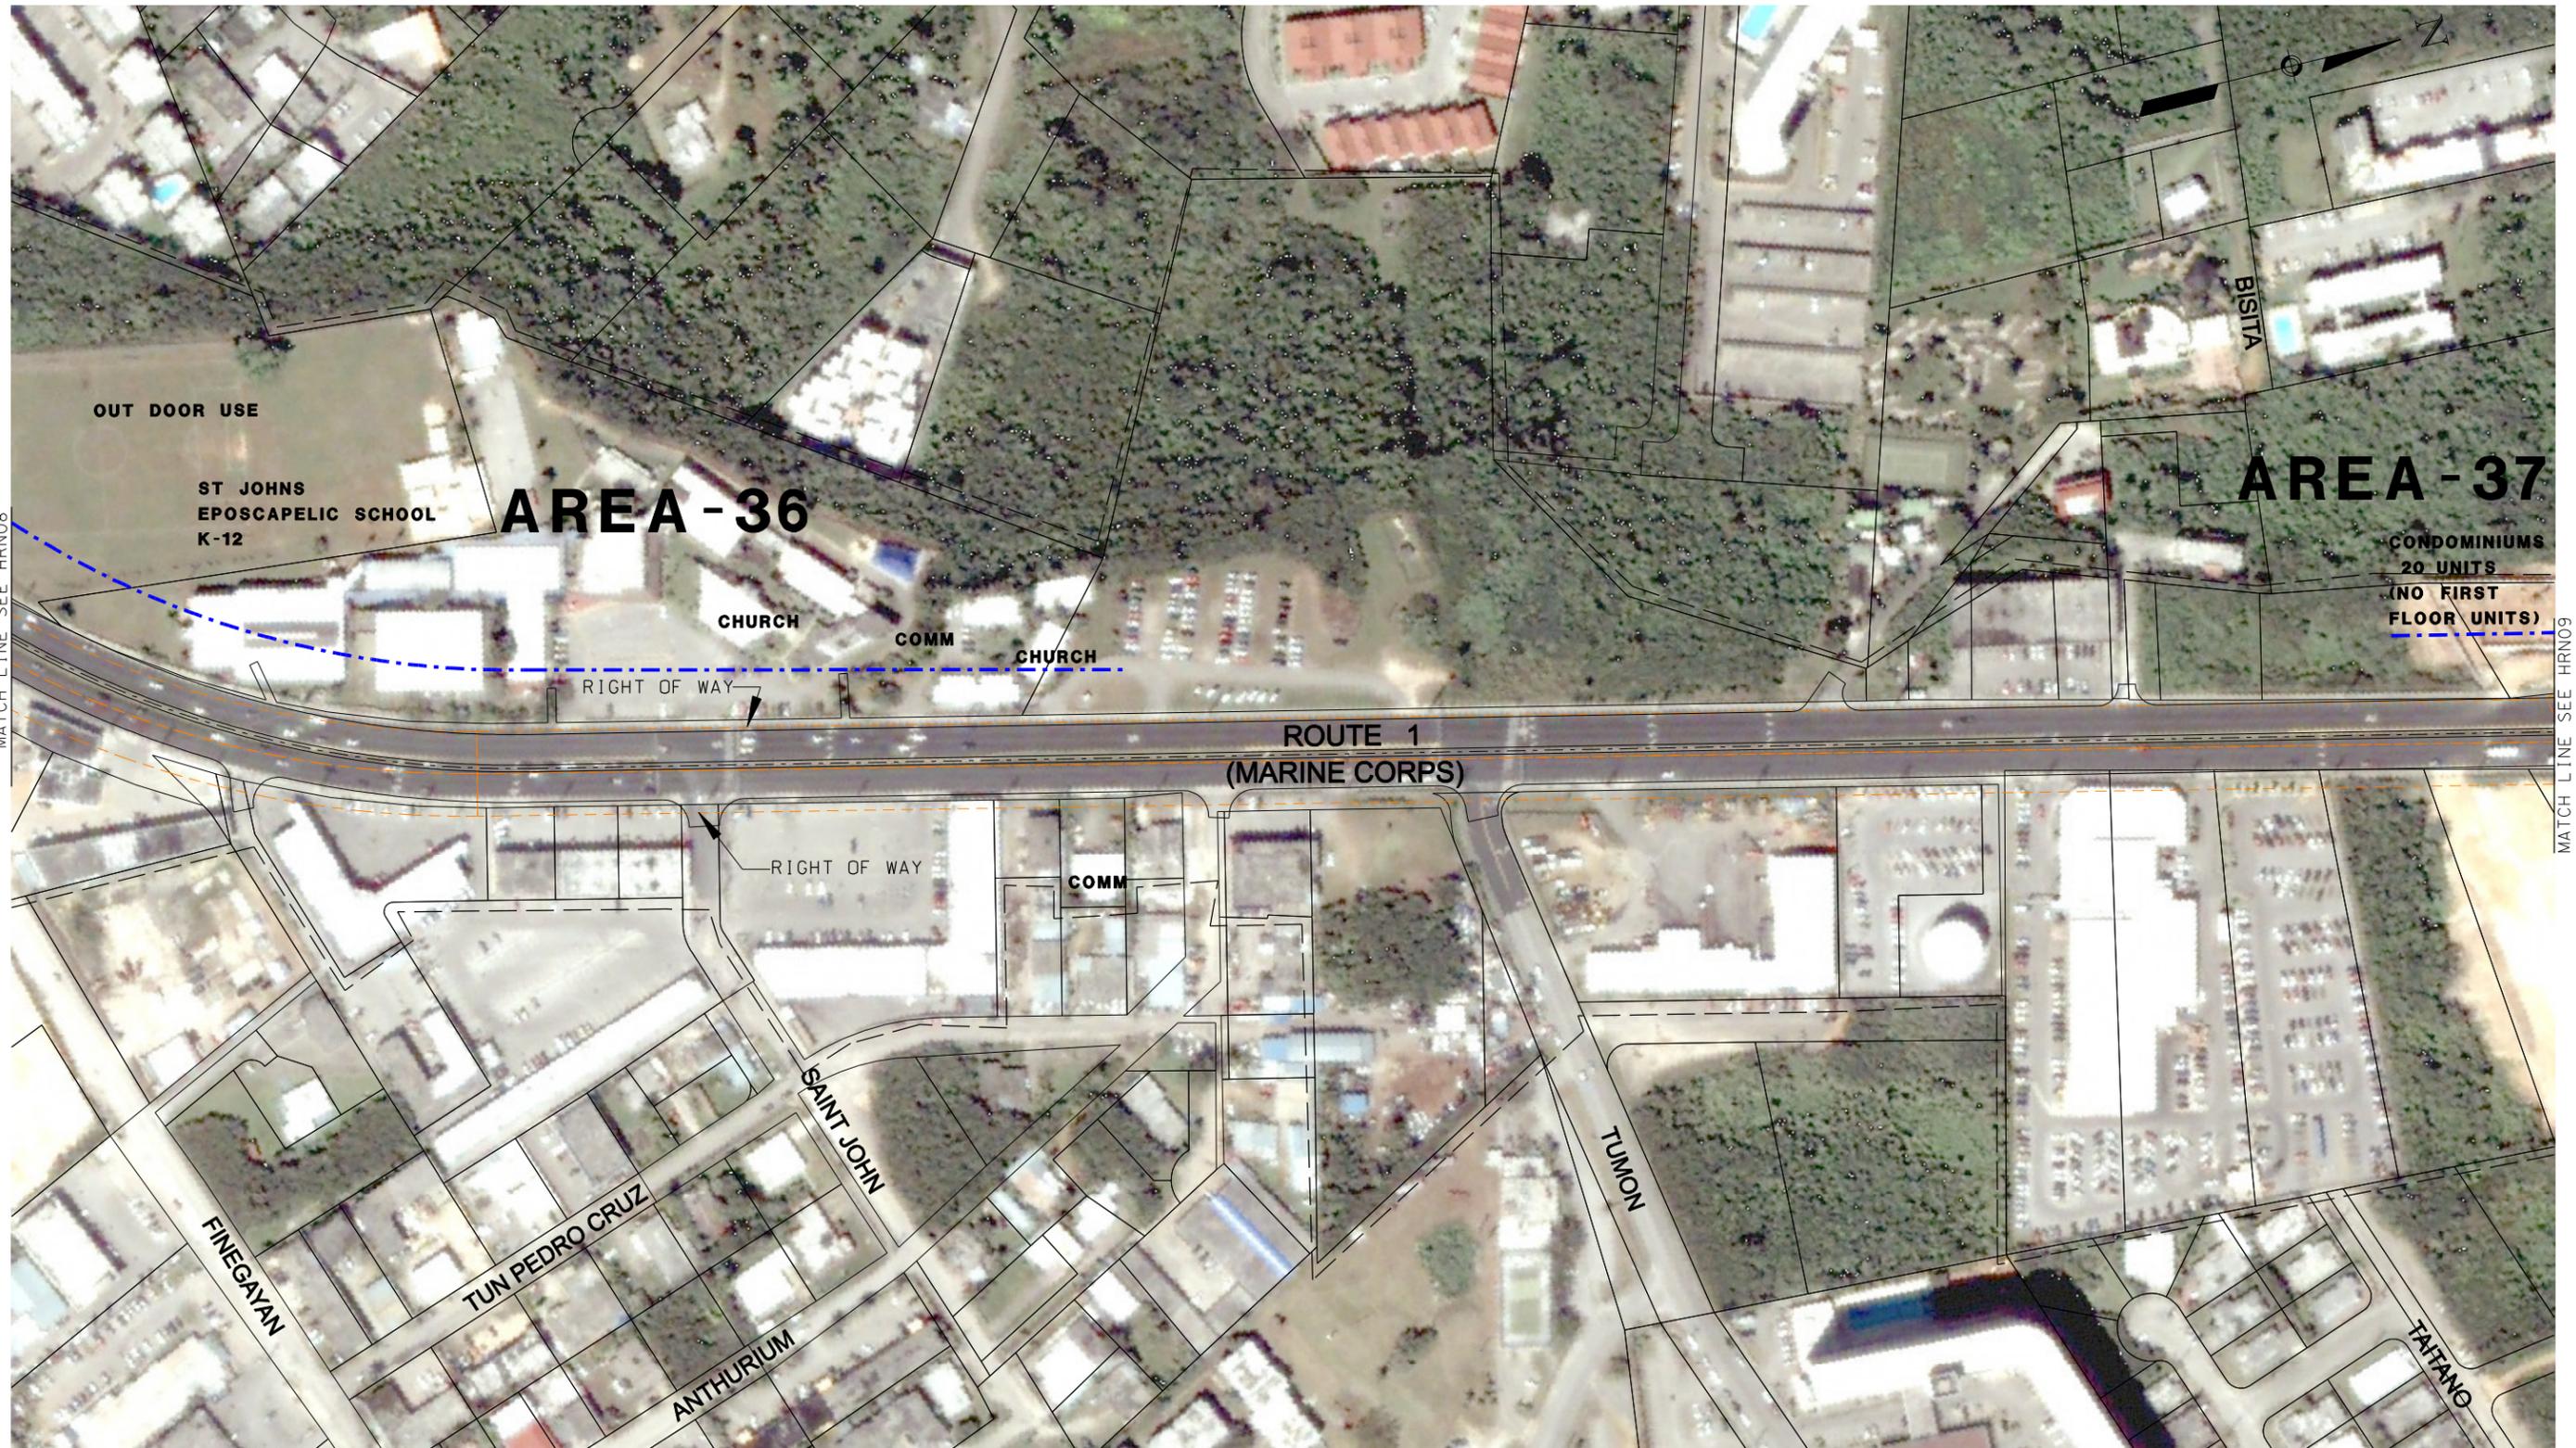
Scale 1"=200' Drawing HRN033 Sheet 36 of 69

**66 dBA NOISE  
IMPACT CONTOUR LINE  
FOR NON ABATEMENT**

**GUAM COMMUNITY BUILD-UP: HAUL ROAD NETWORK**

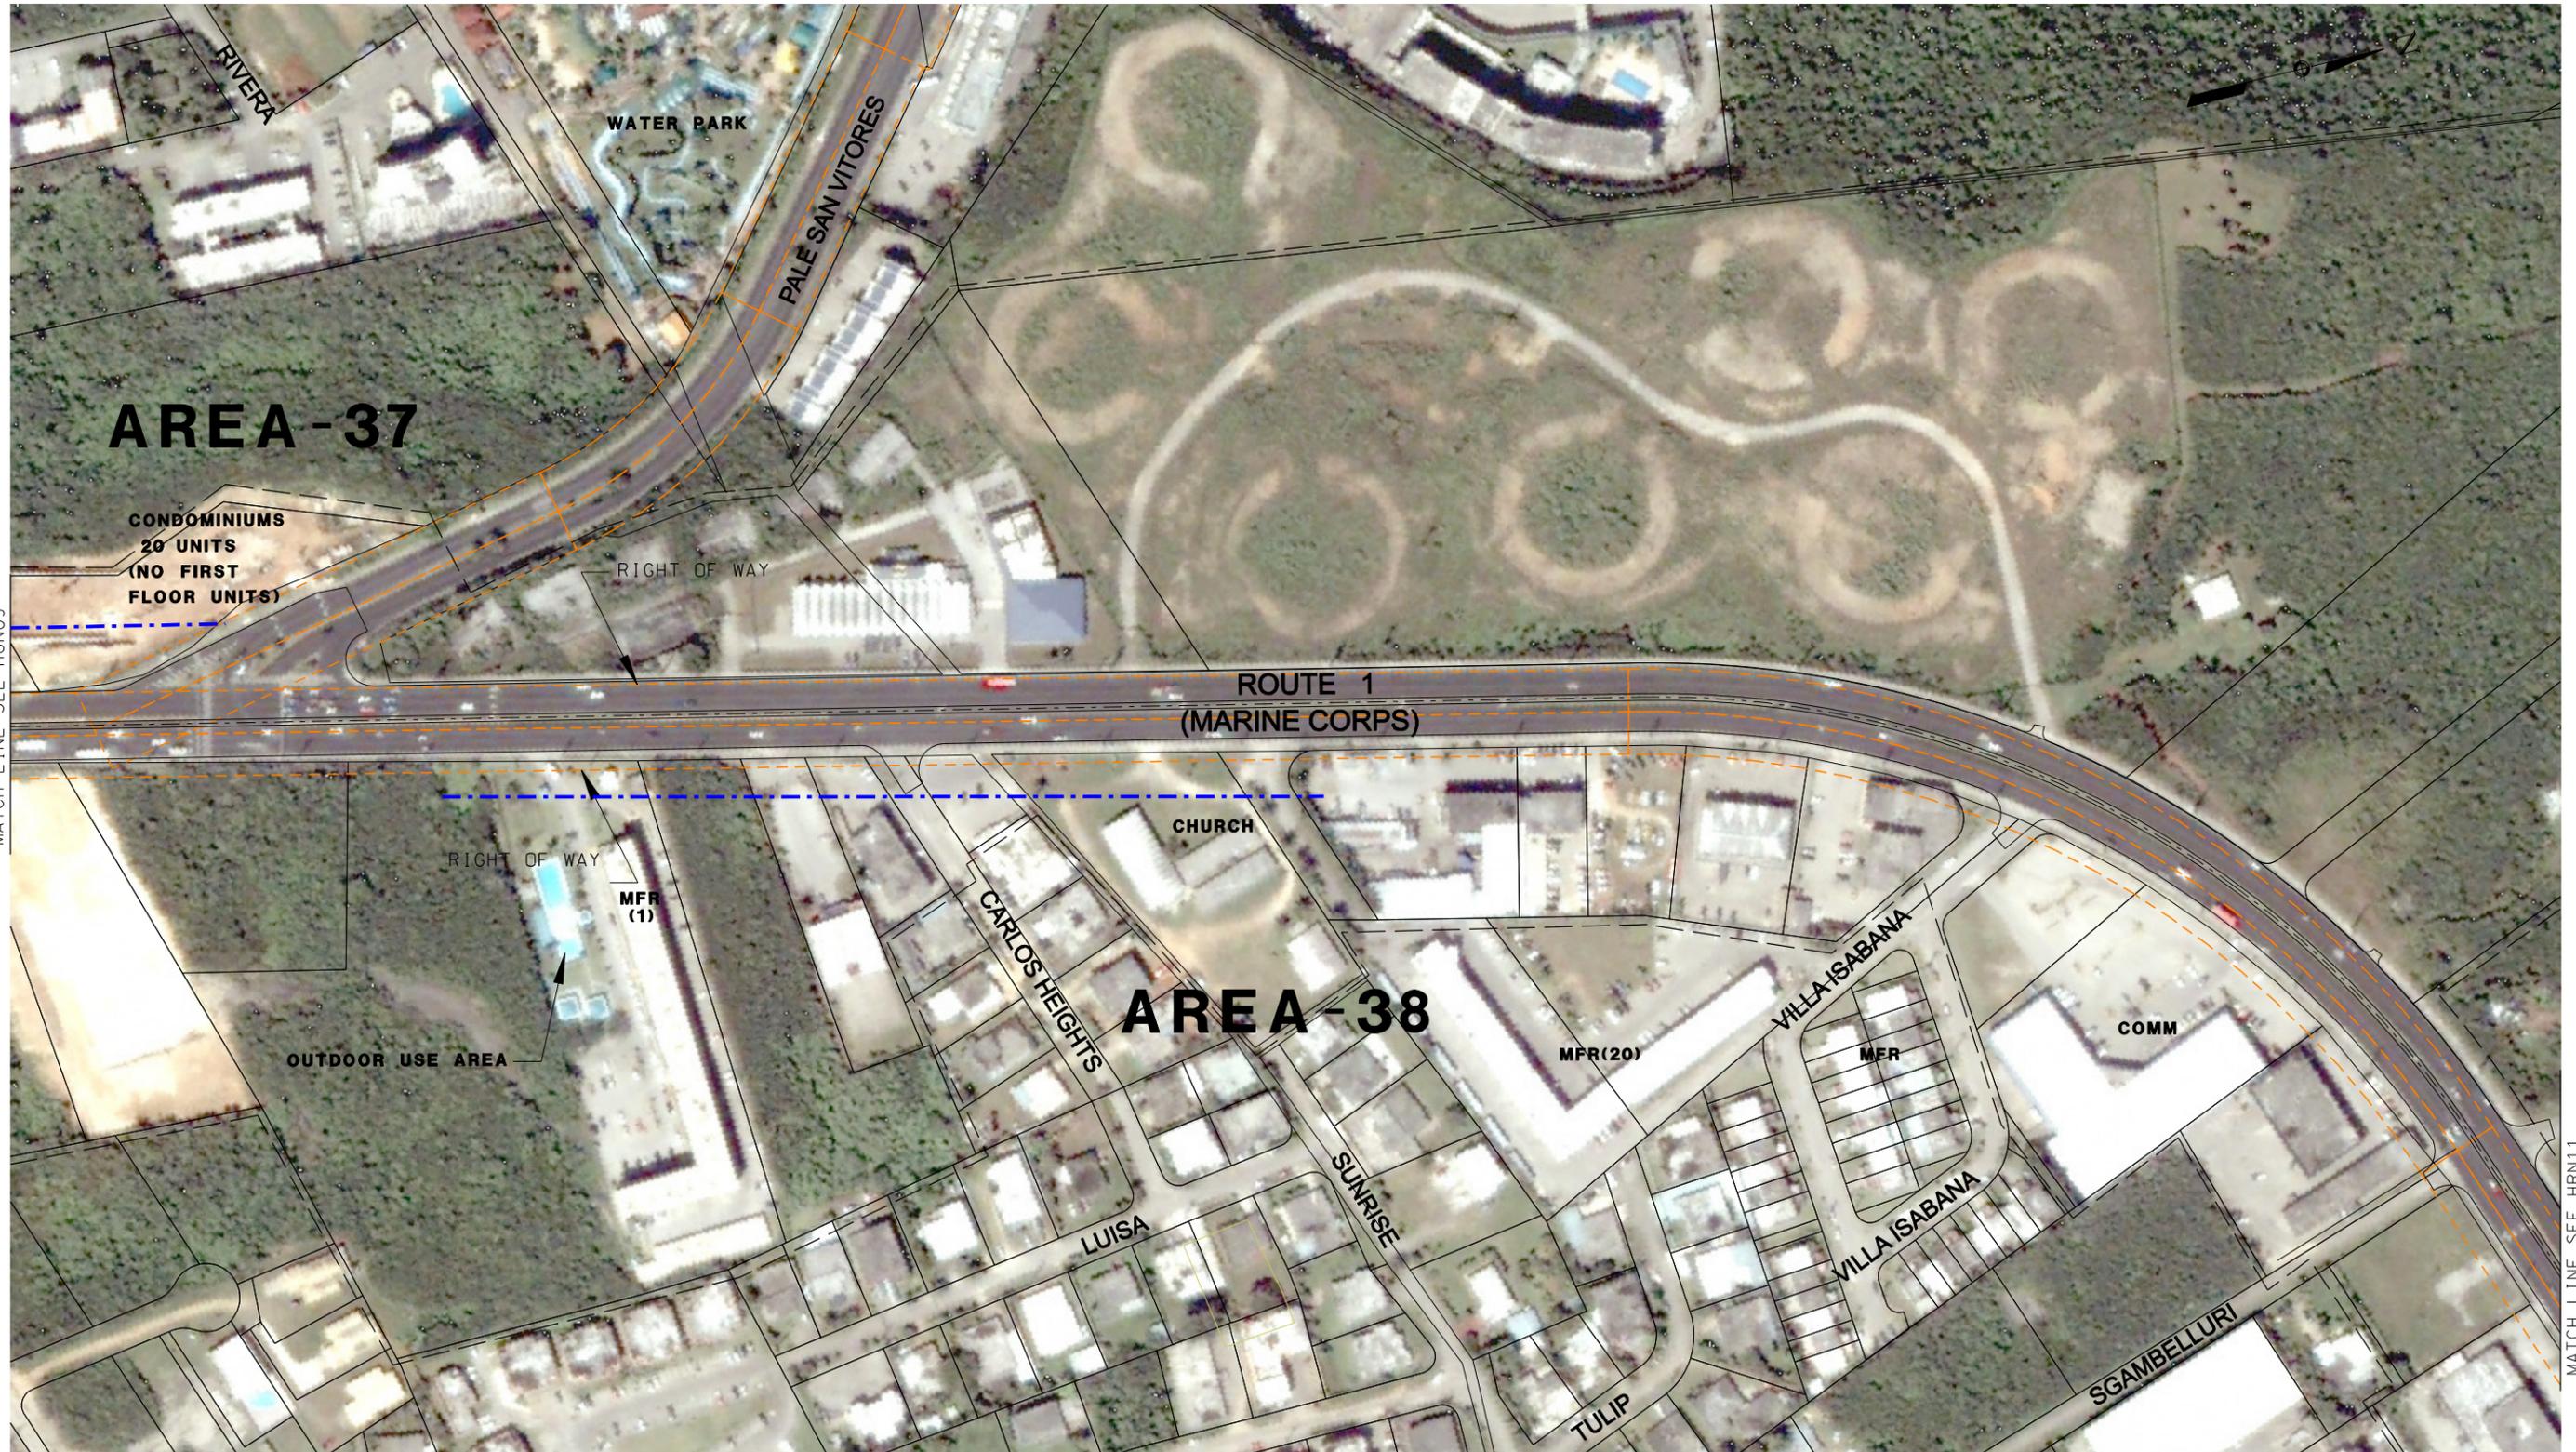
Scale 1"=200' Drawing HRN033 Sheet 37 of 69

**66 dBA NOISE  
IMPACT CONTOUR LINE  
FOR NON ABATEMENT**

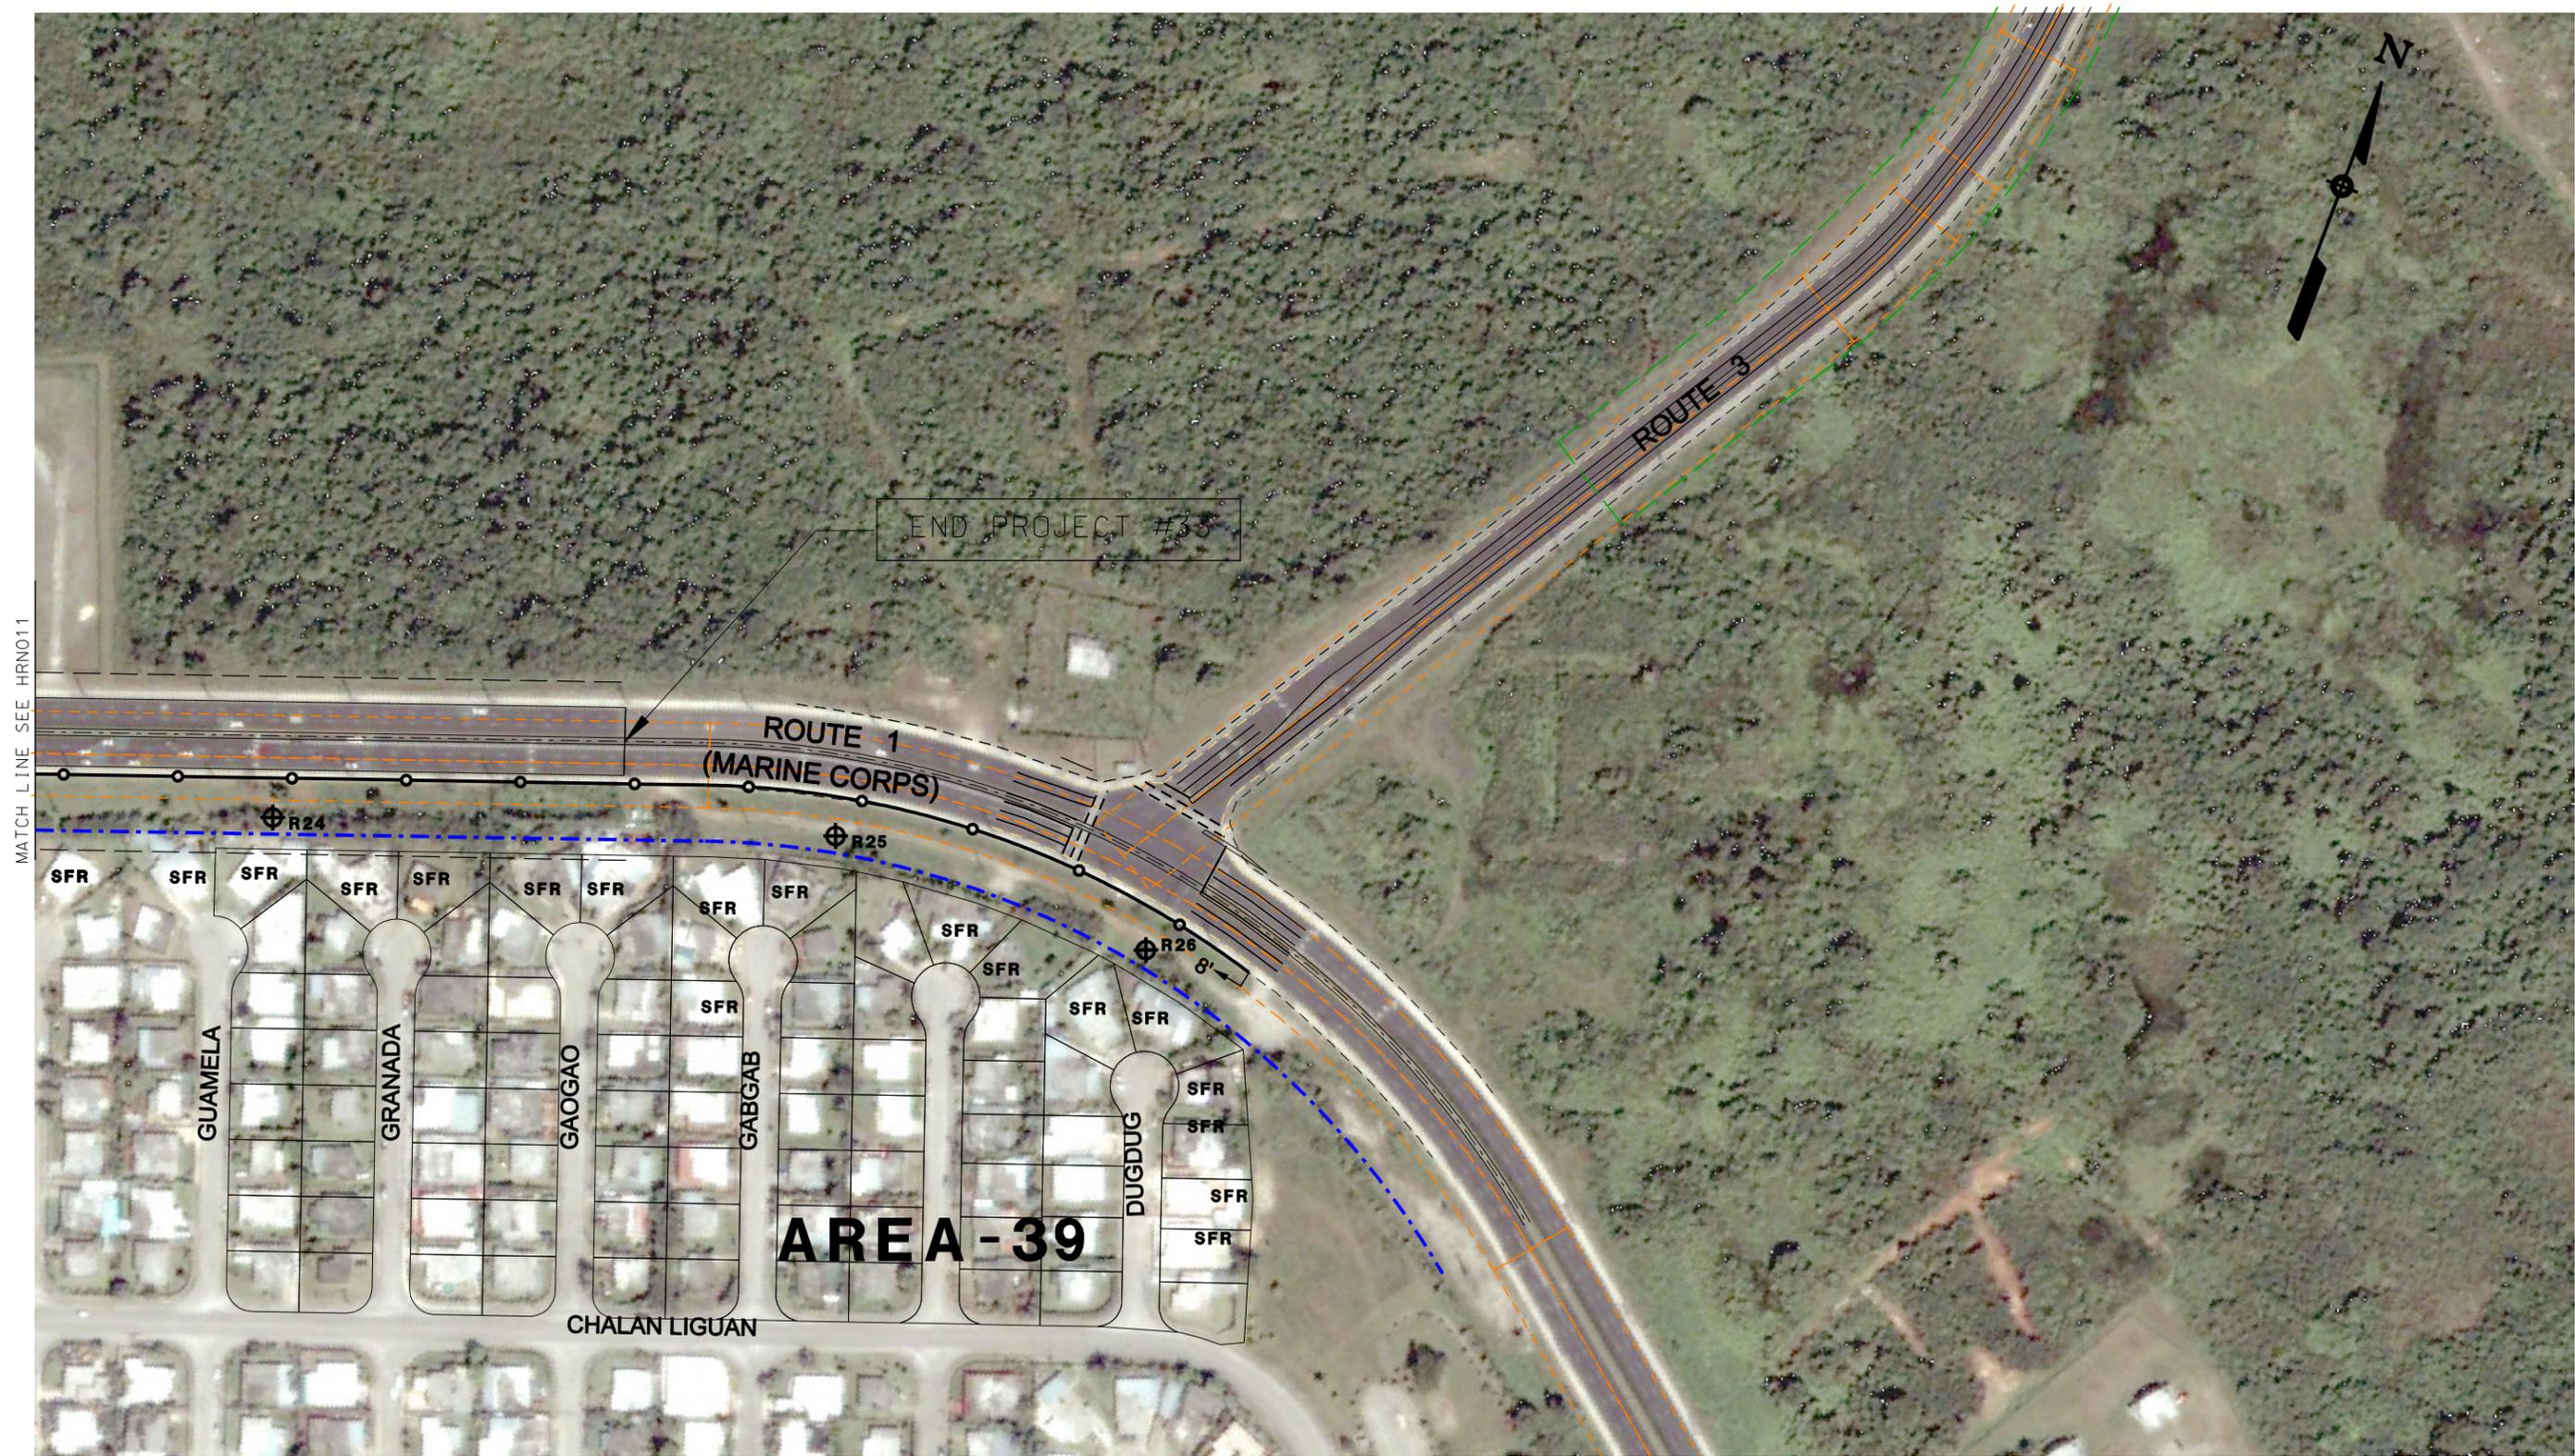
Scale 1"=200' Drawing HRN033 Sheet 39 of 69

**66 dBA NOISE  
IMPACT CONTOUR LINE  
FOR NON ABATEMENT**

**GUAM COMMUNITY BUILD-UP: HAUL ROAD NETWORK**

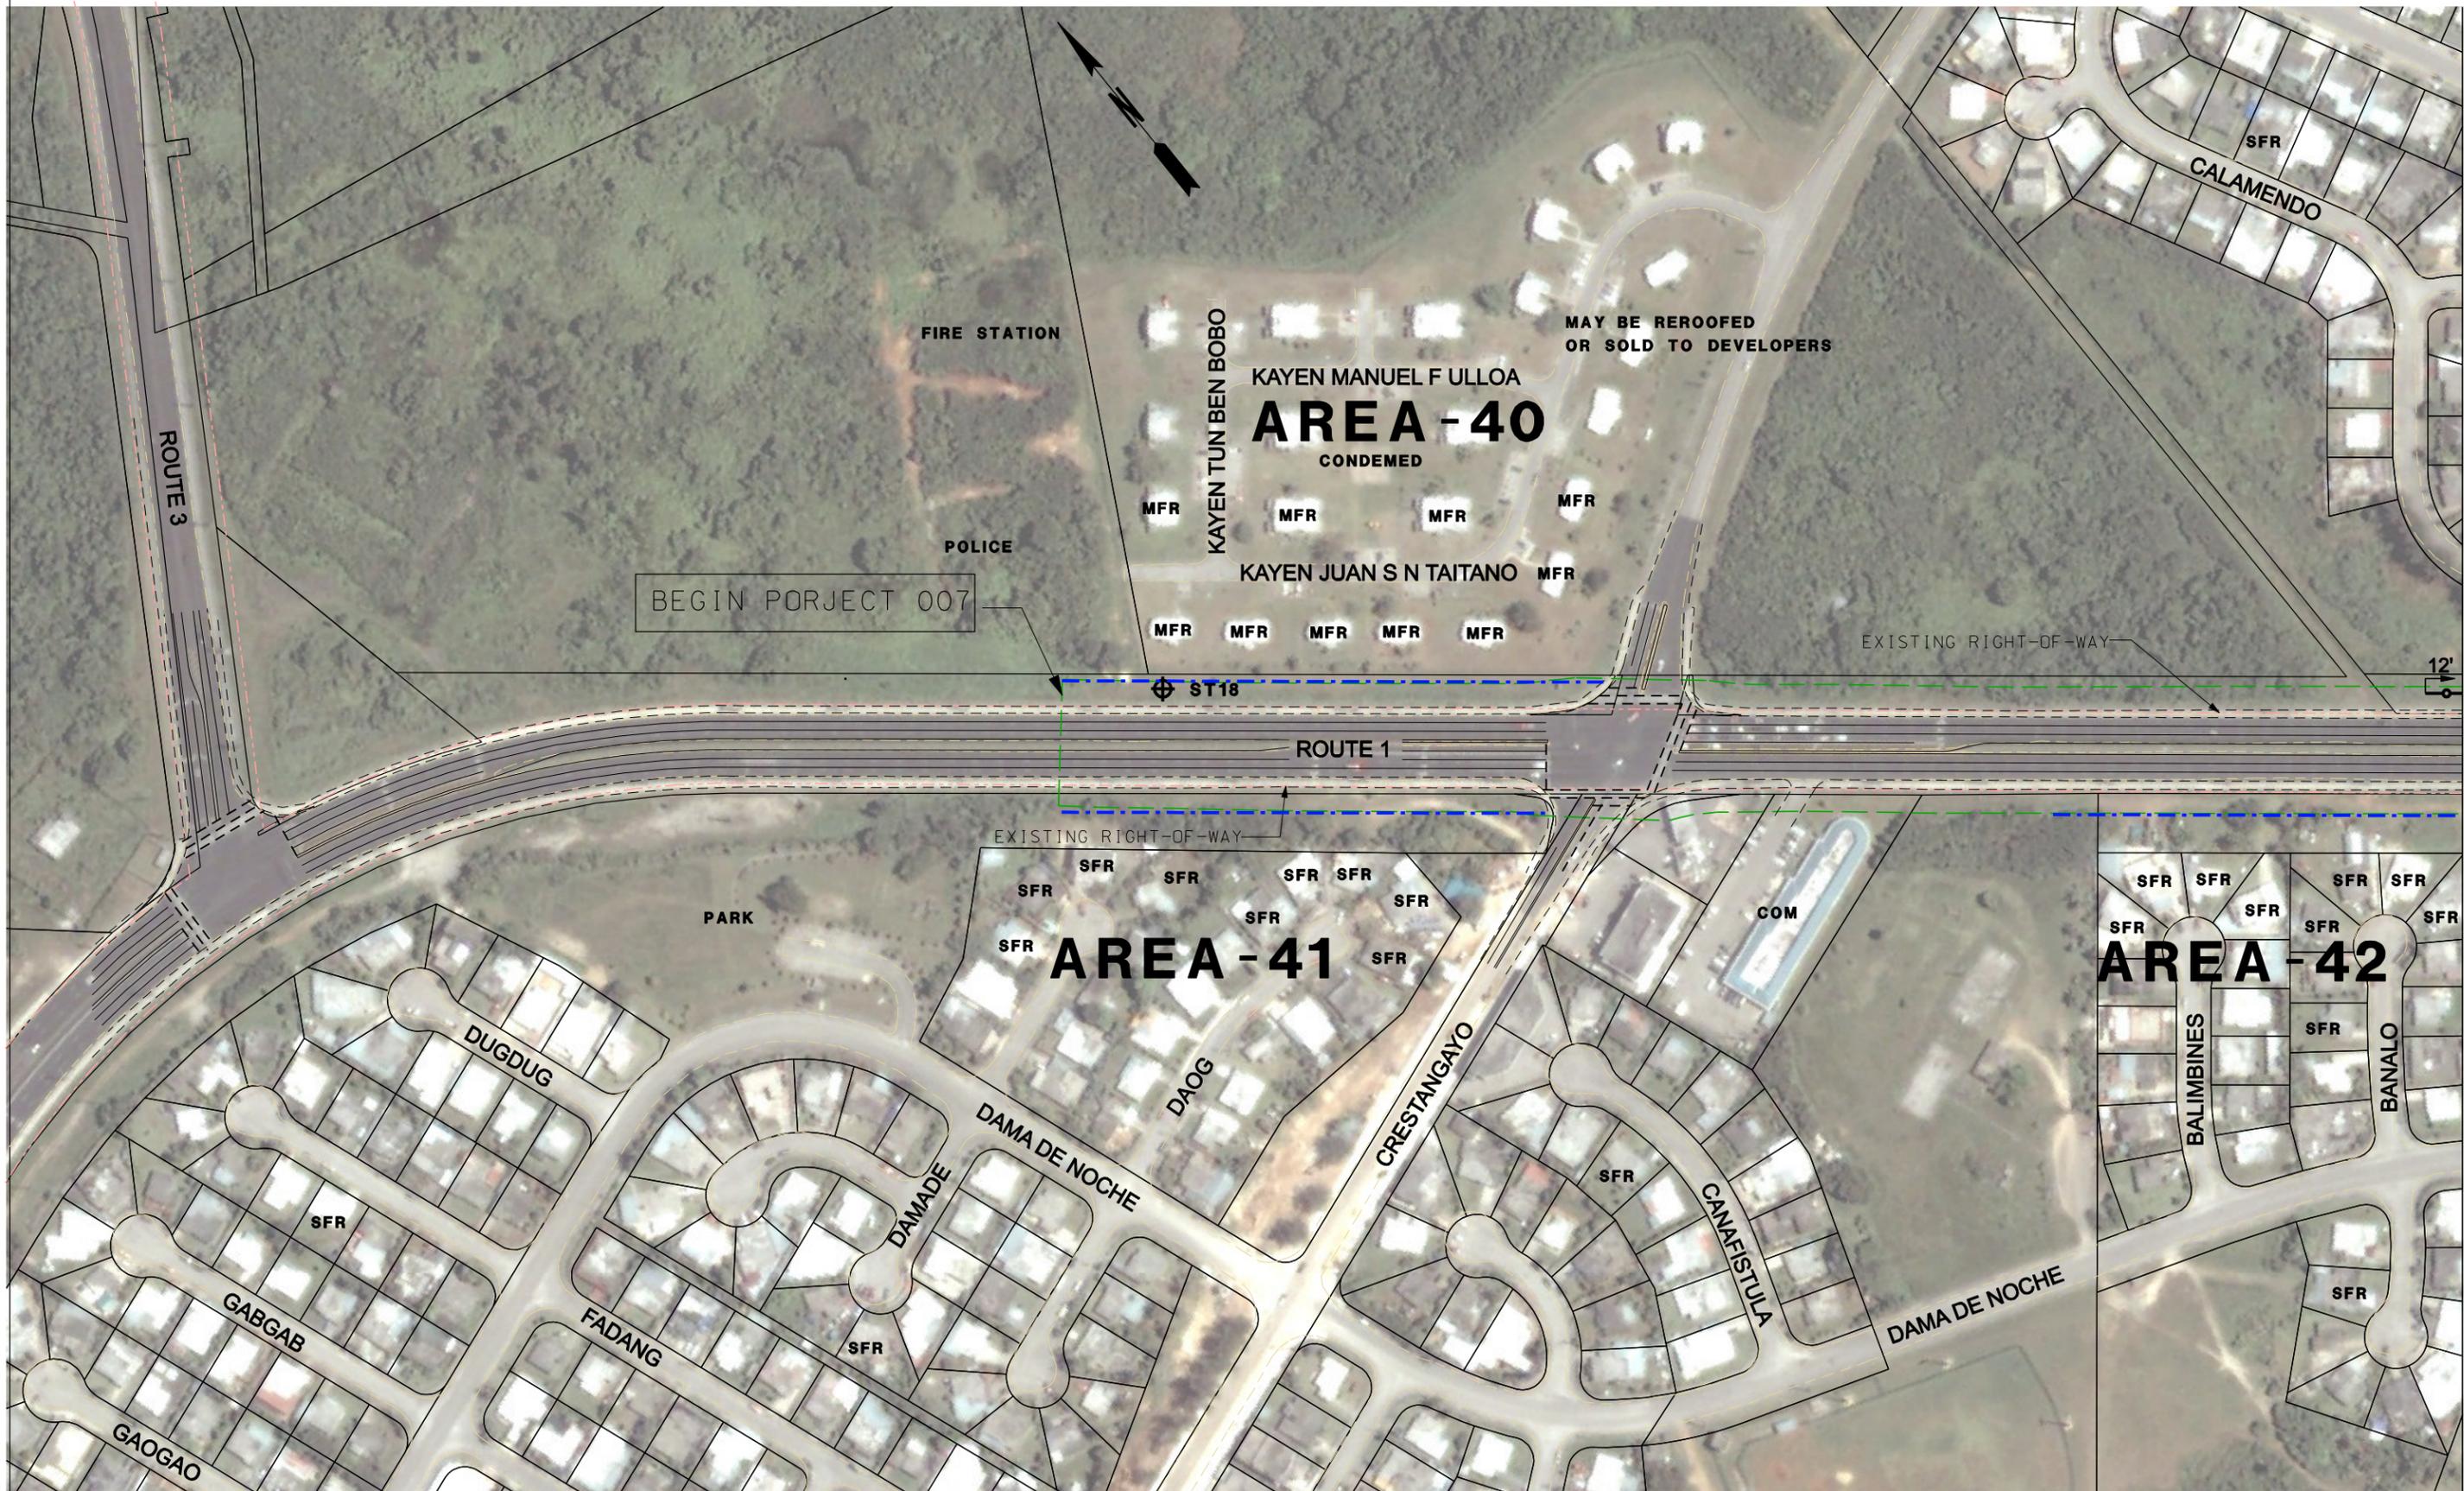
Scale 1"=200' Drawing HRN033 Sheet 40 of 69

**66 dBA NOISE  
IMPACT CONTOUR LINE  
FOR NON ABATEMENT**

**GUAM COMMUNITY BUILD-UP: HAUL ROAD NETWORK**
