## Appendix G

### EIS Resource Technical Appendix

# Guam and CNMI Military Relocation EIS

## Volume 9: EIS Resource Technical Appendix

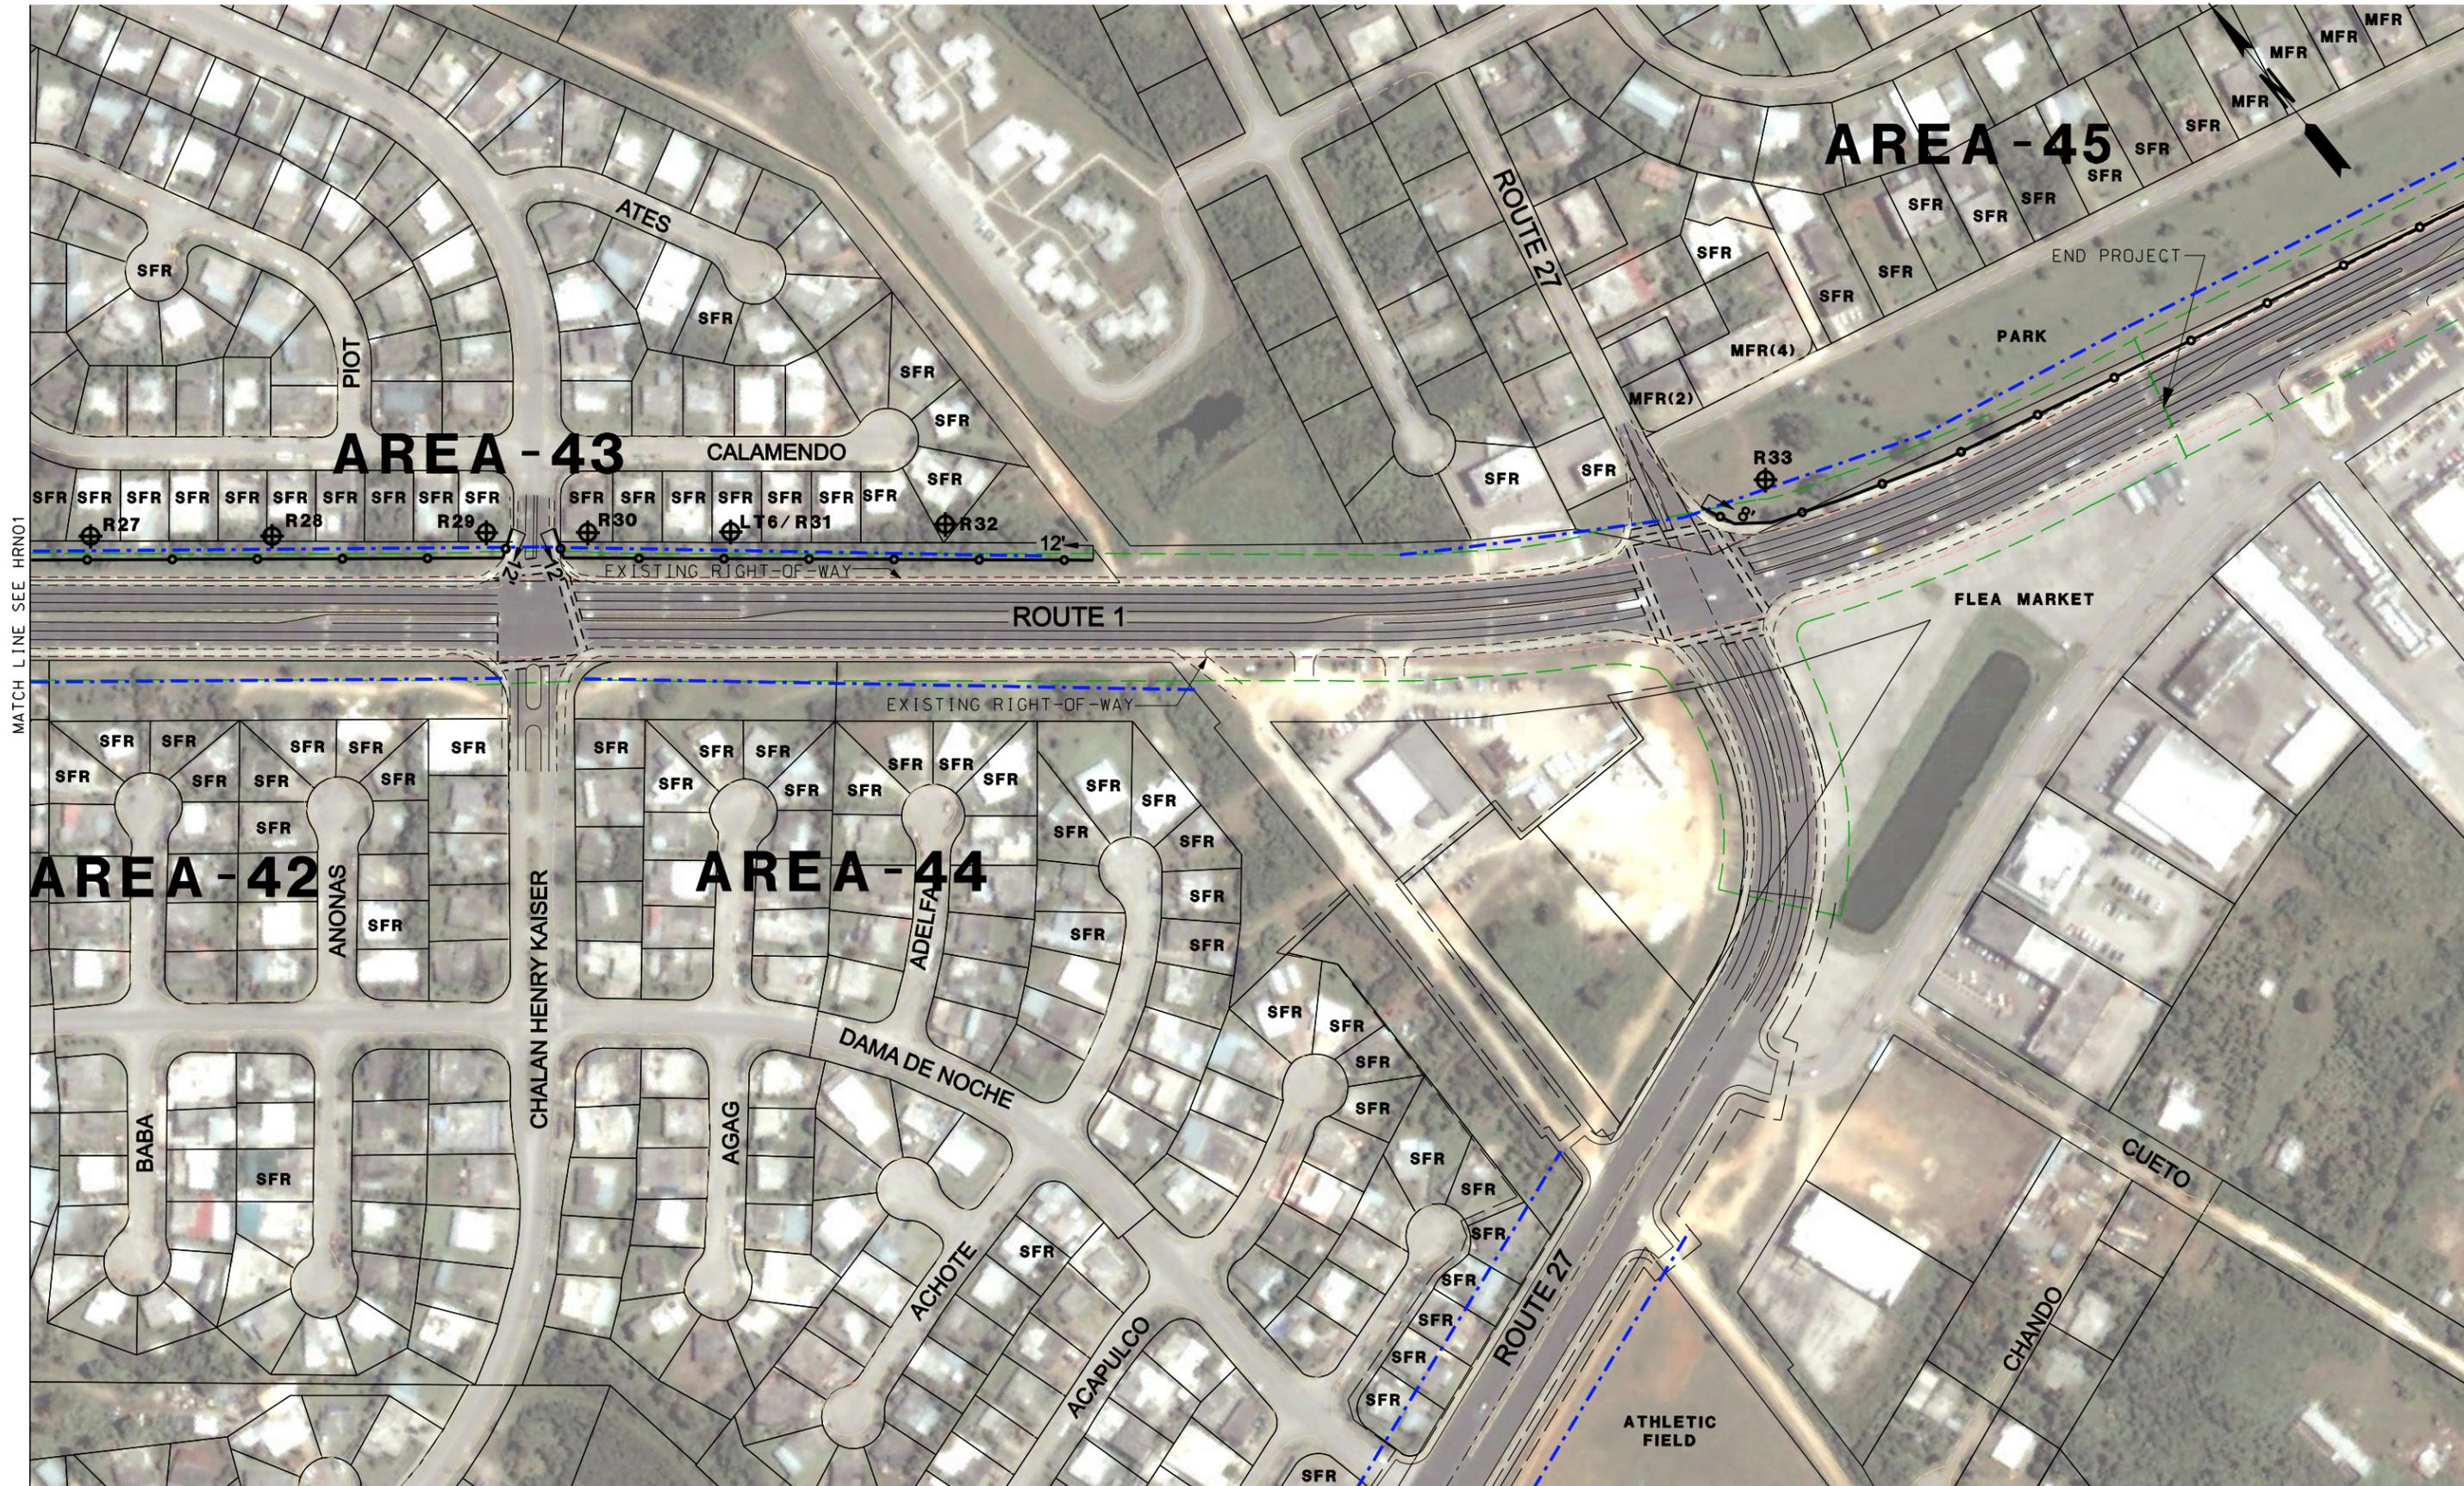
Scale 1"=200' Drawing HRN007 Sheet 41 of 69

**66 dBA NOISE  
IMPACT CONTOUR LINE  
FOR NON ABATEMENT**

**GUAM COMMUNITY BUILD-UP: HAUL ROAD NETWORK**

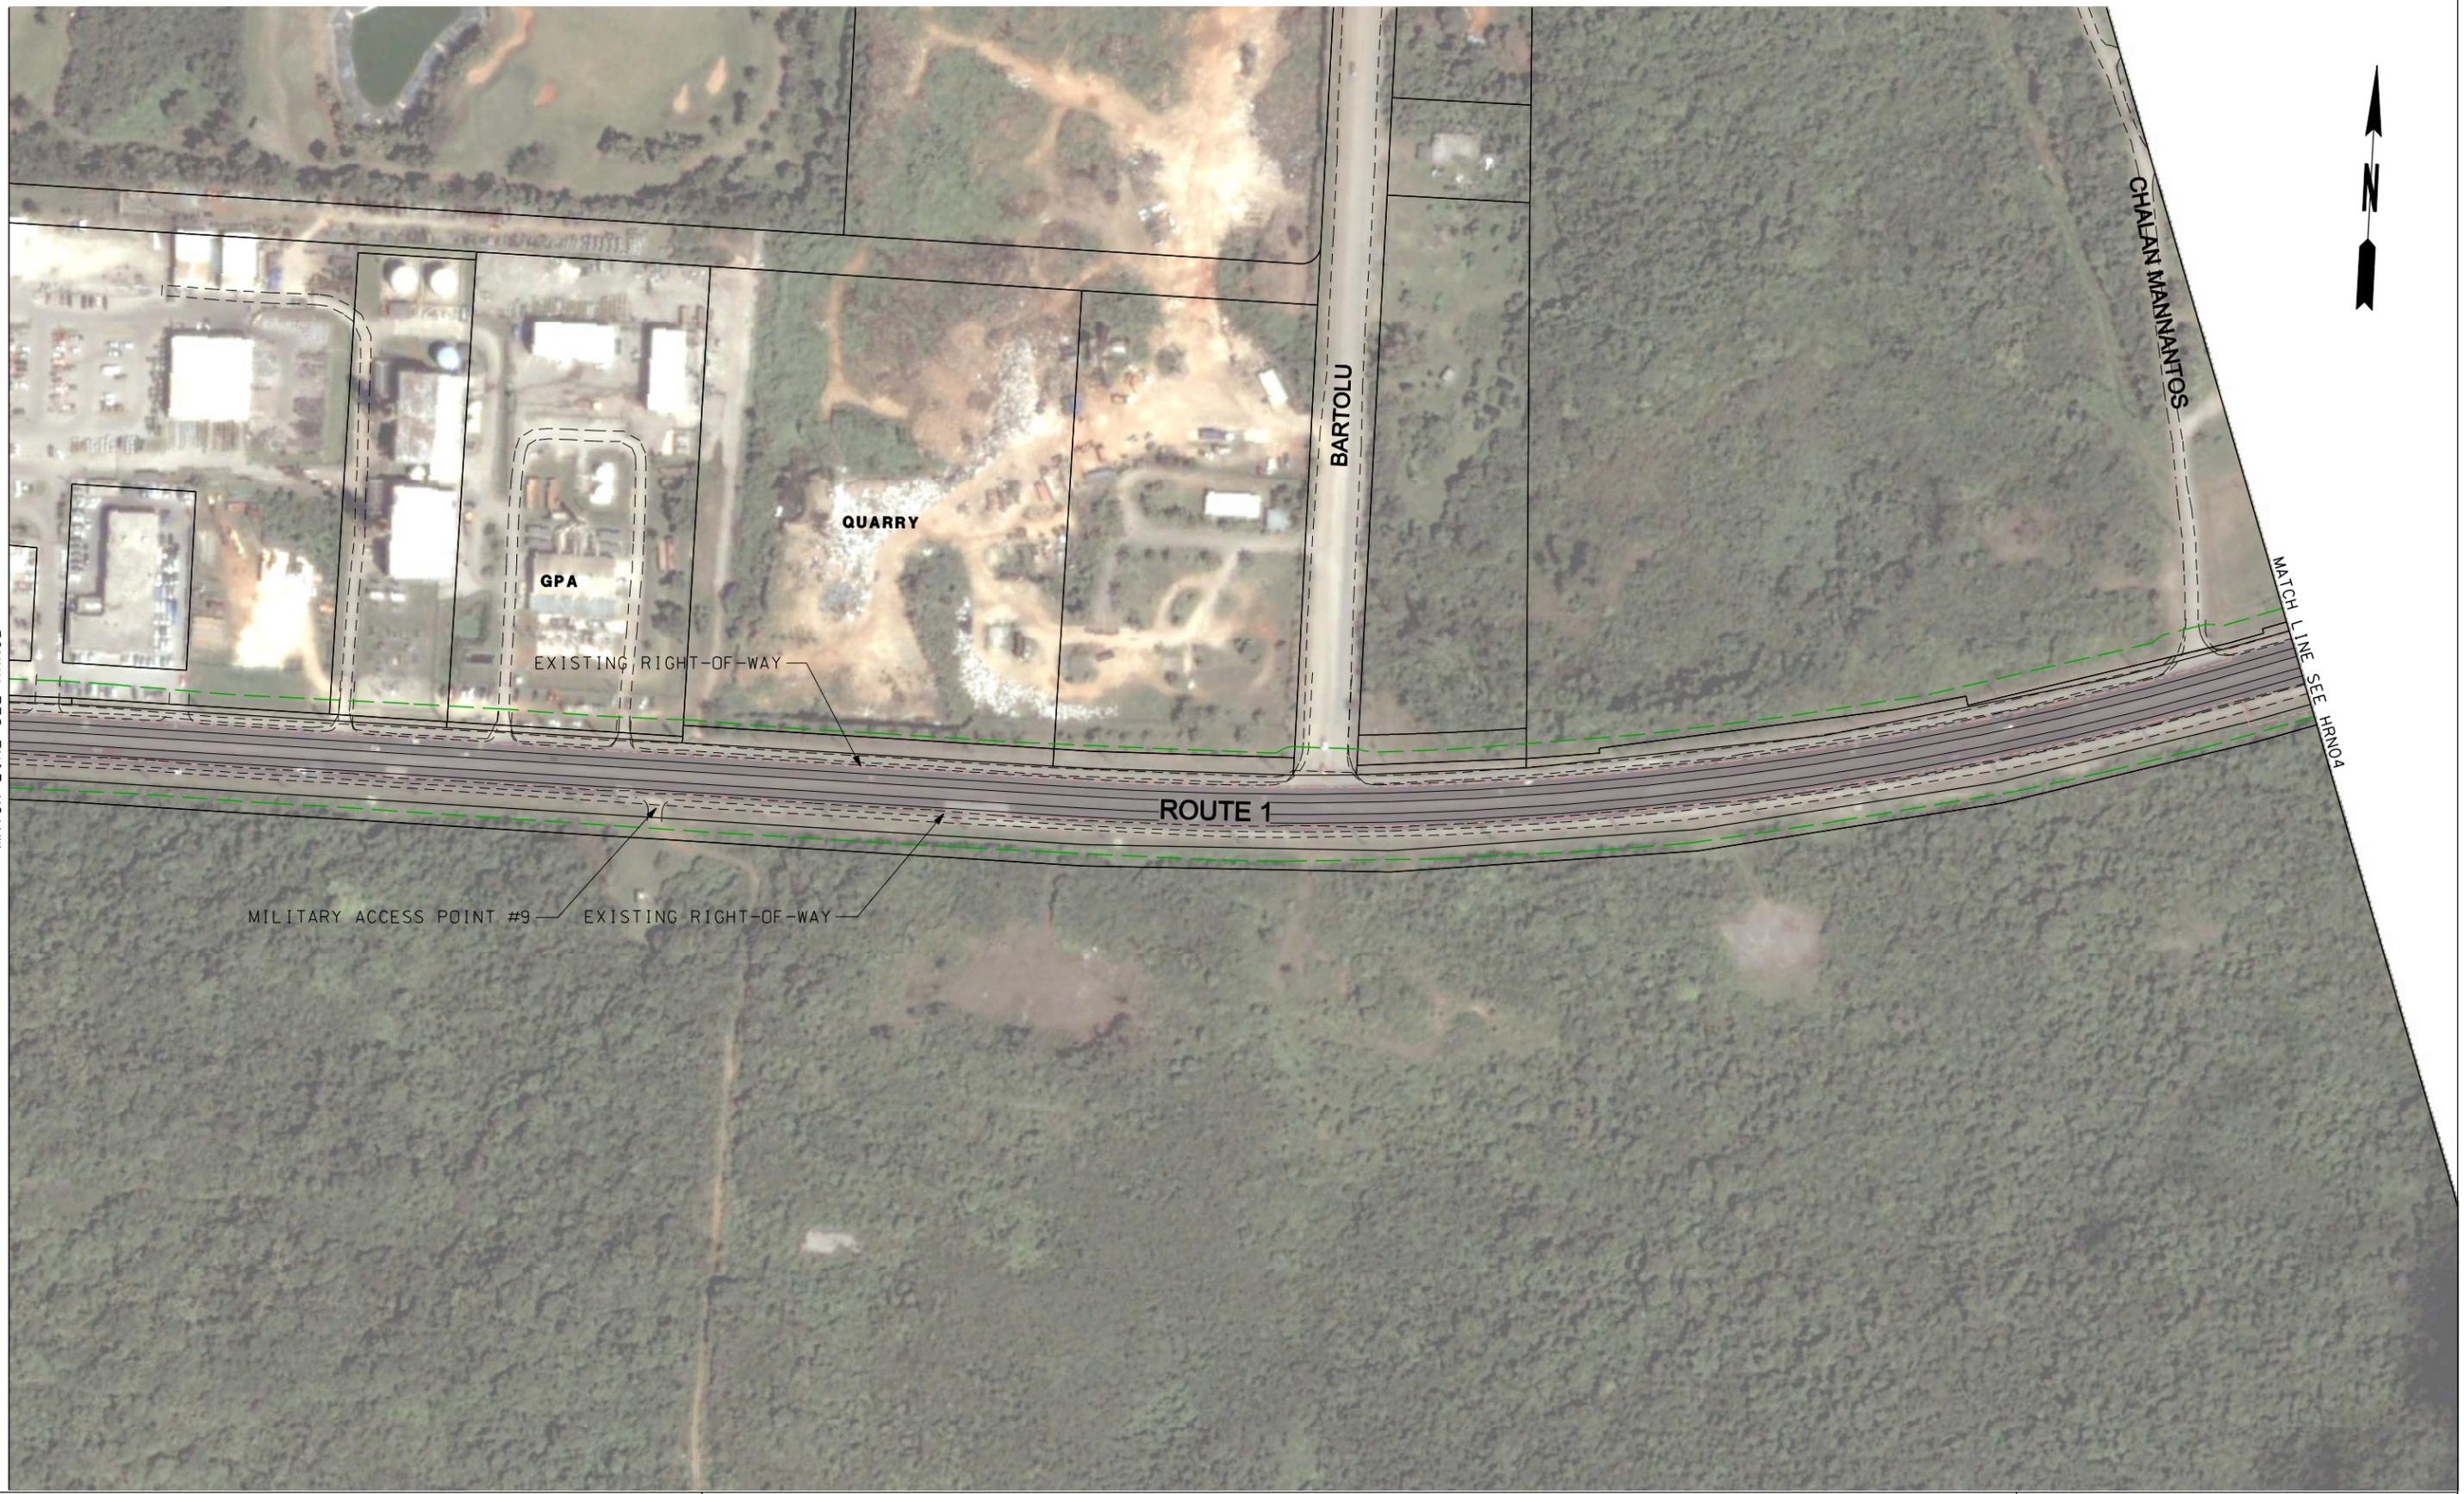
Scale 1"=200' Drawing HRN006 Sheet 44 of 69

**FOR NON ABATEMENT**

**GUAM COMMUNITY BUILD-UP: HAUL ROAD NETWORK**  
**PAVEMENT STRENGTHENING**  
**ROUTE 1**  
**(ROUTE 27 TO CHALAN LUJUNA)**  
**ROADWAY PLAN**

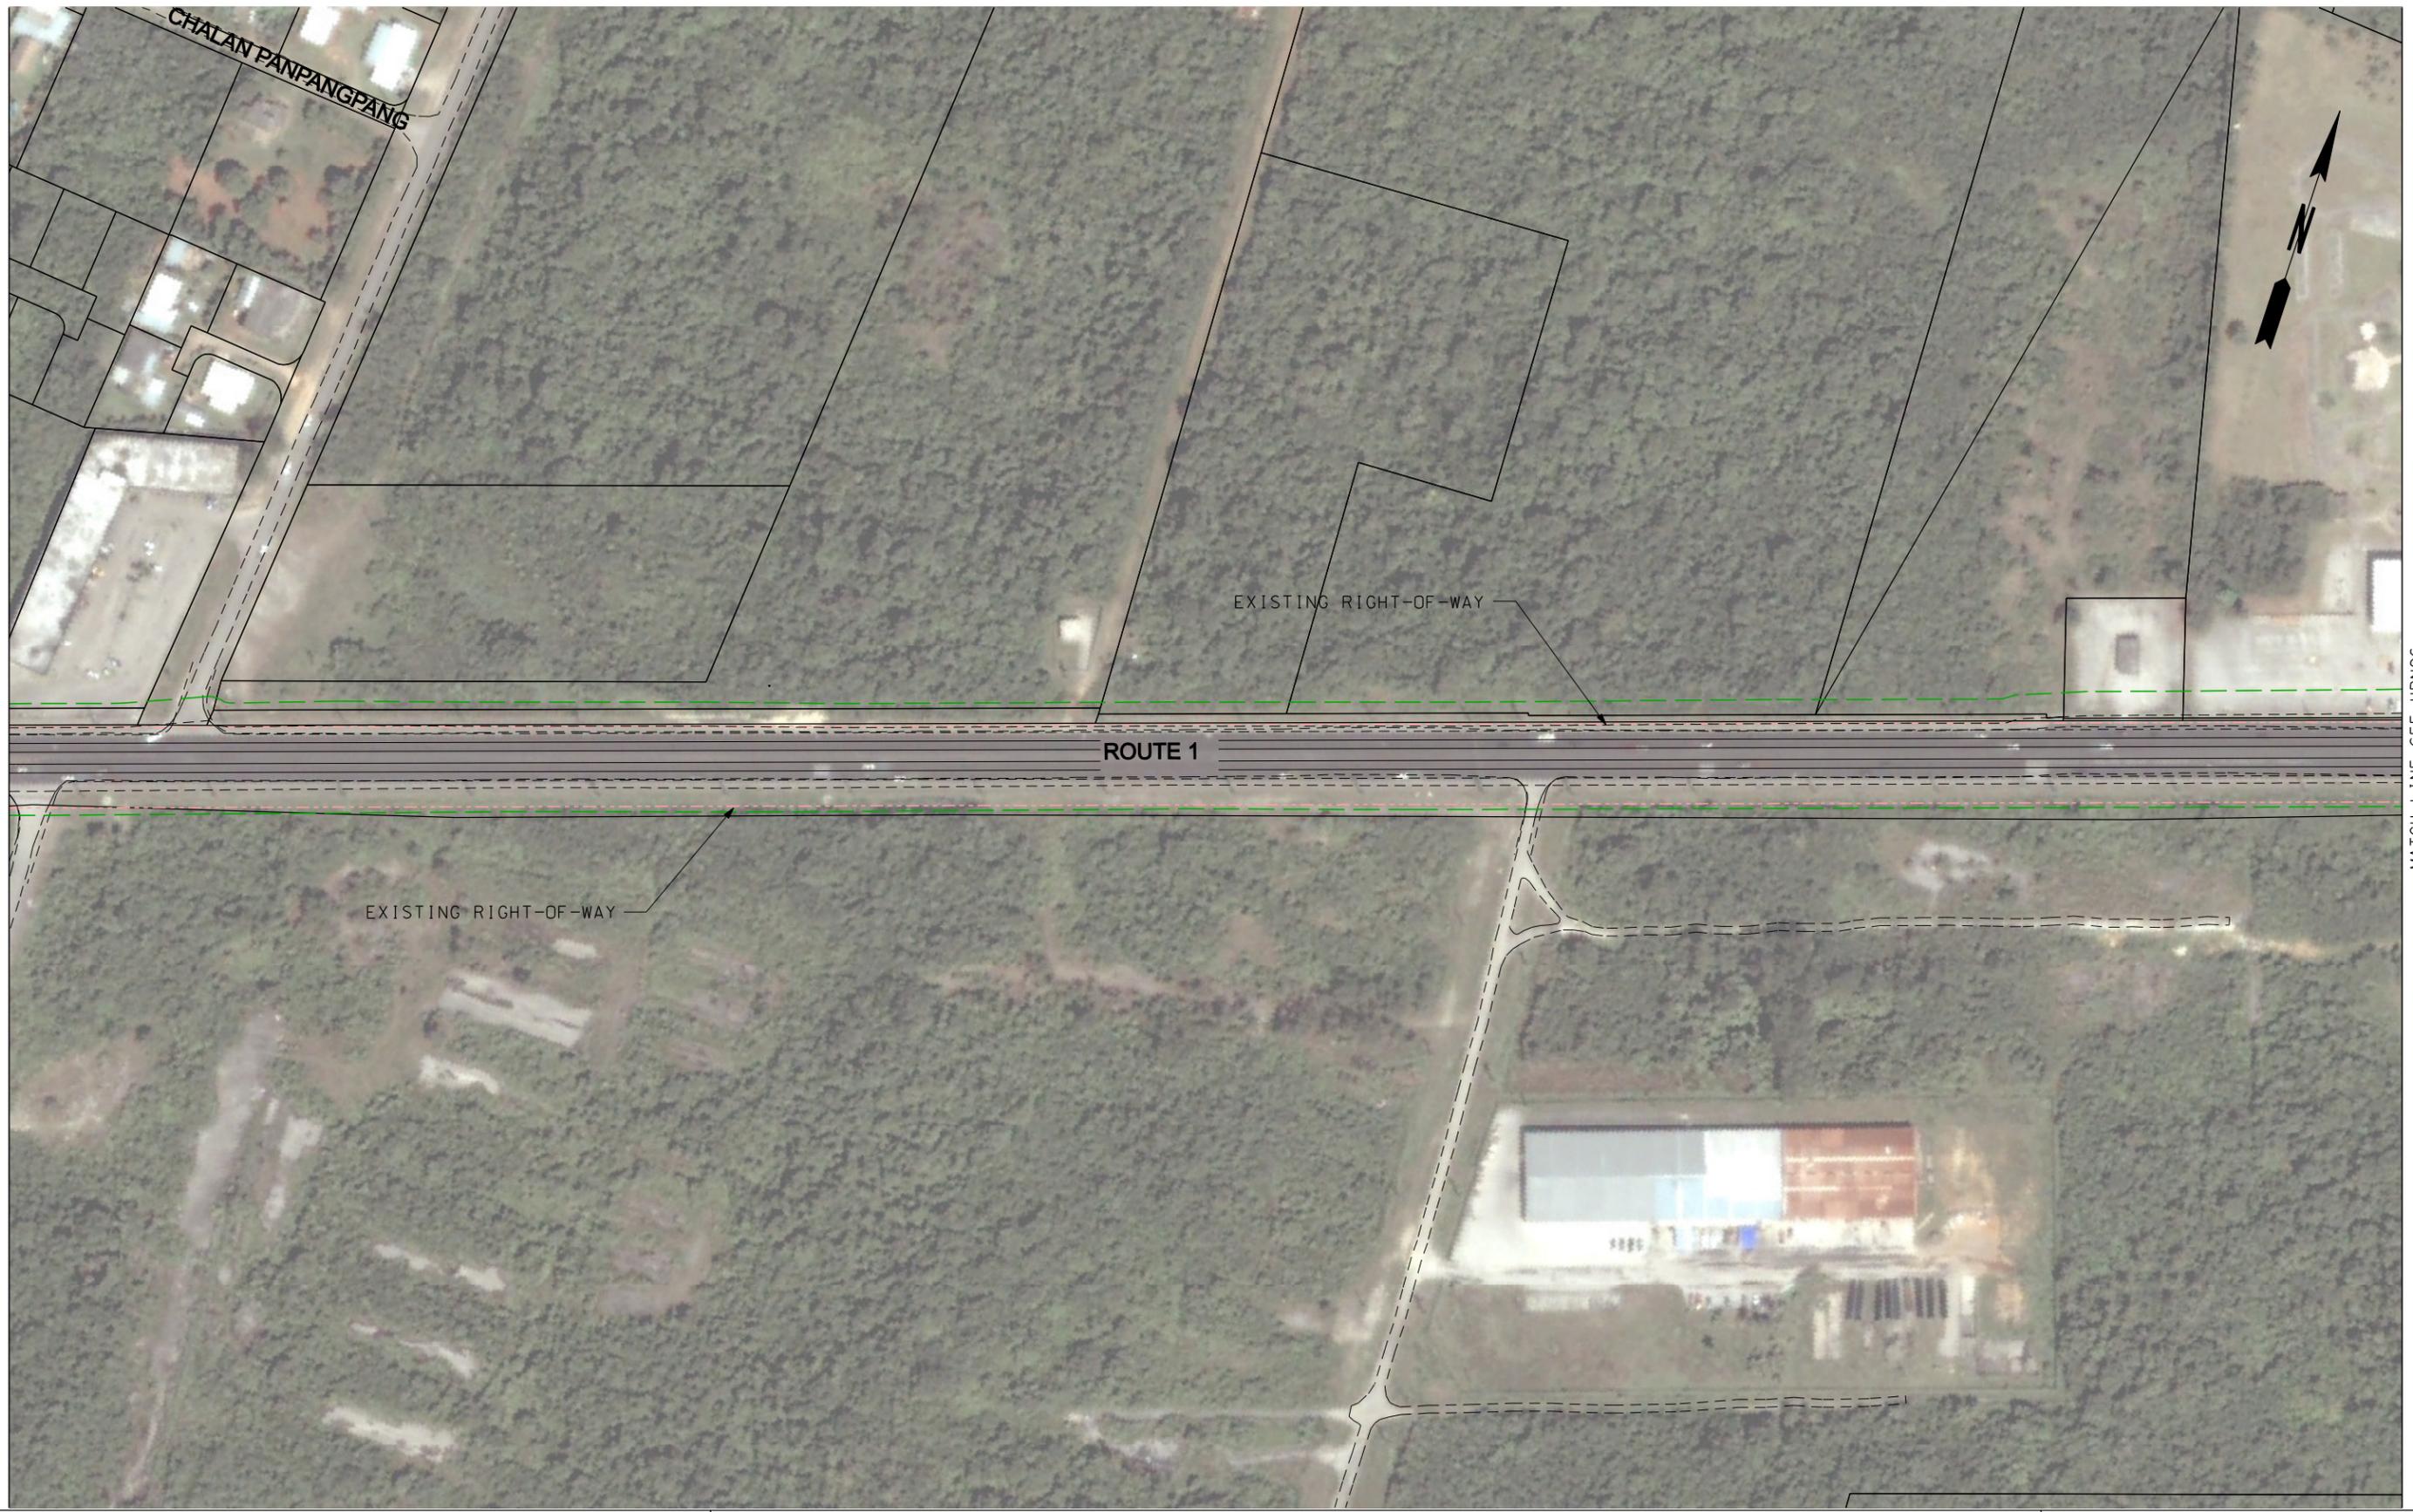
Scale 1"=200' | Drawing HRN006 | Sheet 46 of 69

**66 dBA NOISE**  
**IMPACT CONTOUR LINE**  
**FOR NON ABATEMENT**

**GUAM COMMUNITY BUILD-UP: HAUL ROAD NETWORK**  
**PAVEMENT STRENGTHENING**  
**ROUTE 1**  
**(ROUTE 27 TO CHALAN LUJUNA)**  
**ROADWAY PLAN**

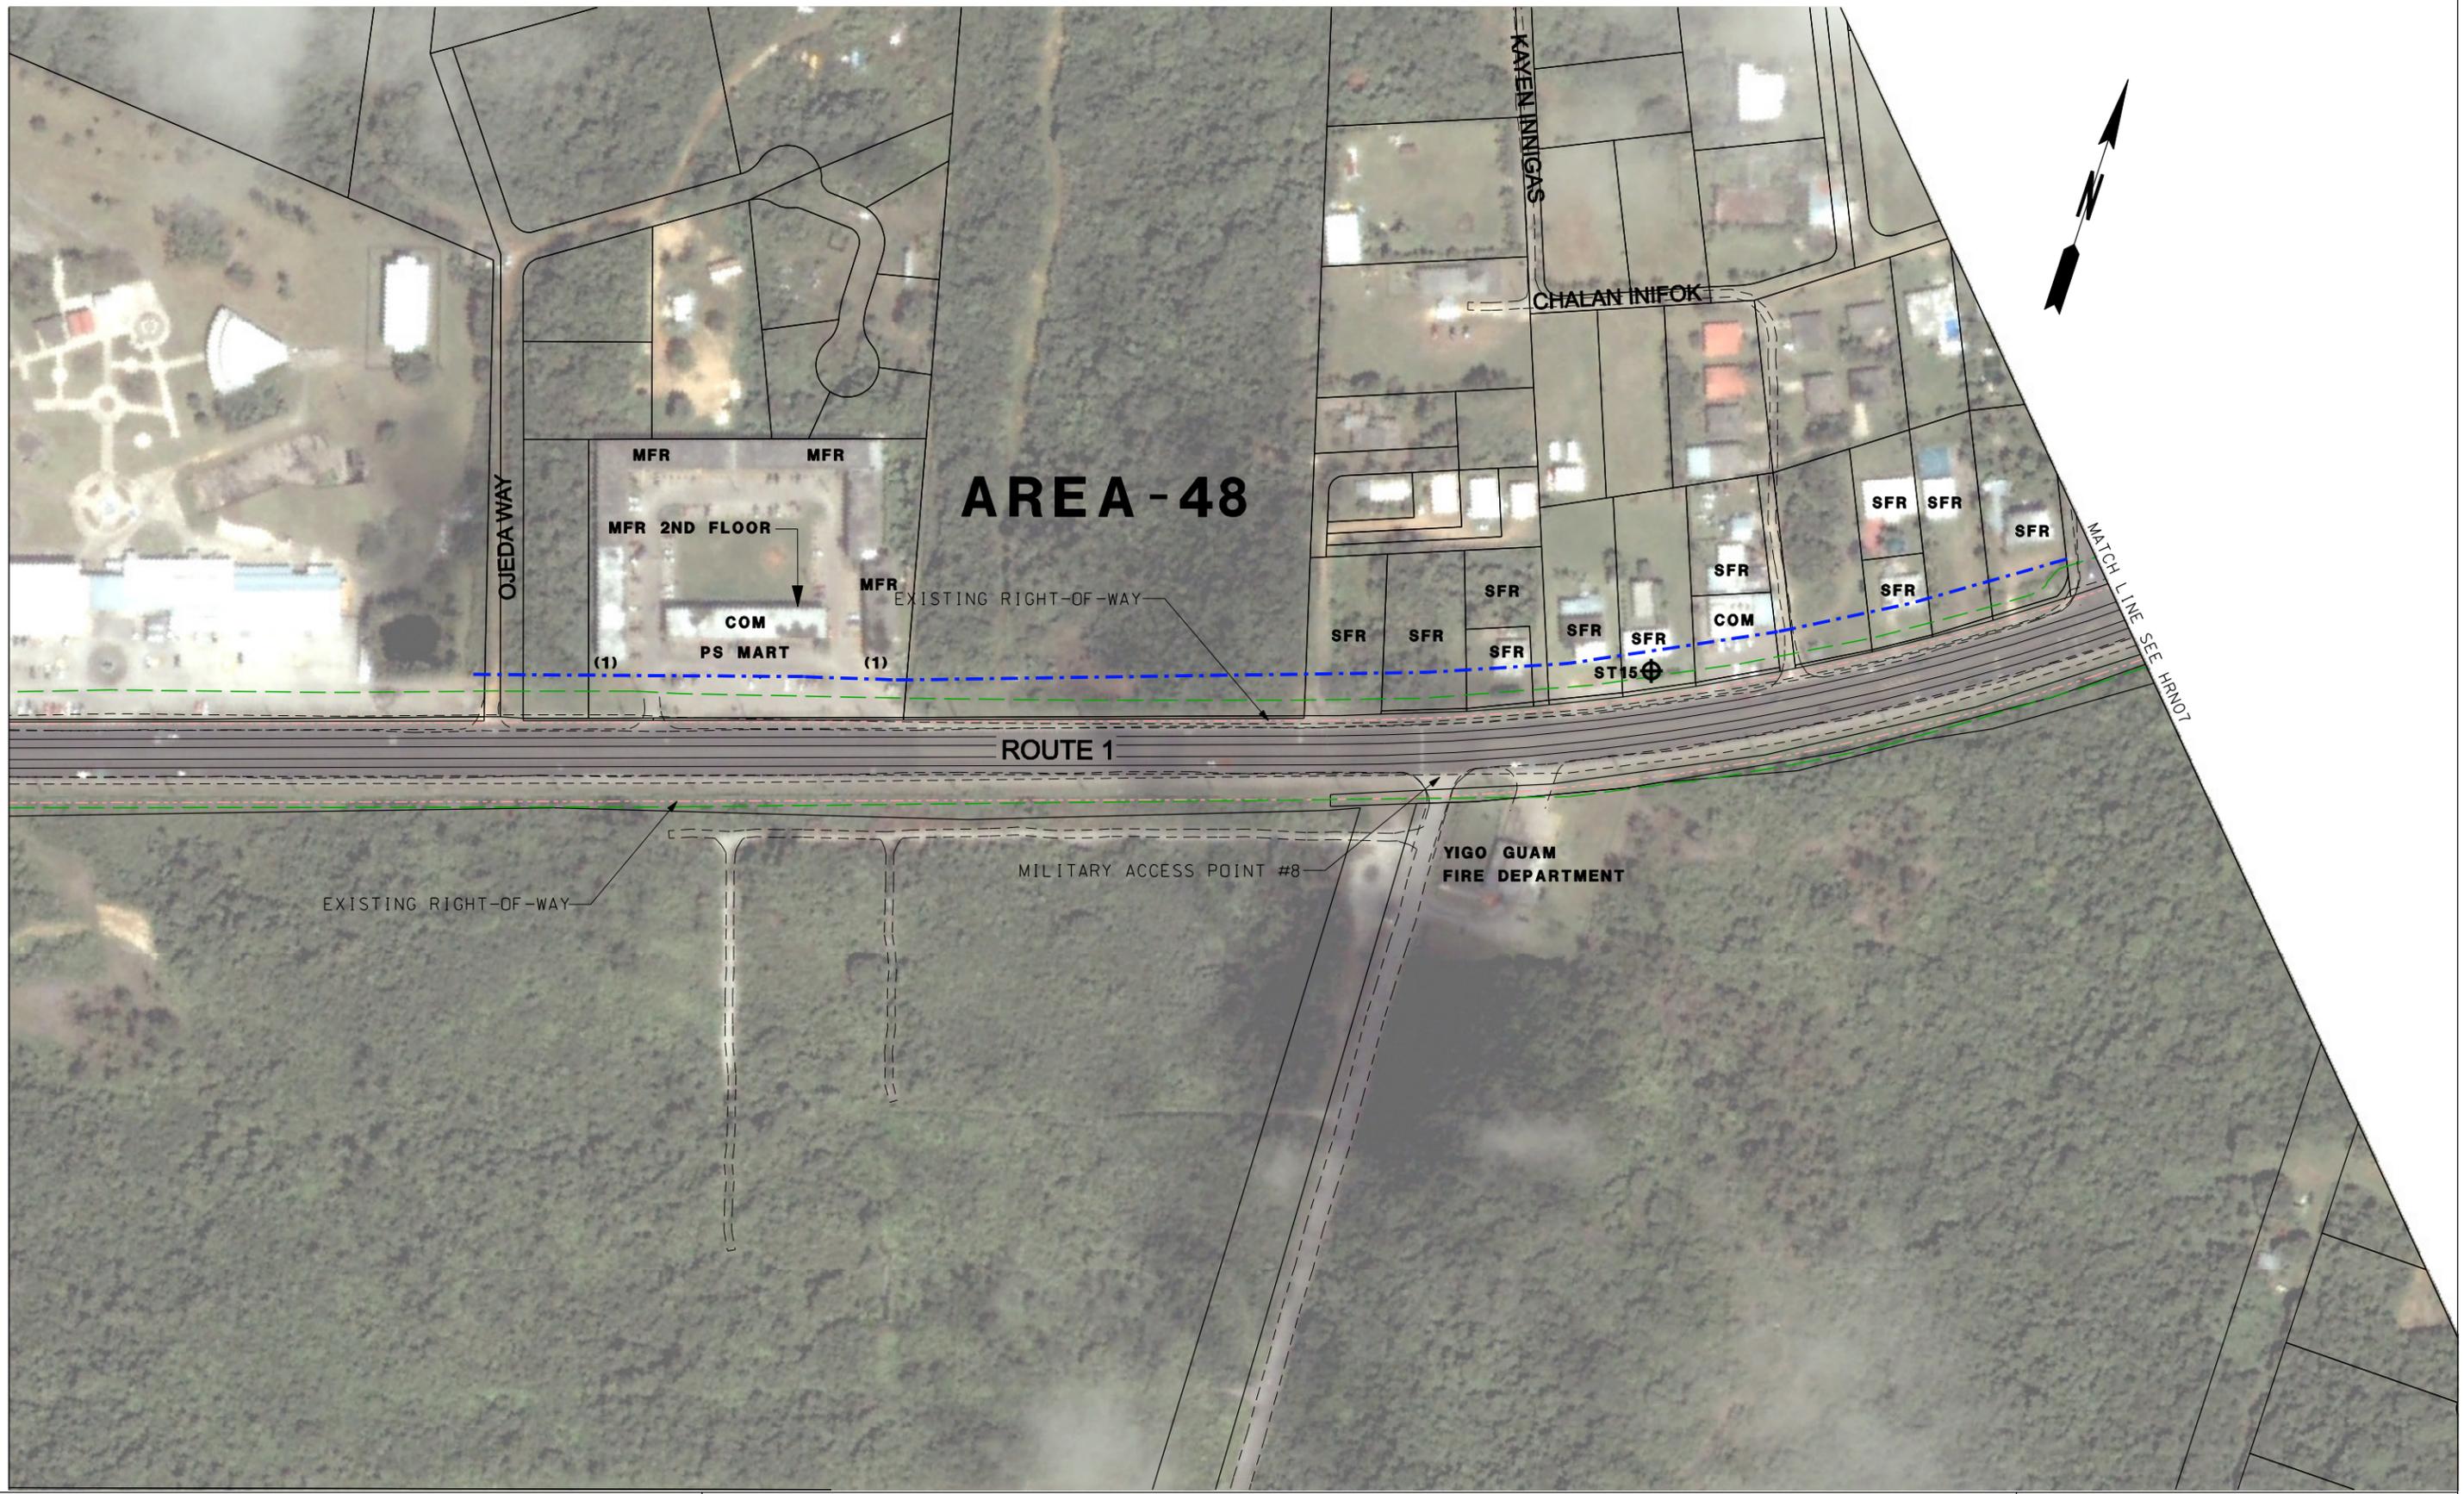
Scale 1"=200' | Drawing HRN006 | Sheet 47 of 69

**66 dBA NOISE**  
**IMPACT CONTOUR LINE**  
**FOR NON ABATEMENT**

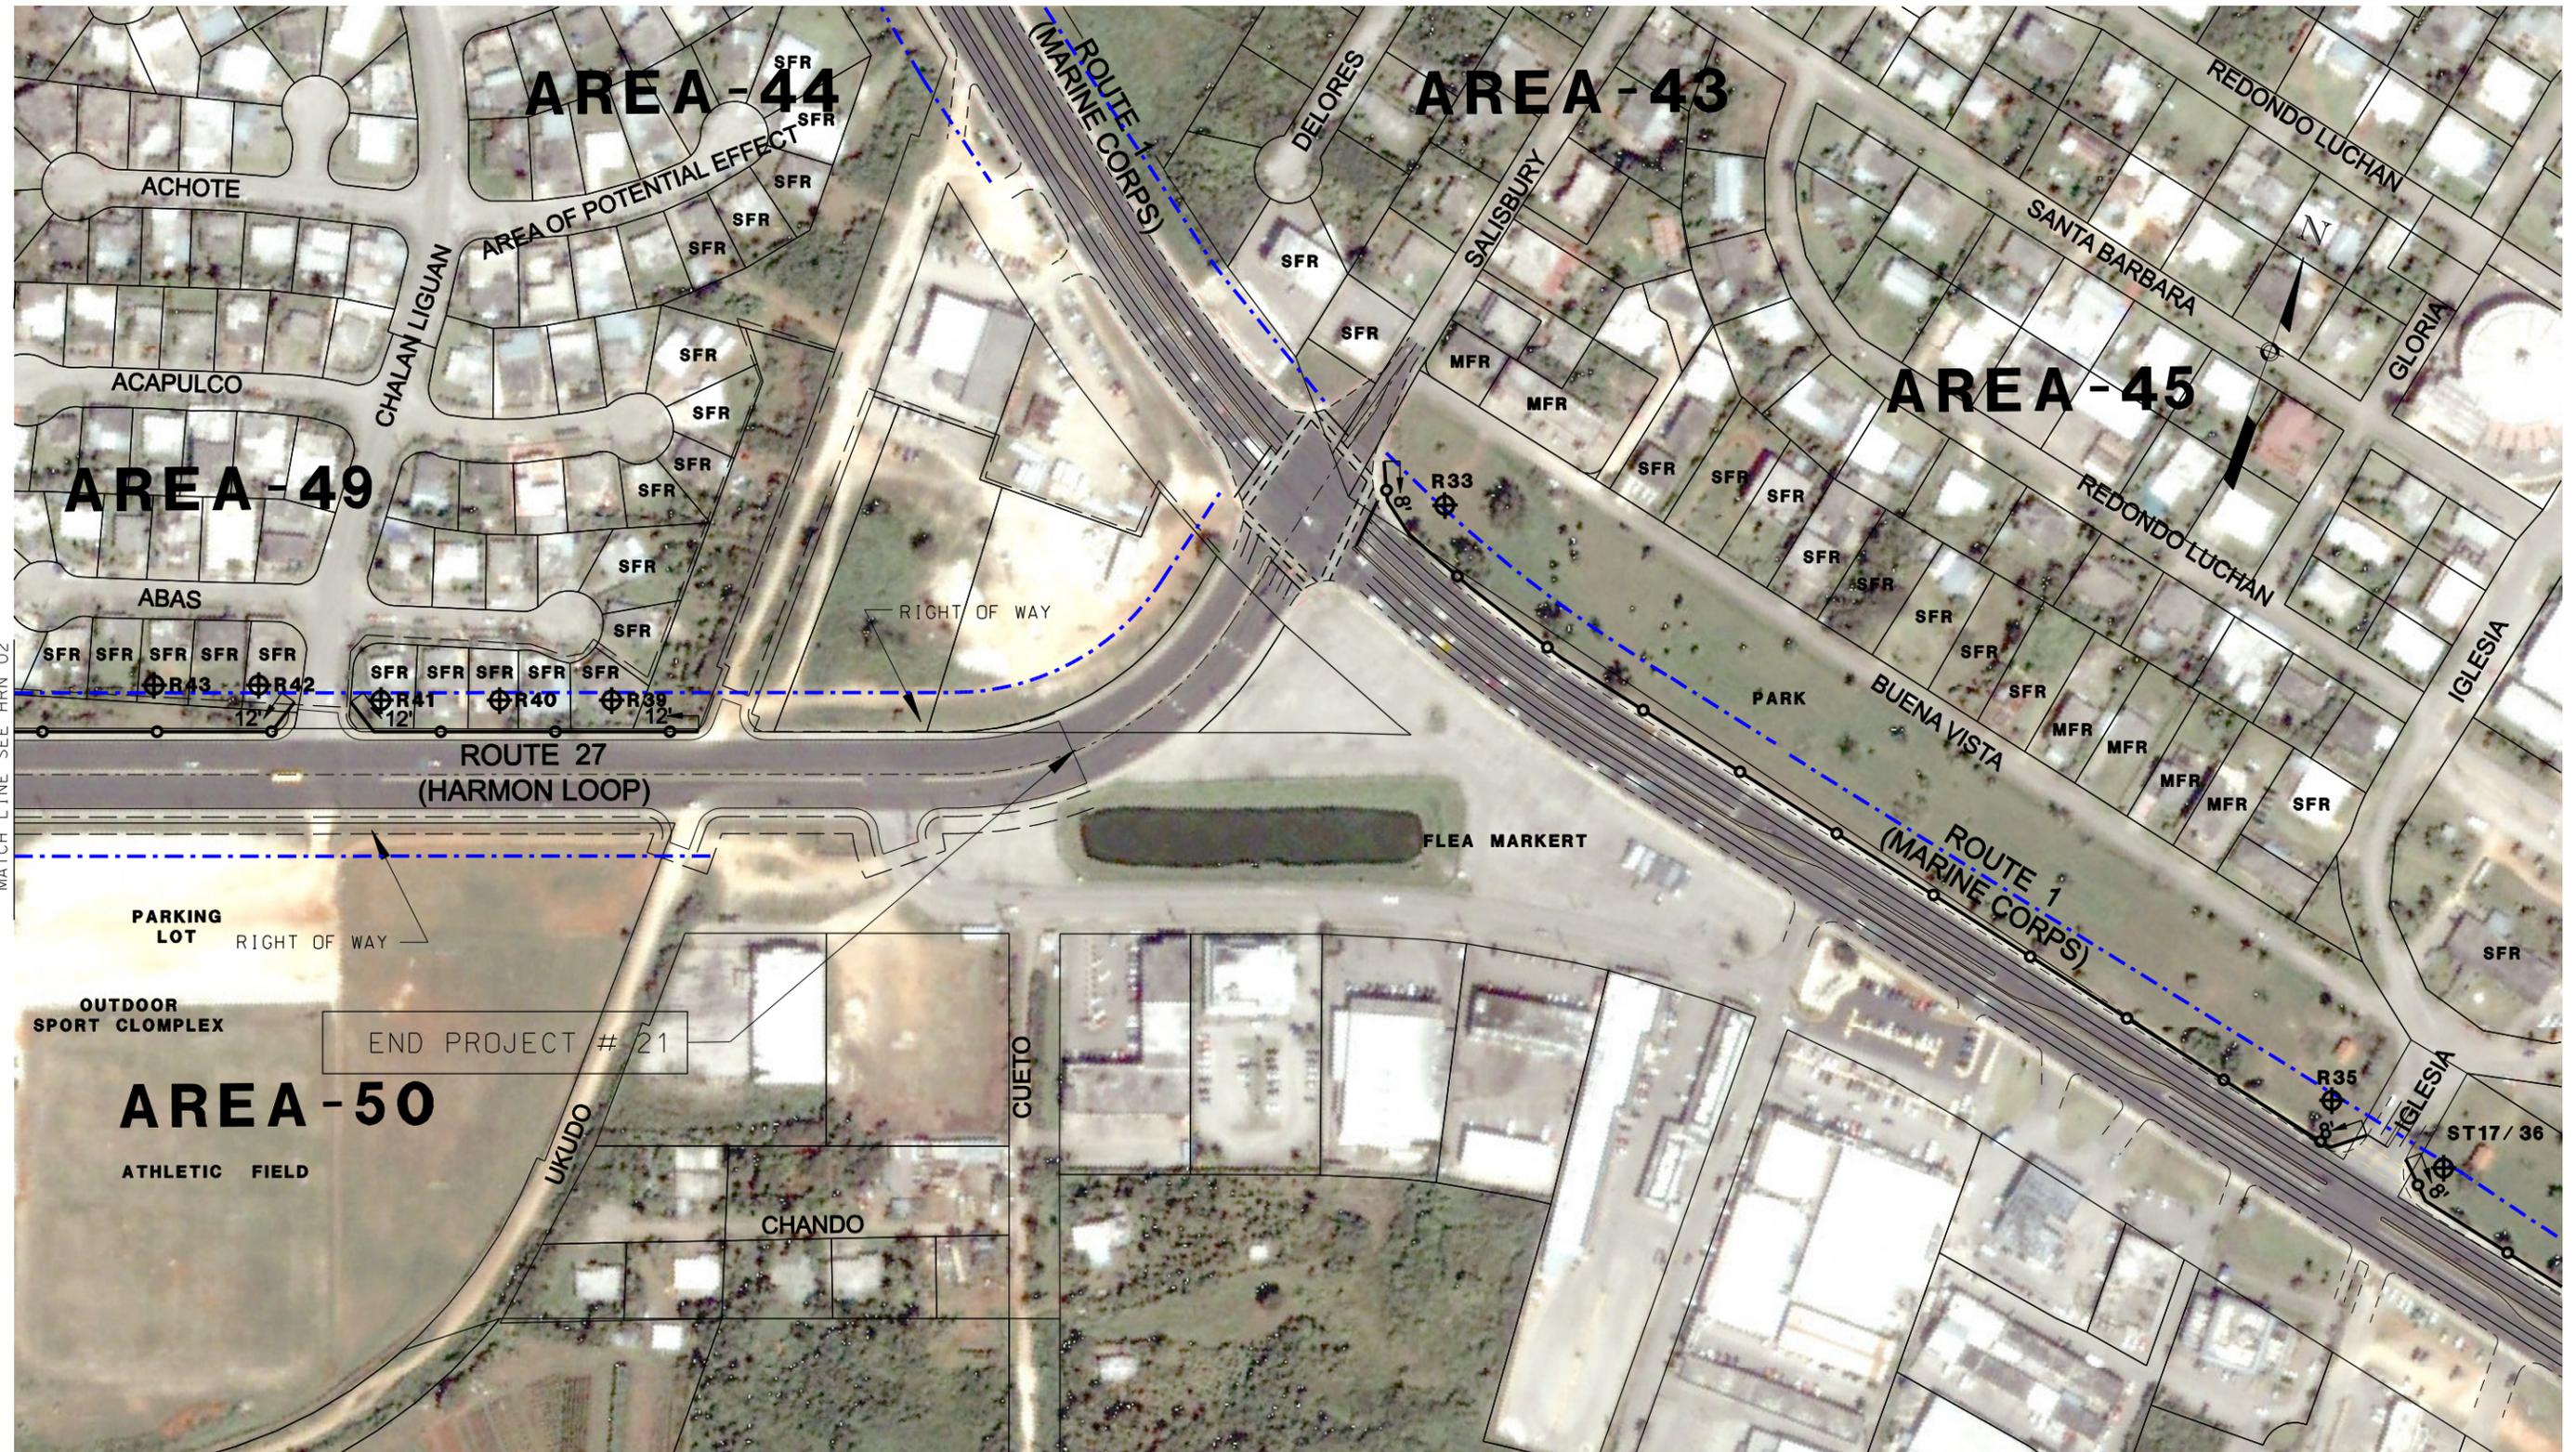
Scale 1"=200' Drawing HRN006 Sheet 49 of 69

**66 dBA NOISE  
IMPACT CONTOUR LINE  
FOR NON ABATEMENT**

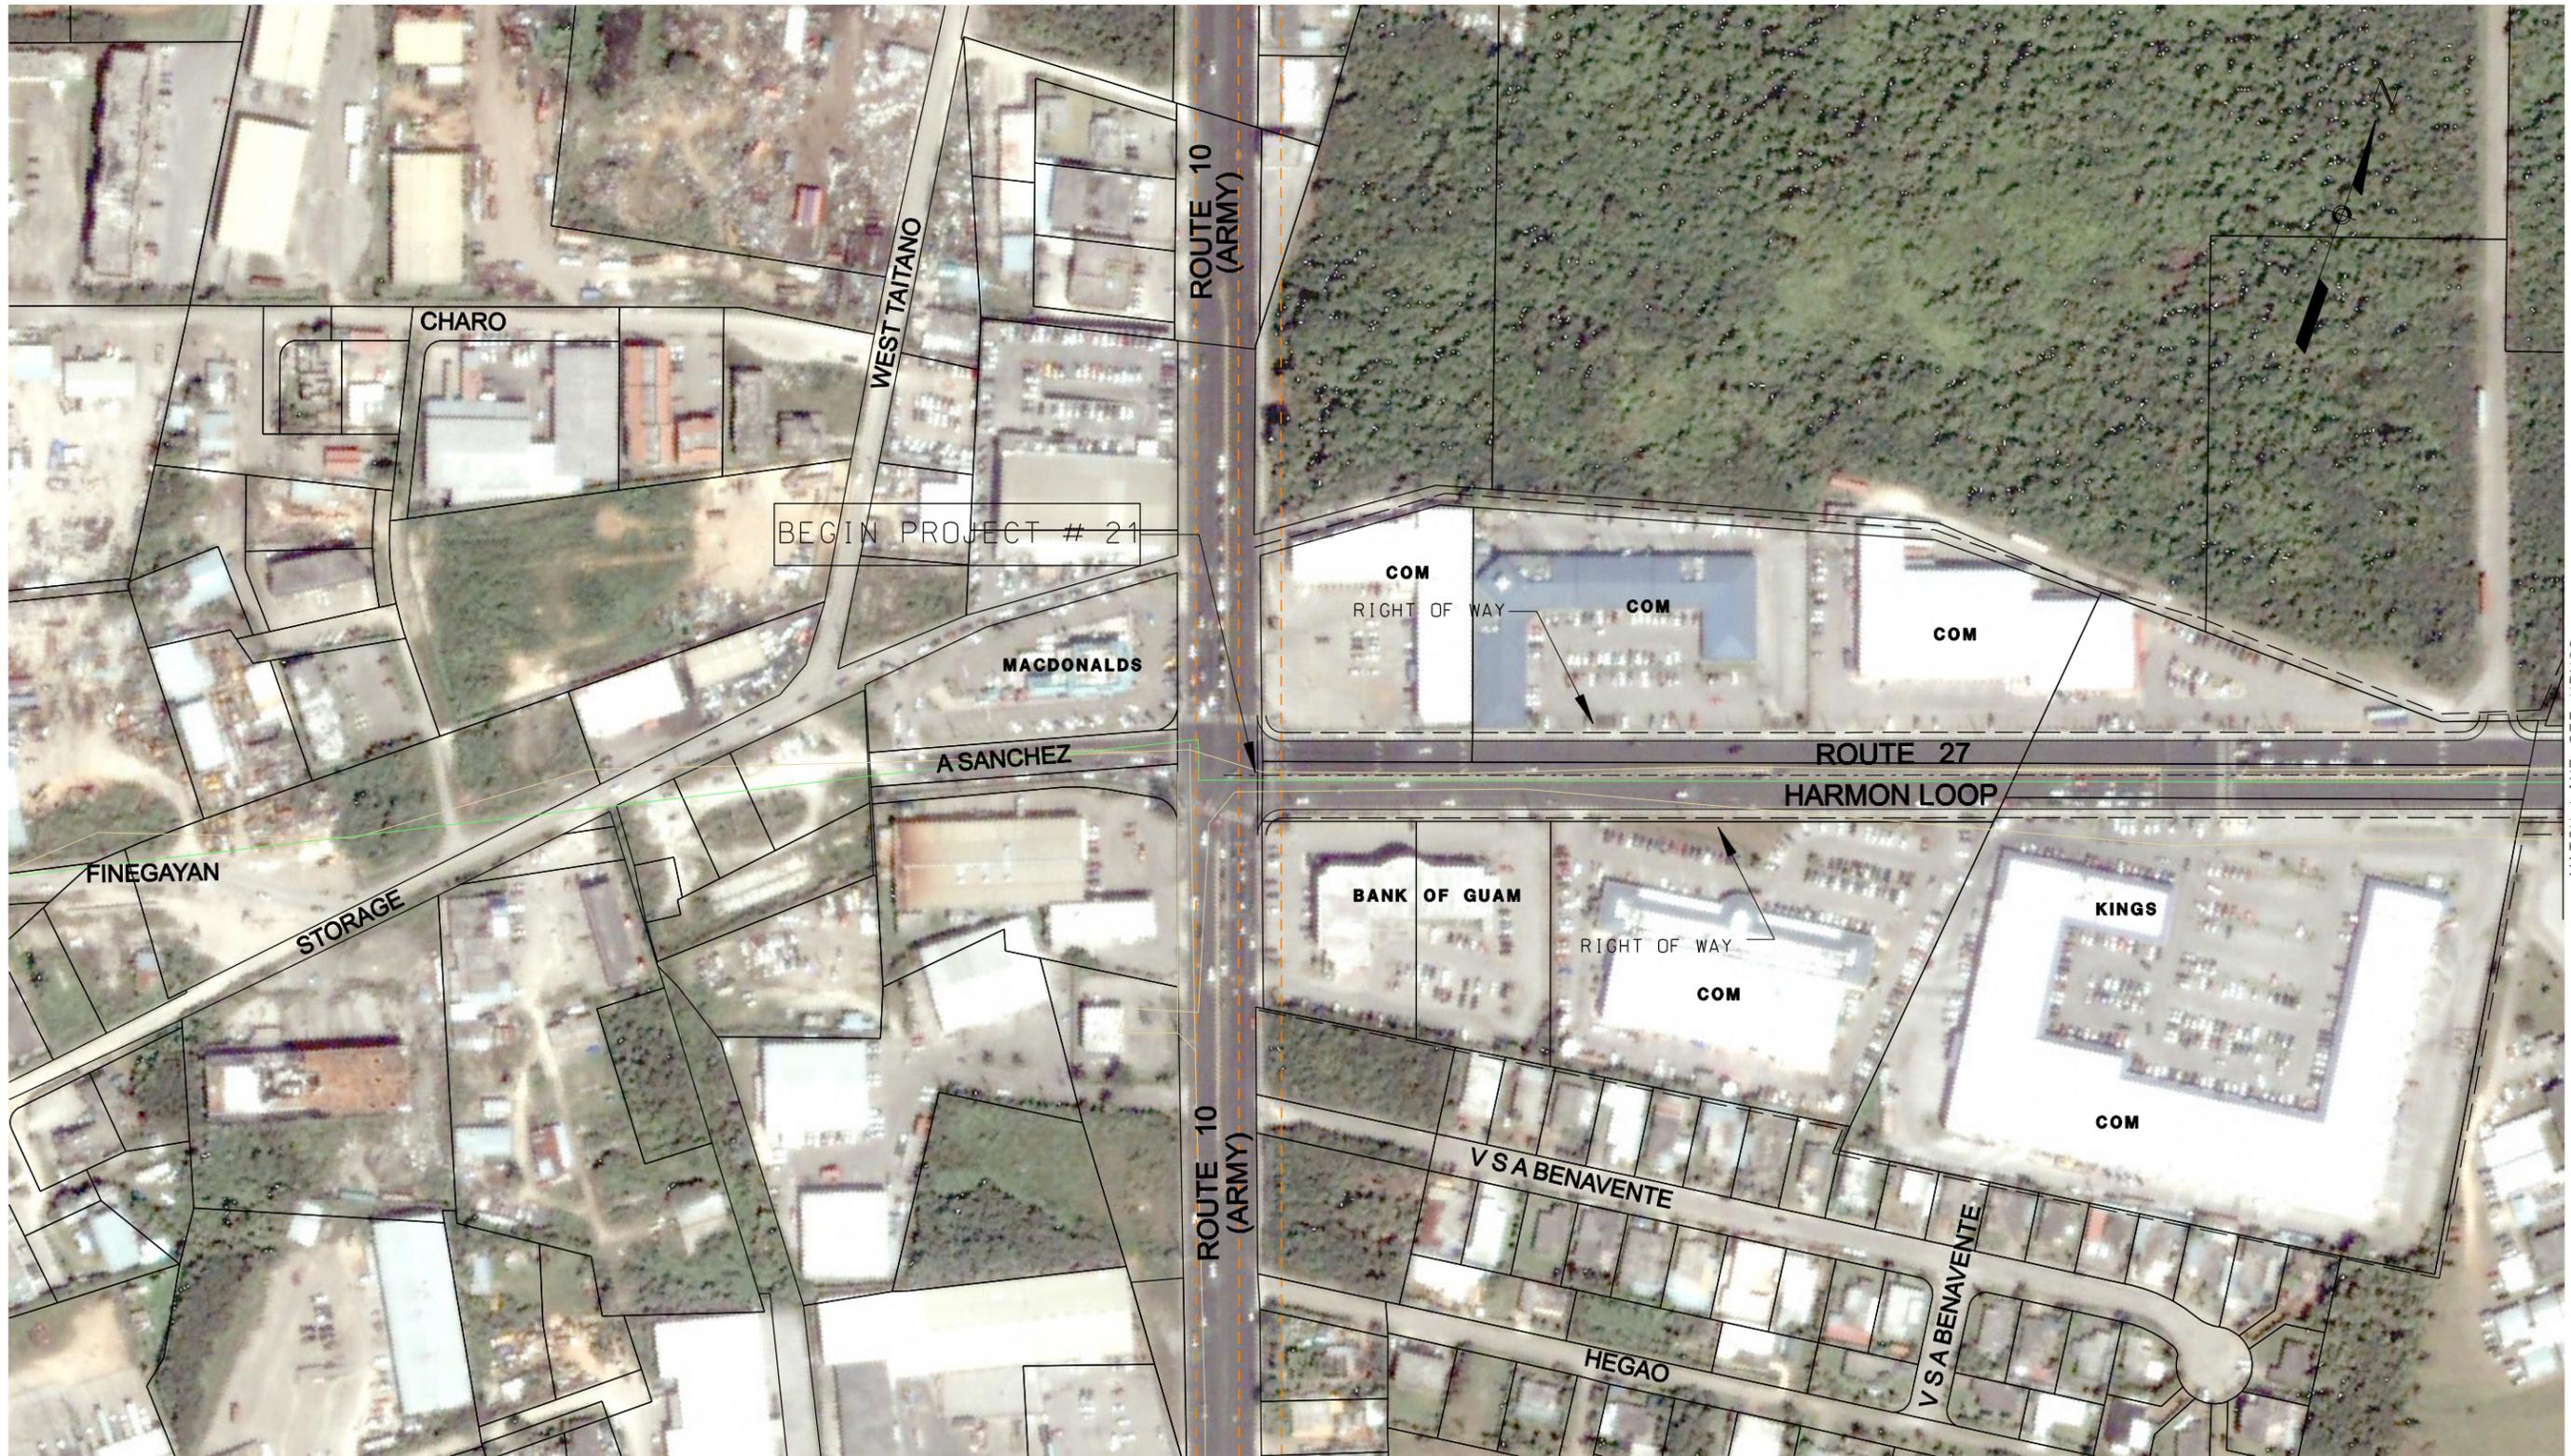
Scale 1"=200' Drawing HRN021 Sheet 51 of 69

**66 dBA NOISE  
IMPACT CONTOUR LINE  
FOR NON ABATEMENT**
