## Appendix G

### EIS Resource Technical Appendix

# Guam and CNMI Military Relocation EIS

## Volume 9: EIS Resource Technical Appendix

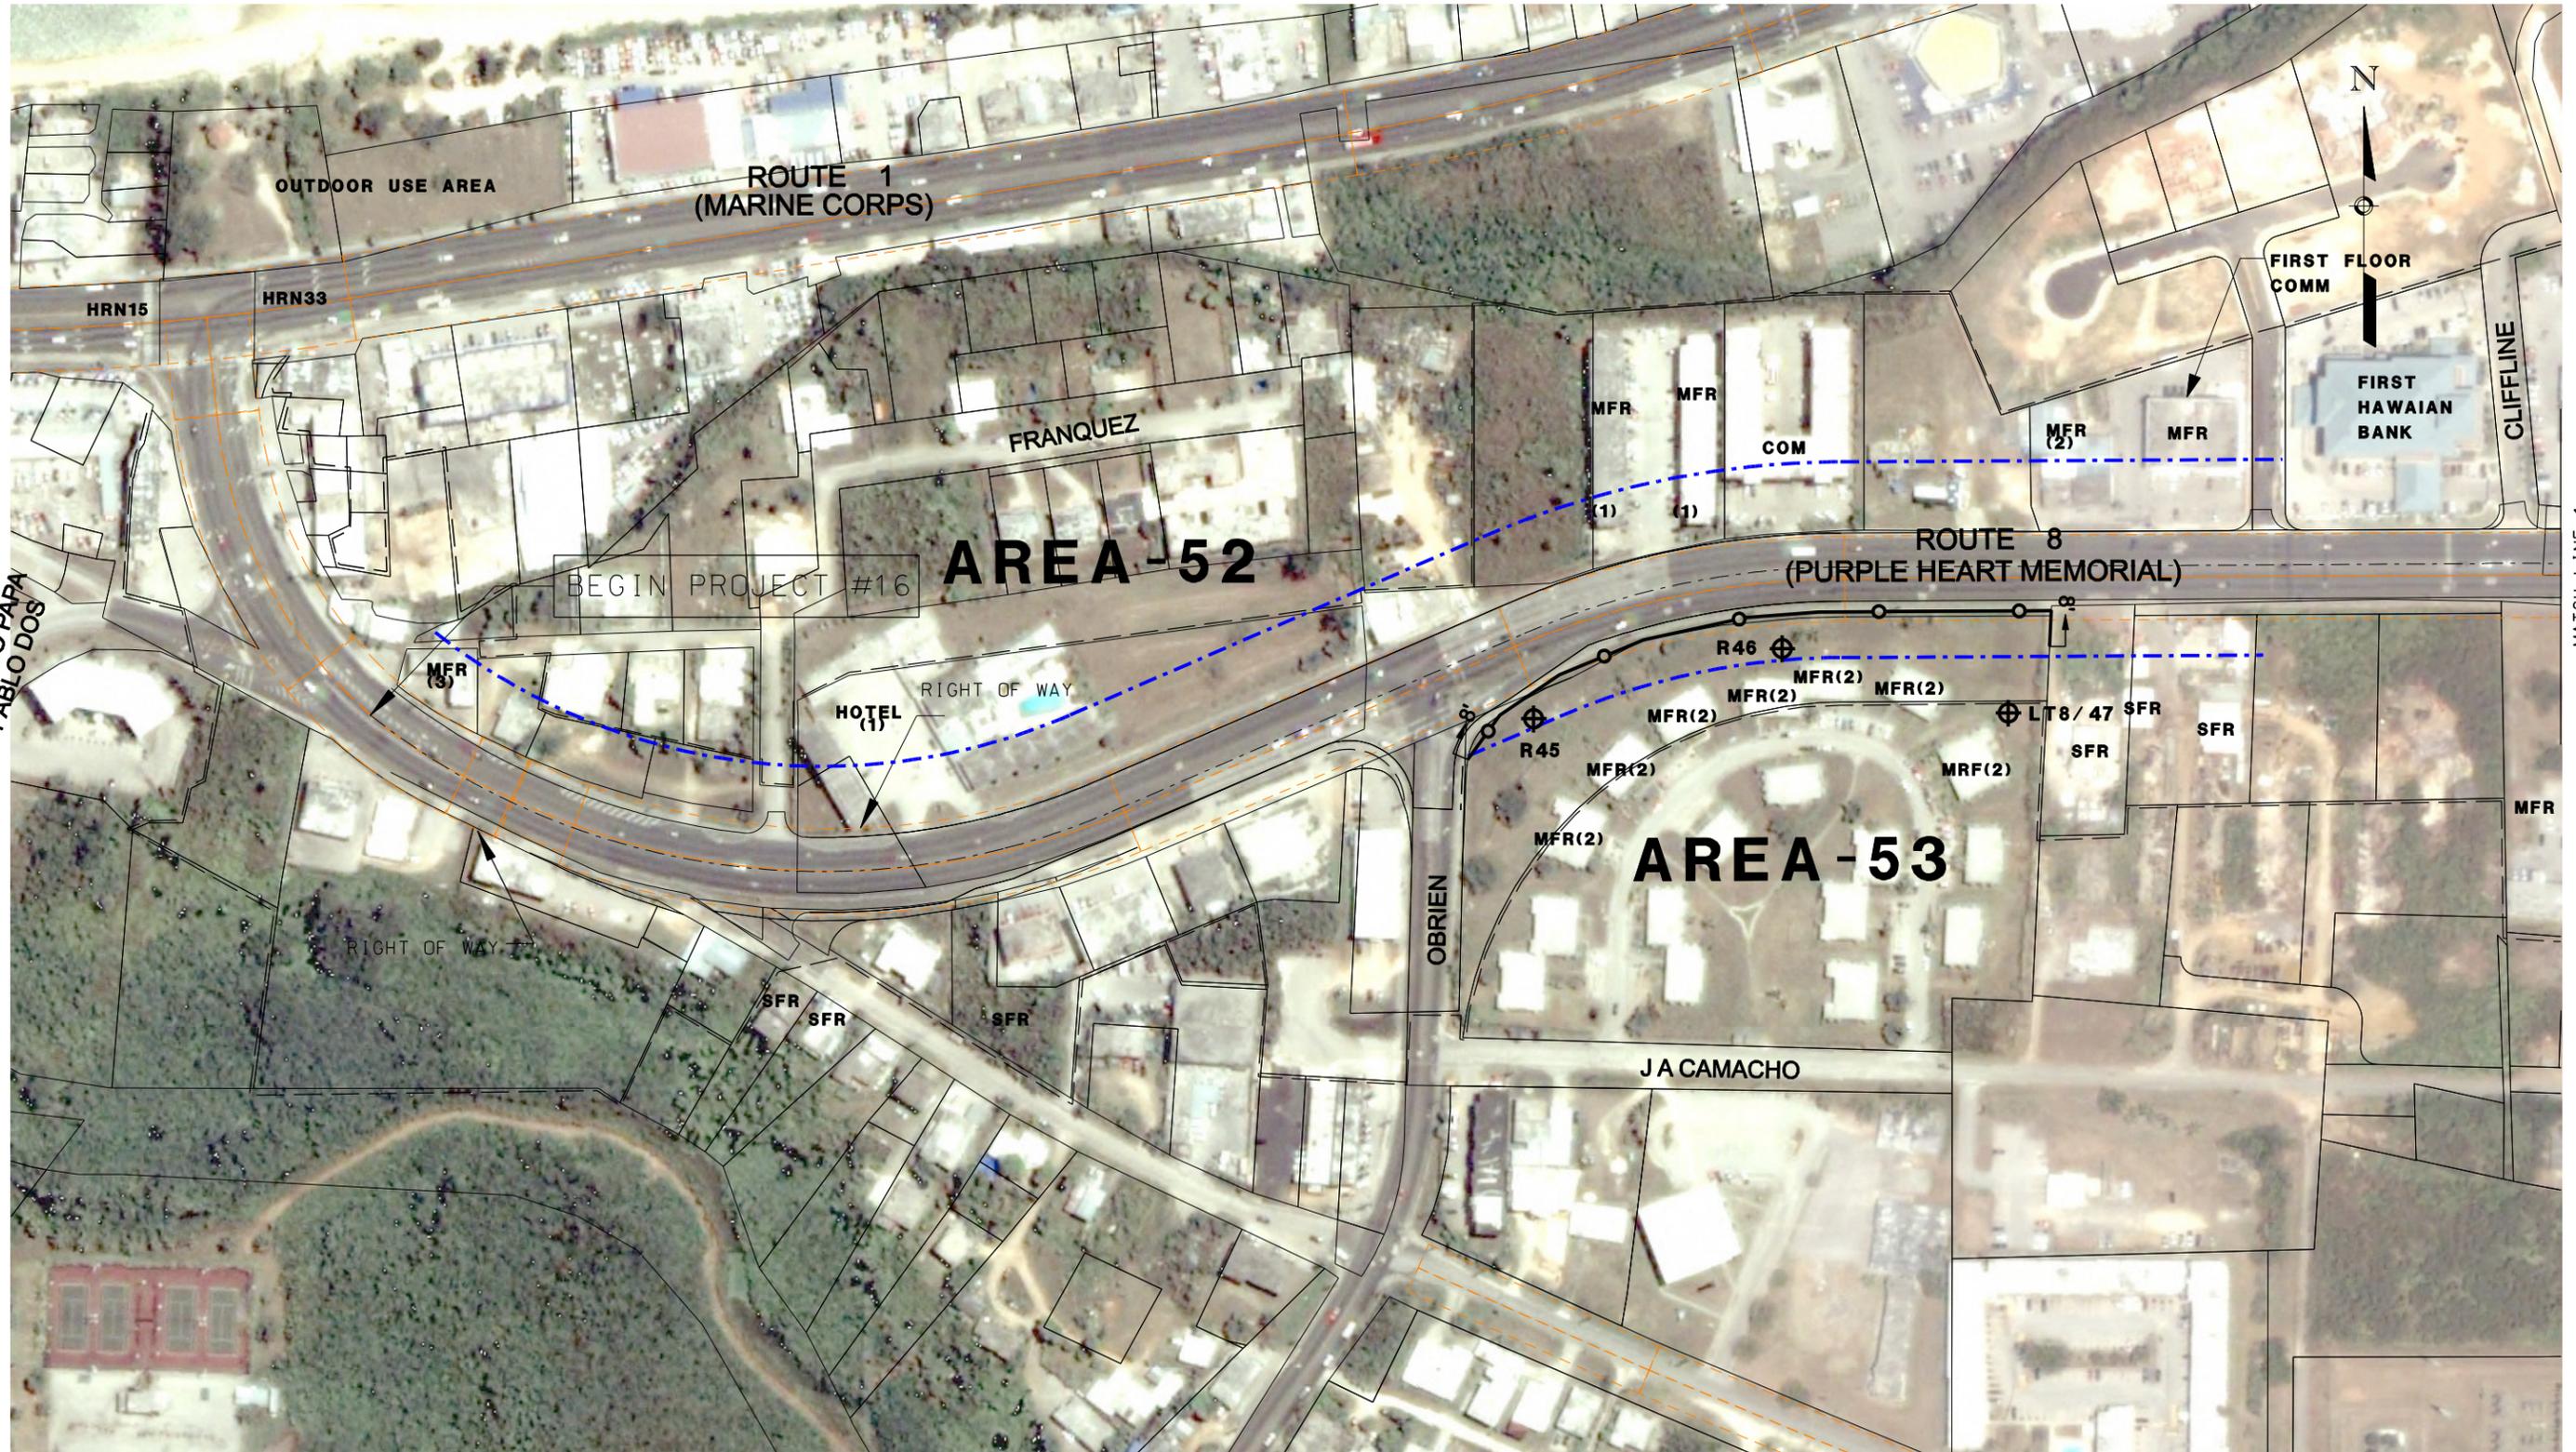
<b>66 dBA NOISE IMPACT CONTOUR LINE FOR NON ABATEMENT</b>		
Scale	1"=200'	Drawing HRN021 Sheet 52 of 69

<b>GUAM COMMUNITY BUILD-UP: HAUL ROAD NETWORK</b>		
<p><b>PAVEMENT STRENGTHENING</b>  <b>ROUTE 27</b>  <b>ROUTE 1 TO ROUTE 16</b>  <b>ROADWAY PLAN</b></p>	<p><b>PARSONS</b>          100 WALNUT ST.          PASADENA, CALIFORNIA 91124          PHONE: (626) 440-6100 FAX: (626) 440-6200          CERTIFICATE OF AUTHORIZATION NO. 1838</p>	<p>0 40 200 Feet</p>

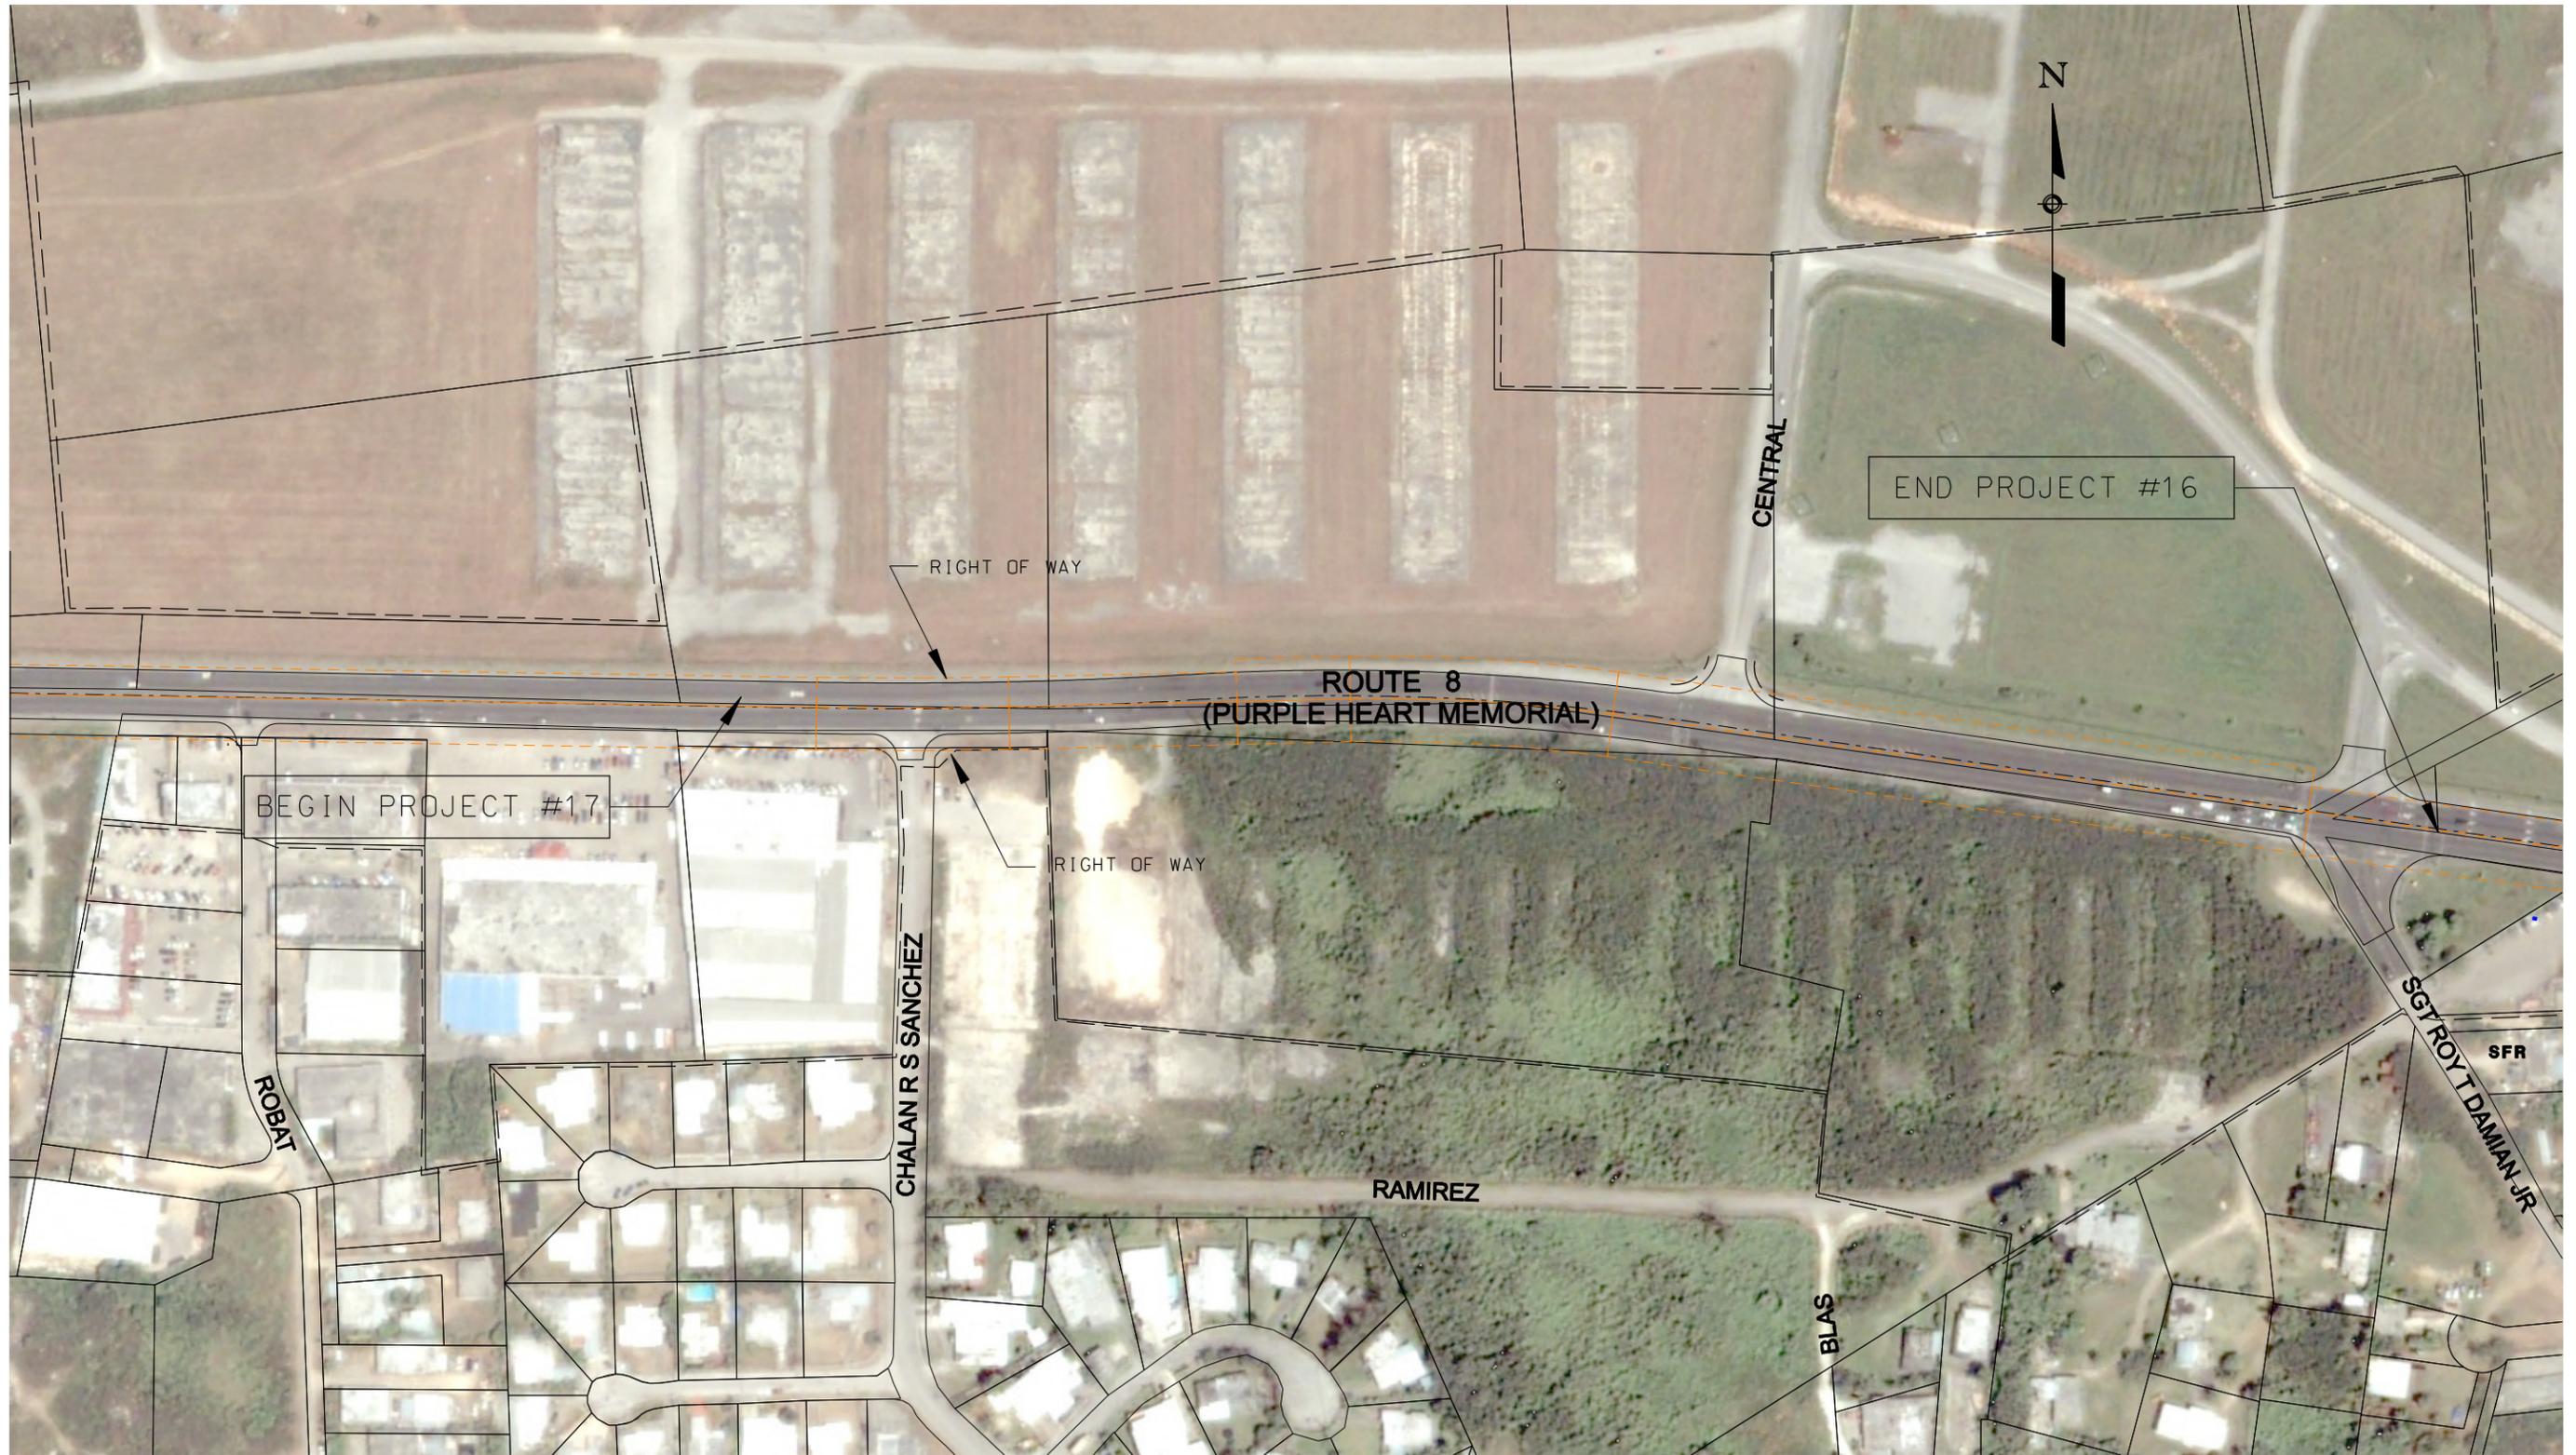
Scale 1"=200'    Drawing HRN016    Sheet 54 of 69

**66 dBA NOISE**  
**IMPACT CONTOUR LINE**  
**FOR NON ABATEMENT**

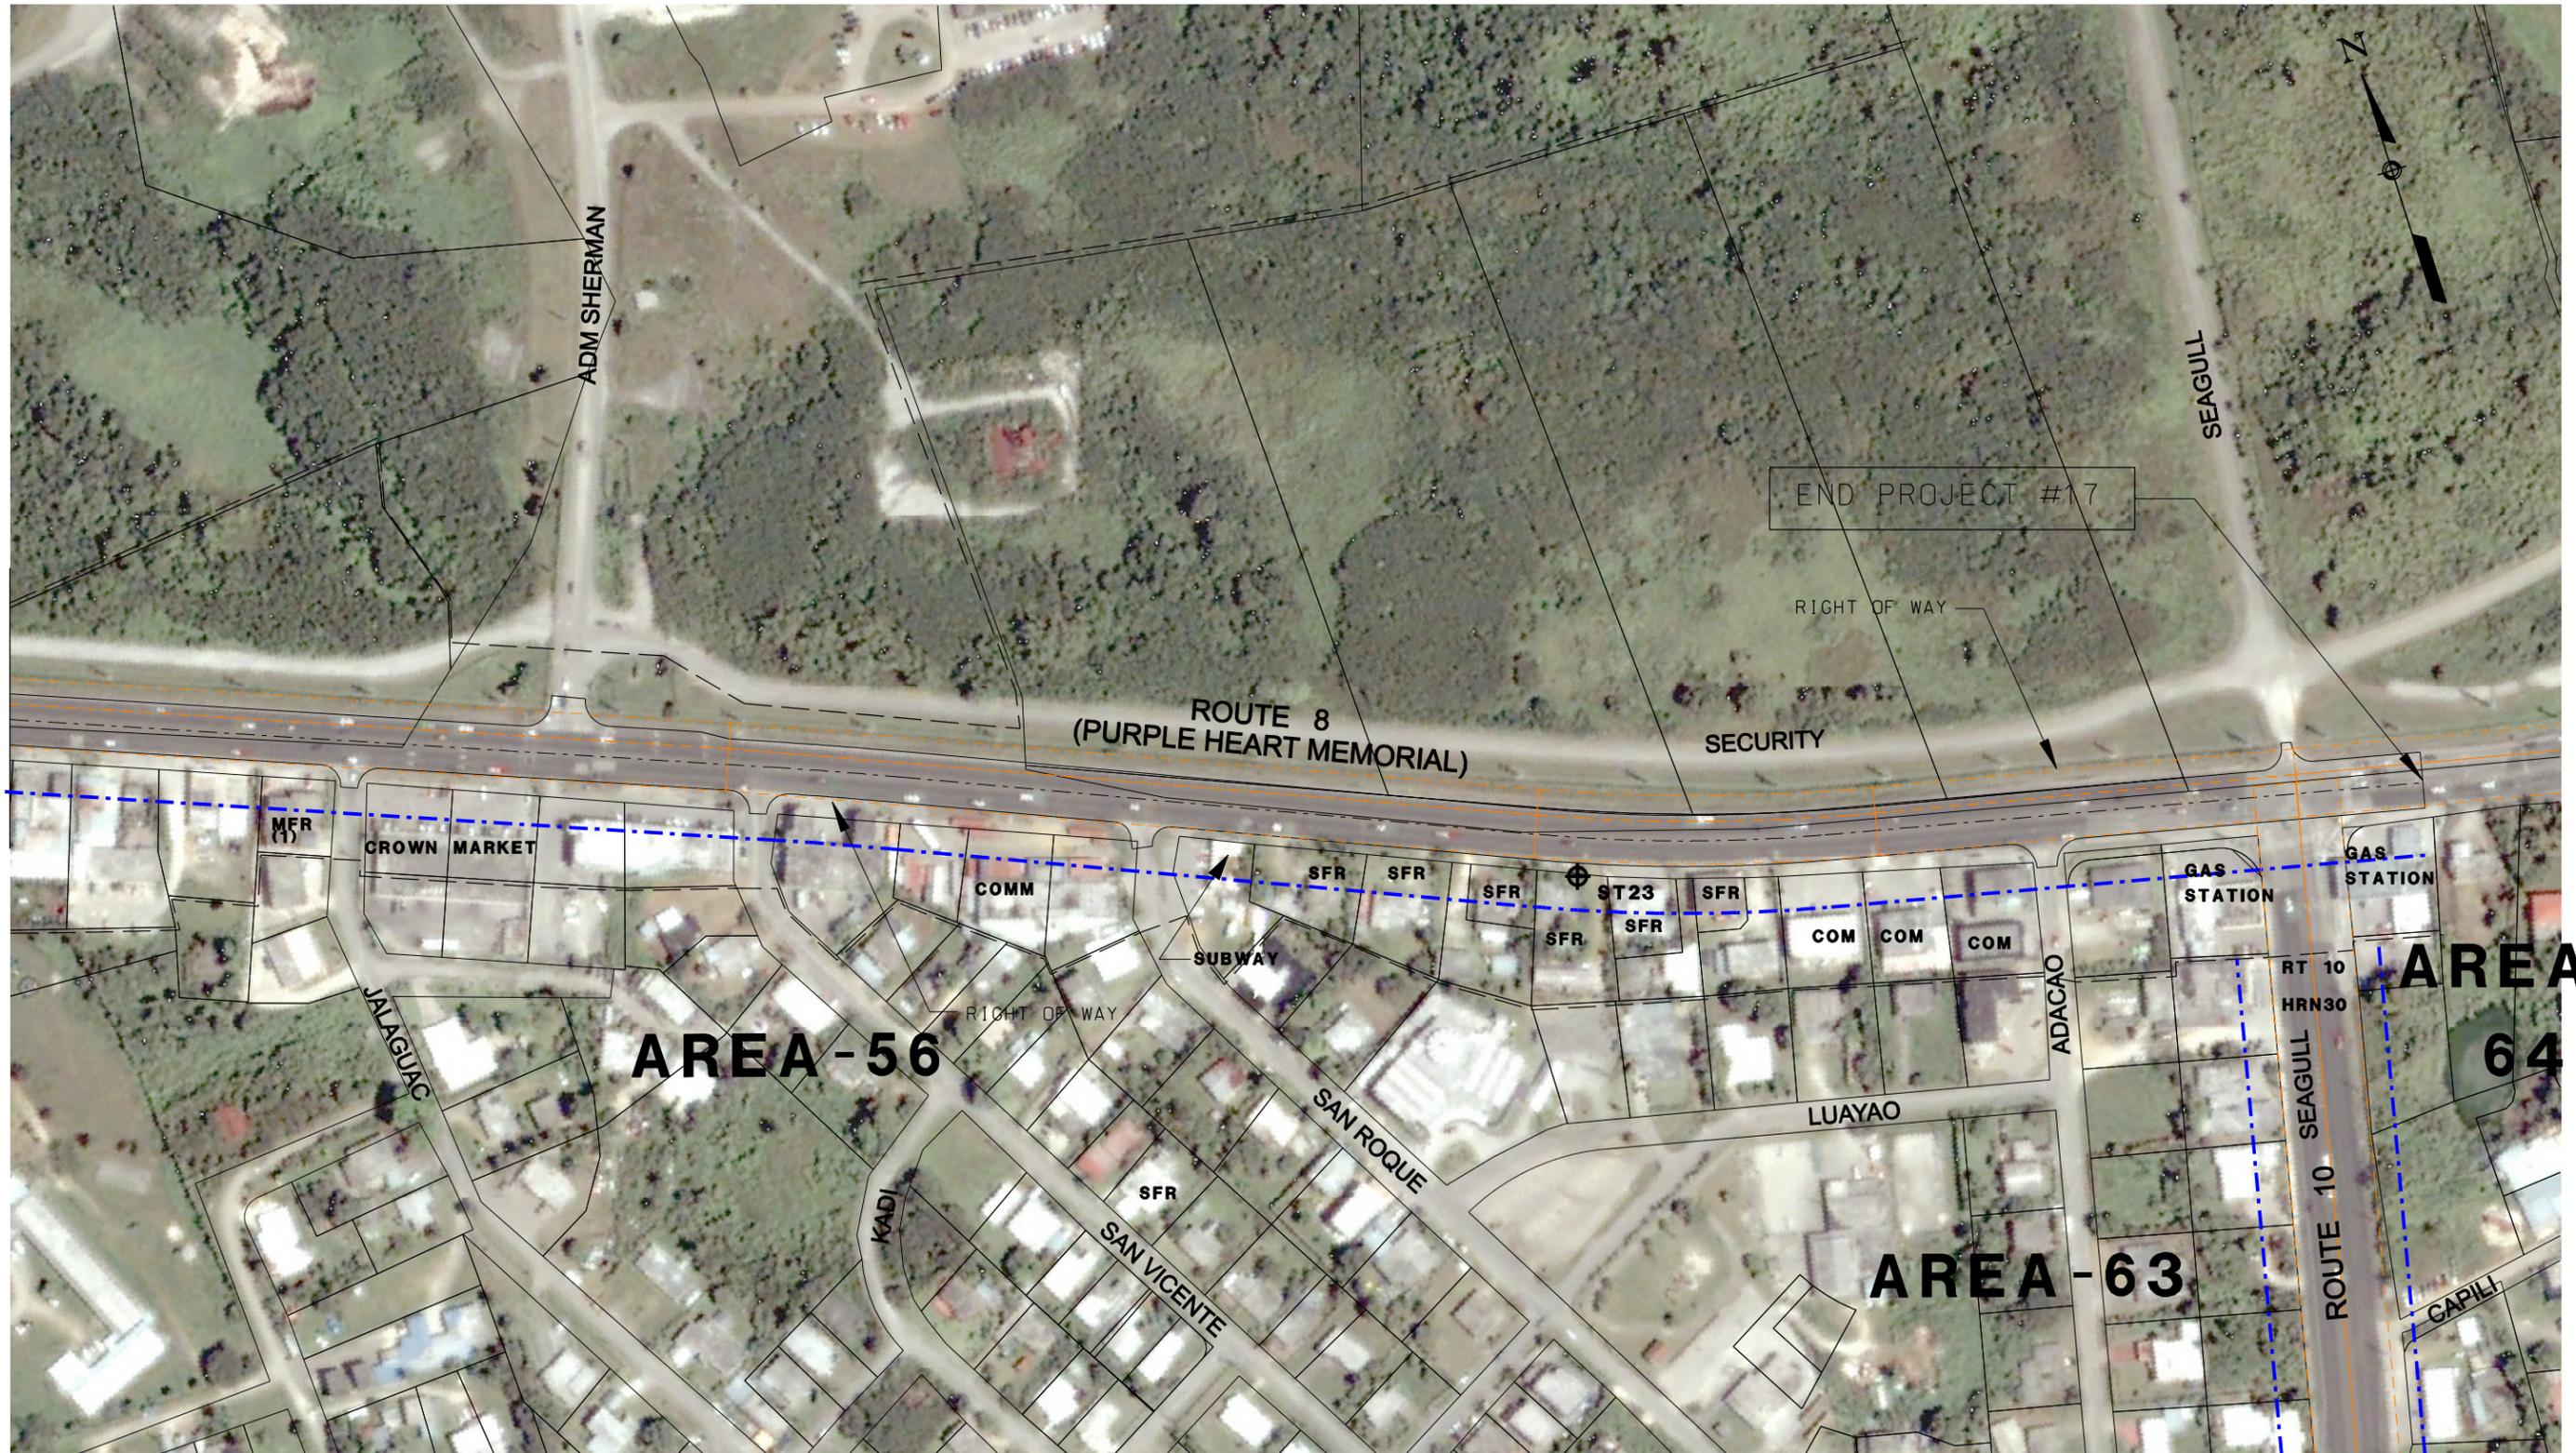
Scale 1"=200' | Drawing HRN017 | Sheet 57 of 69

**66 dBA NOISE**  
**IMPACT CONTOUR LINE**  
**FOR NON ABATEMENT**

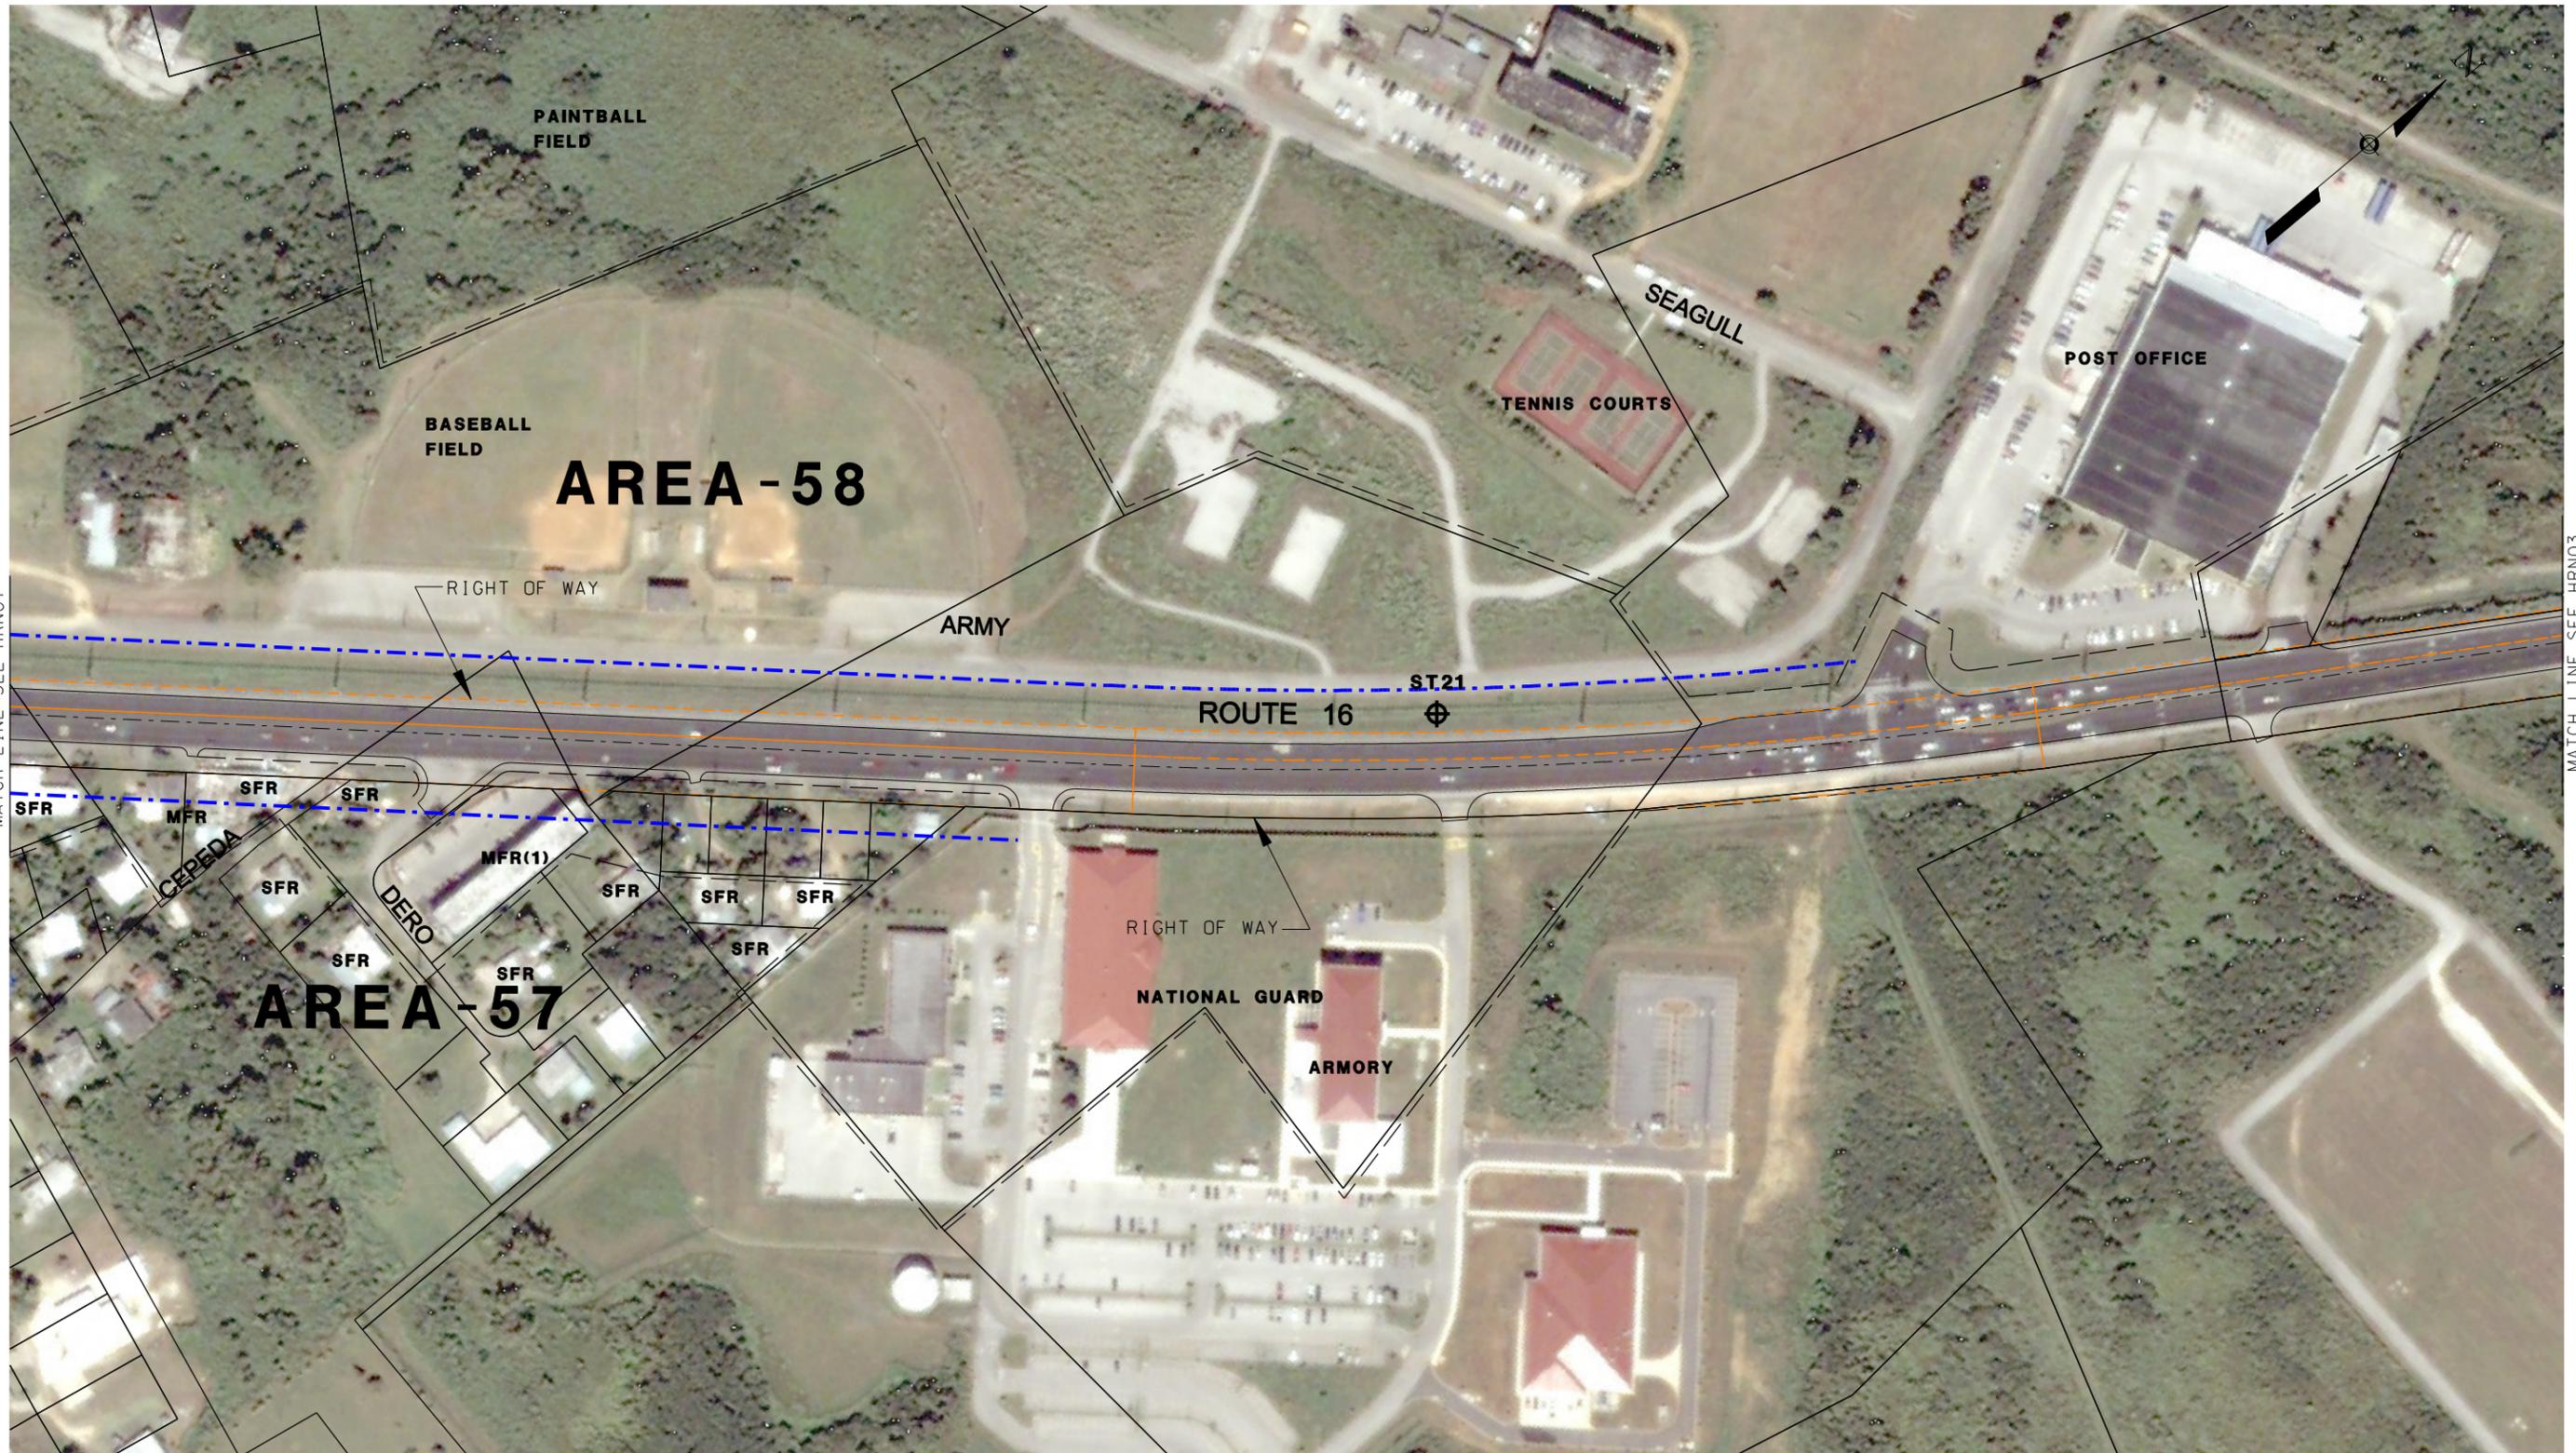
Scale 1"=200' Drawing HRN020 Sheet 59 of 69

**66 dBA NOISE  
IMPACT CONTOUR LINE  
FOR NON ABATEMENT**

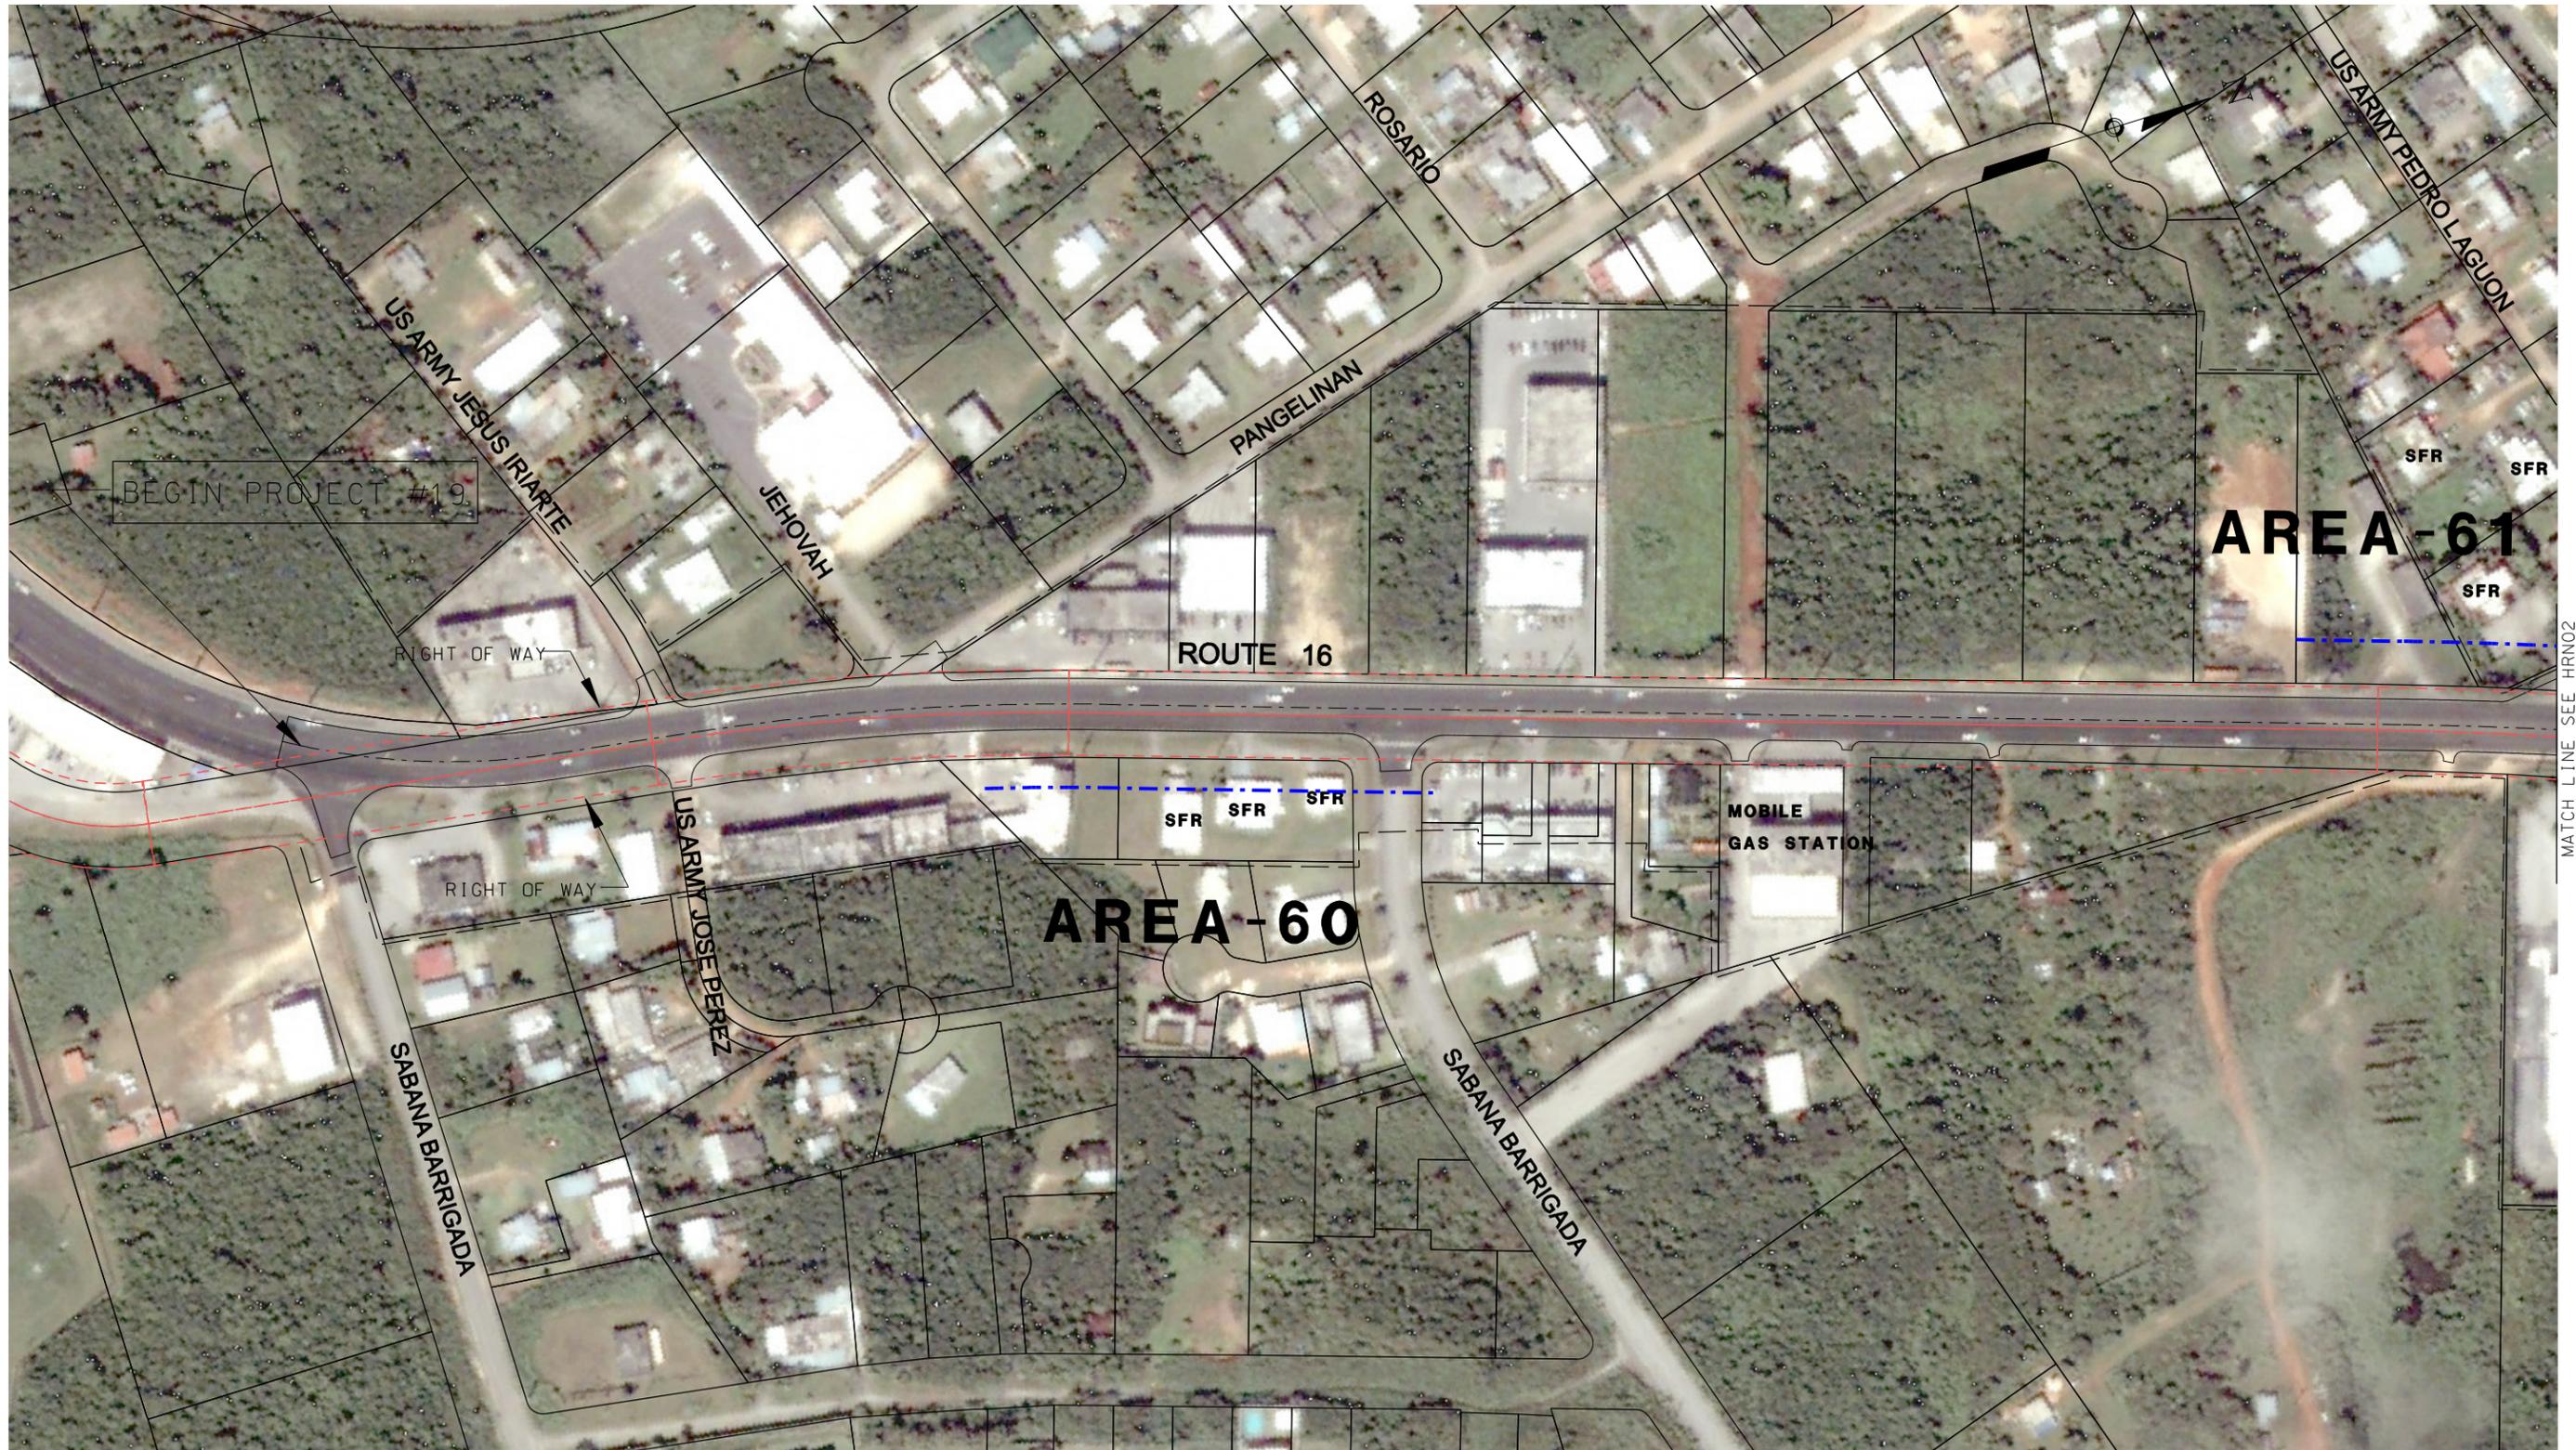
Scale 1"=200' Drawing HRN020 Sheet 62 of 69

**66 dBA NOISE**  
**IMPACT CONTOUR LINE**  
**FOR NON ABATEMENT**

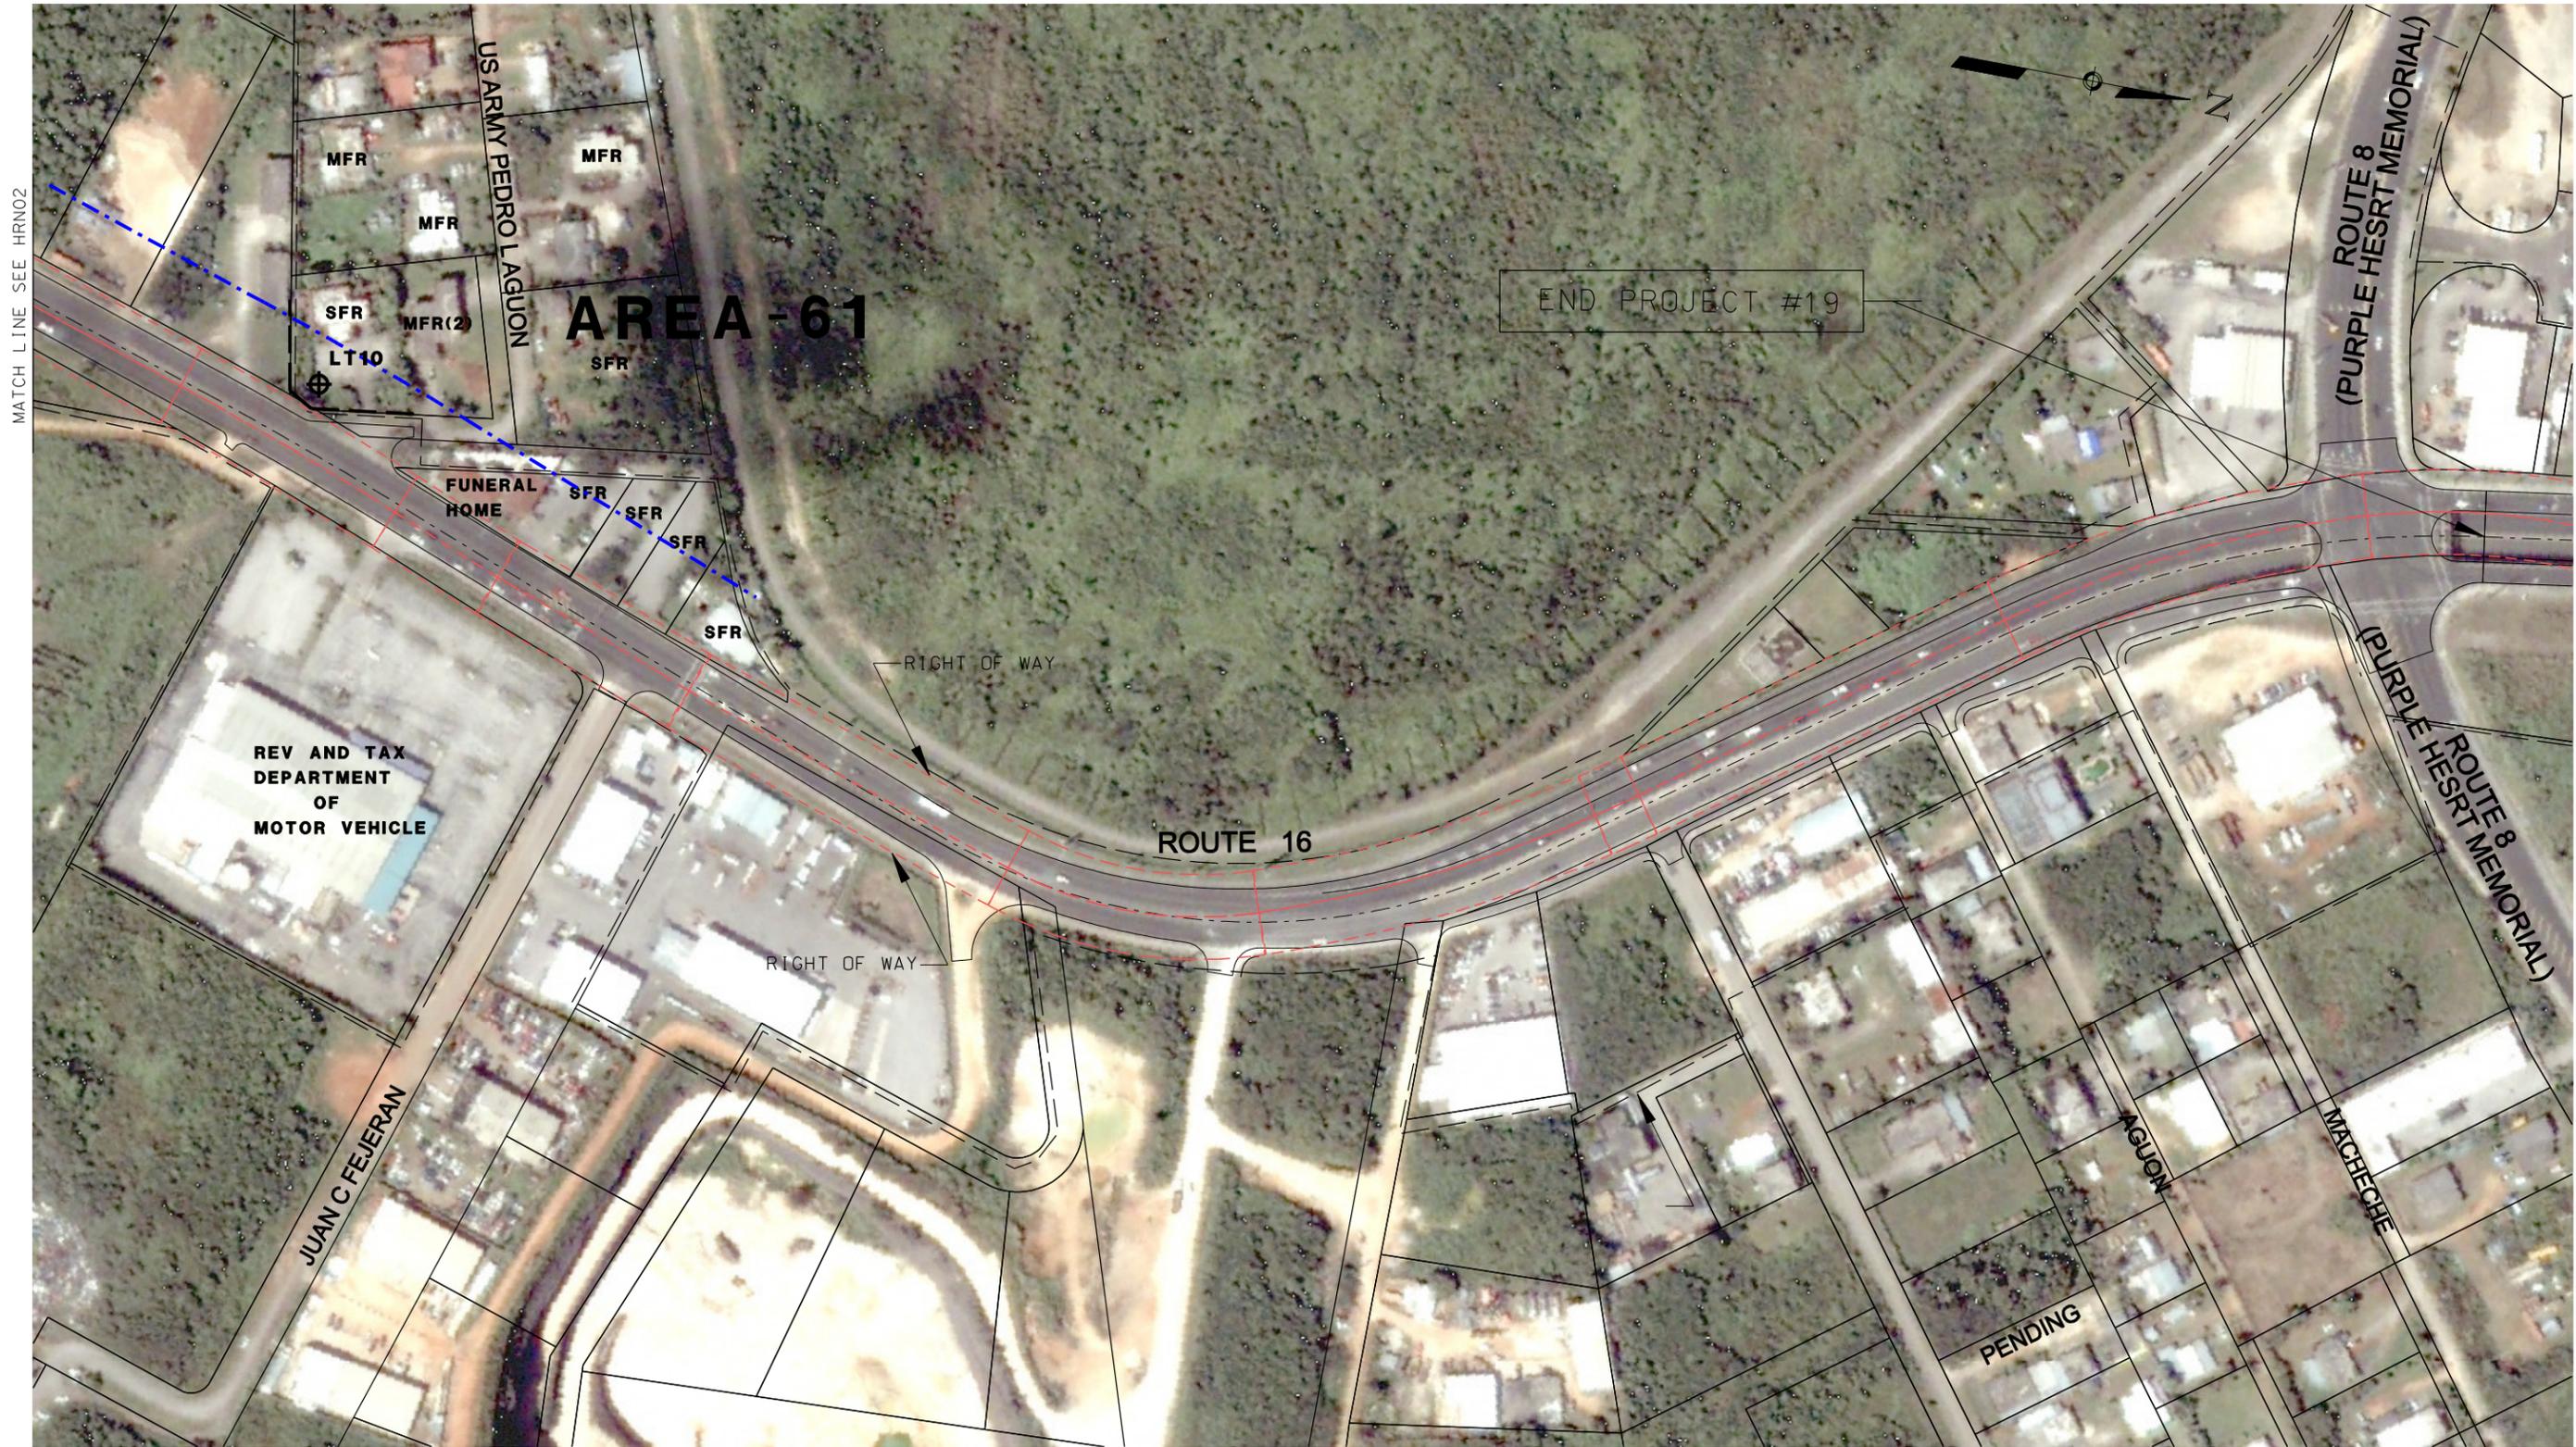
Scale 1"=200' Drawing HRN019 Sheet 64 of 69

**66 dBA NOISE**  
**IMPACT CONTOUR LINE**  
**FOR NON ABATEMENT**
