## Appendix G

### EIS Resource Technical Appendix

# Guam and CNMI Military Relocation EIS

## Volume 9: EIS Resource Technical Appendix

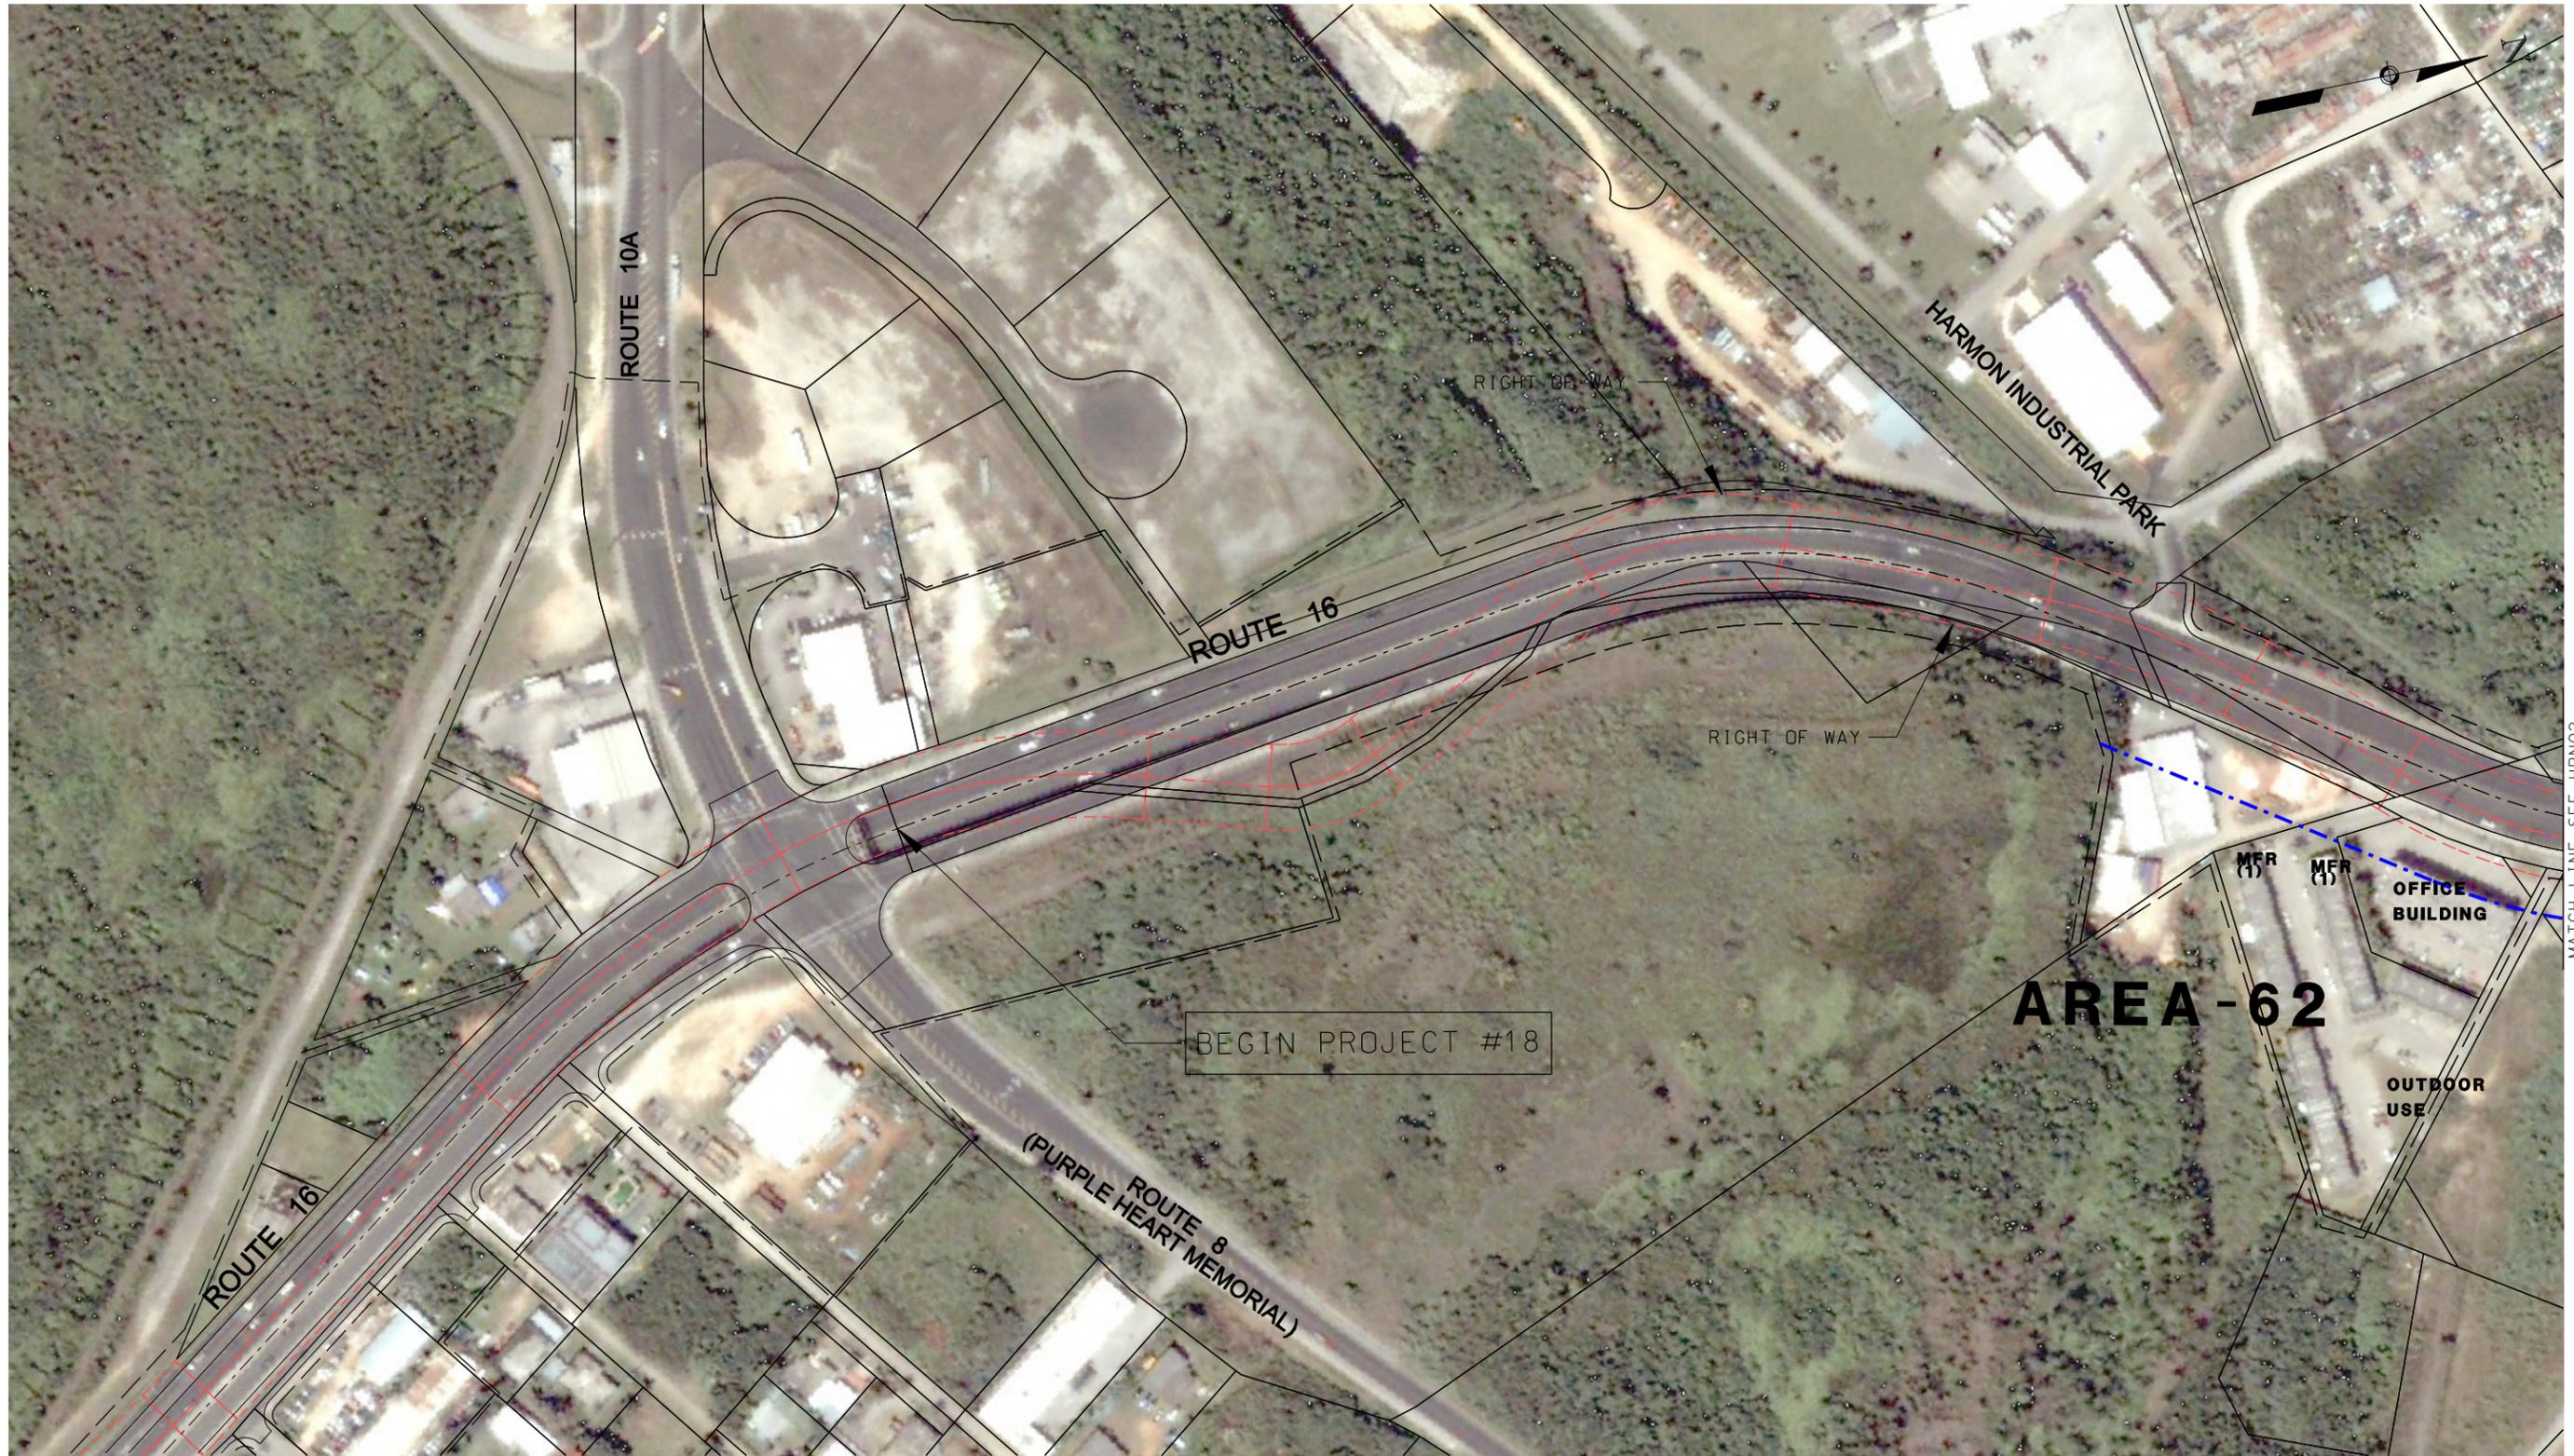
Scale 1"=200' Drawing HRN019 Sheet 64Bof 69

**66 dBA NOISE  
IMPACT CONTOUR LINE  
FOR NON ABATEMENT**

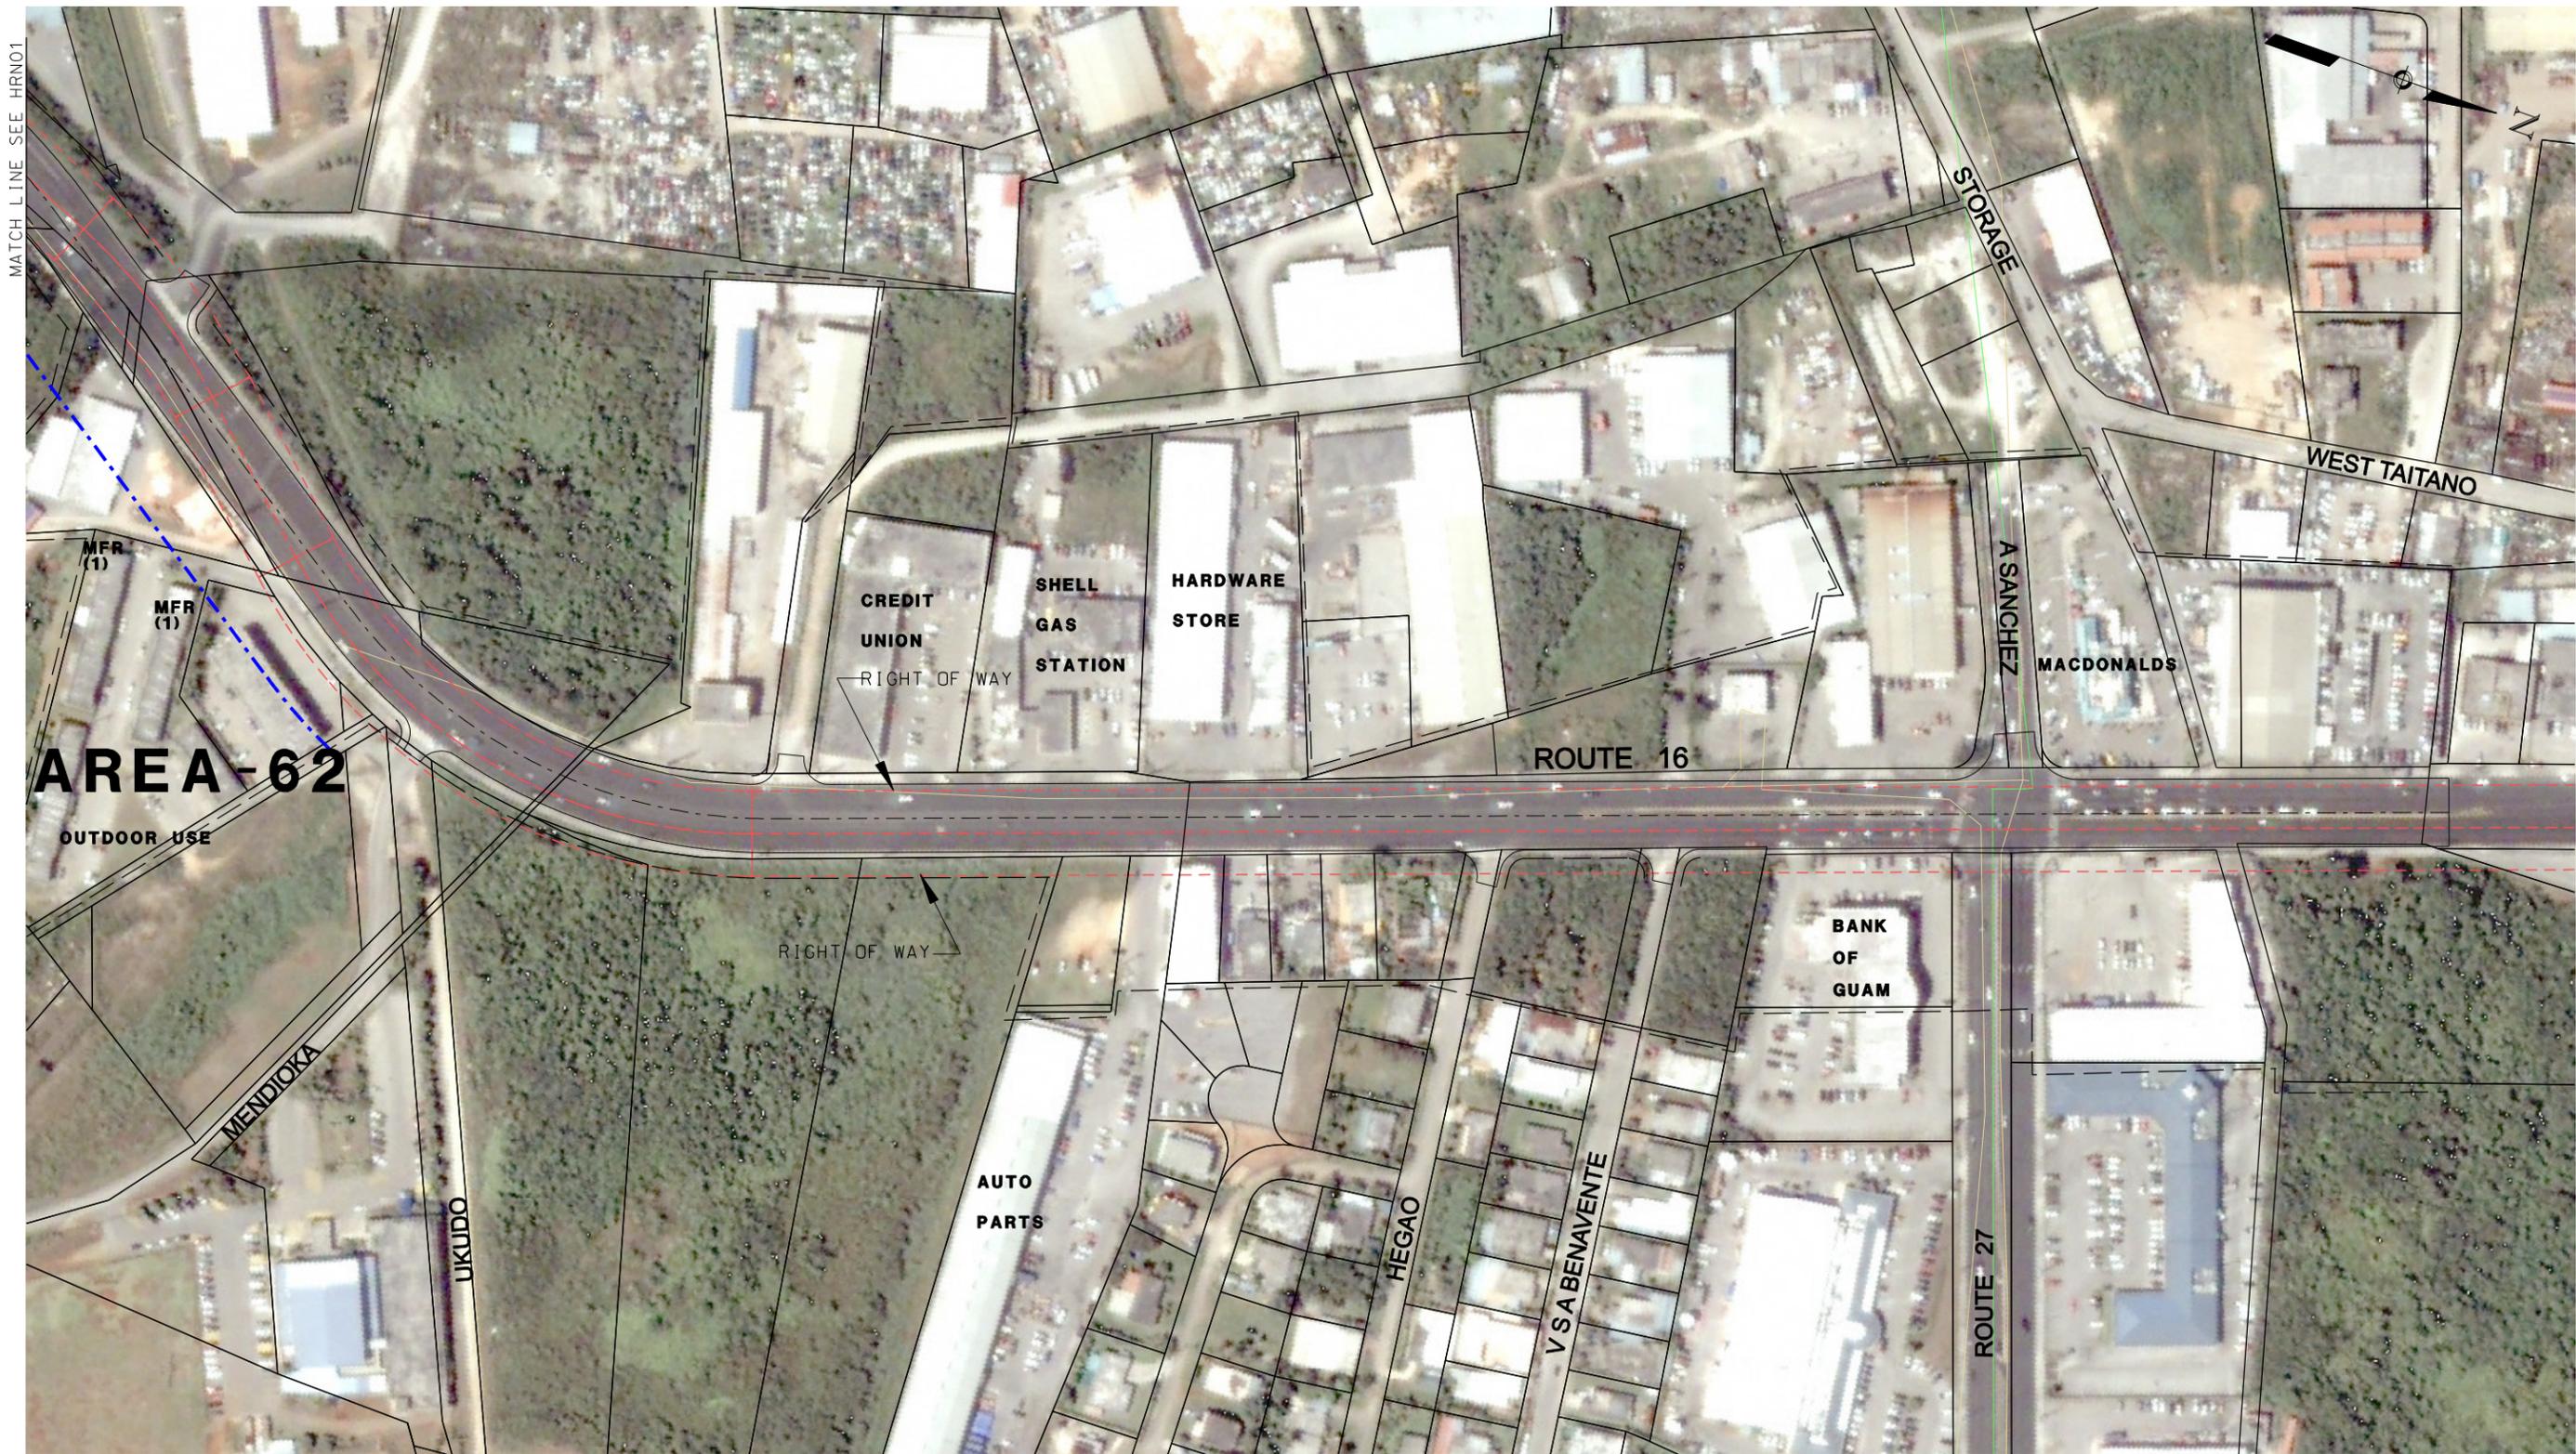
Scale 1"=200'    Drawing HRN018    Sheet 66 of 69

**66 dBA NOISE**  
**IMPACT CONTOUR LINE**  
**FOR NON ABATEMENT**

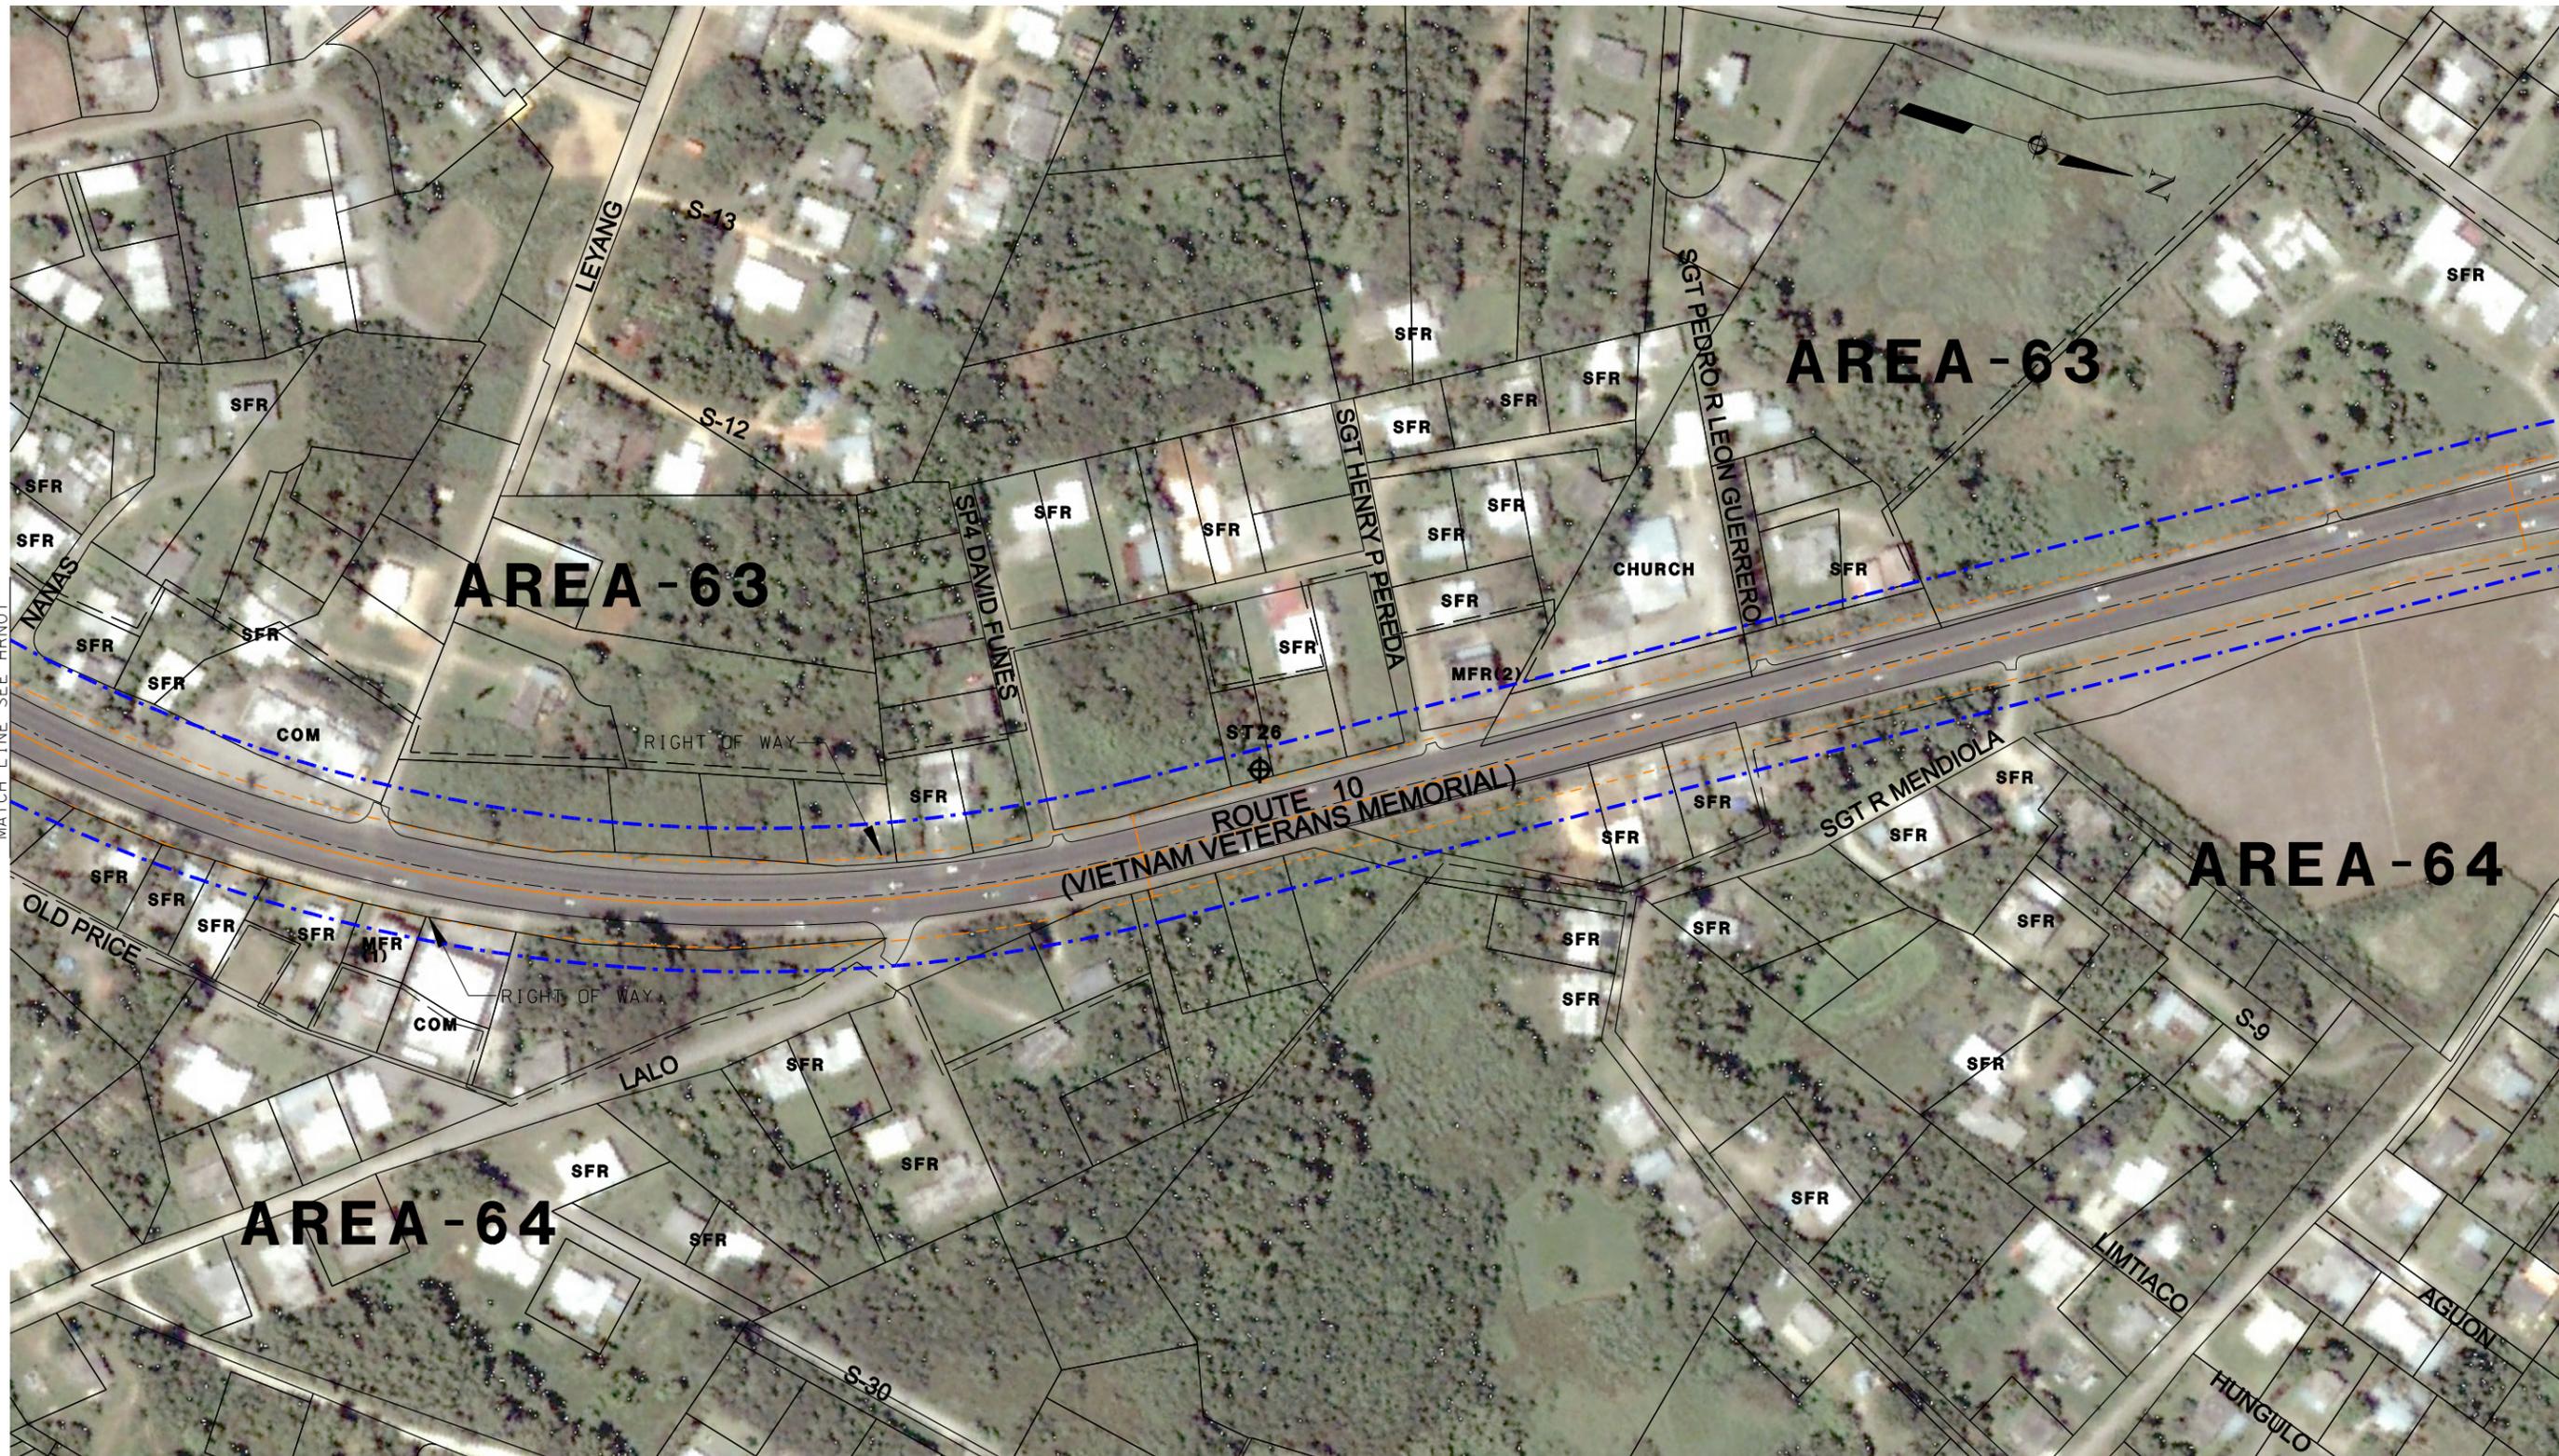
Scale 1"=200' Drawing HRN030 Sheet 67 of 69

**66 dBA NOISE  
IMPACT CONTOUR LINE  
FOR NON ABATEMENT**

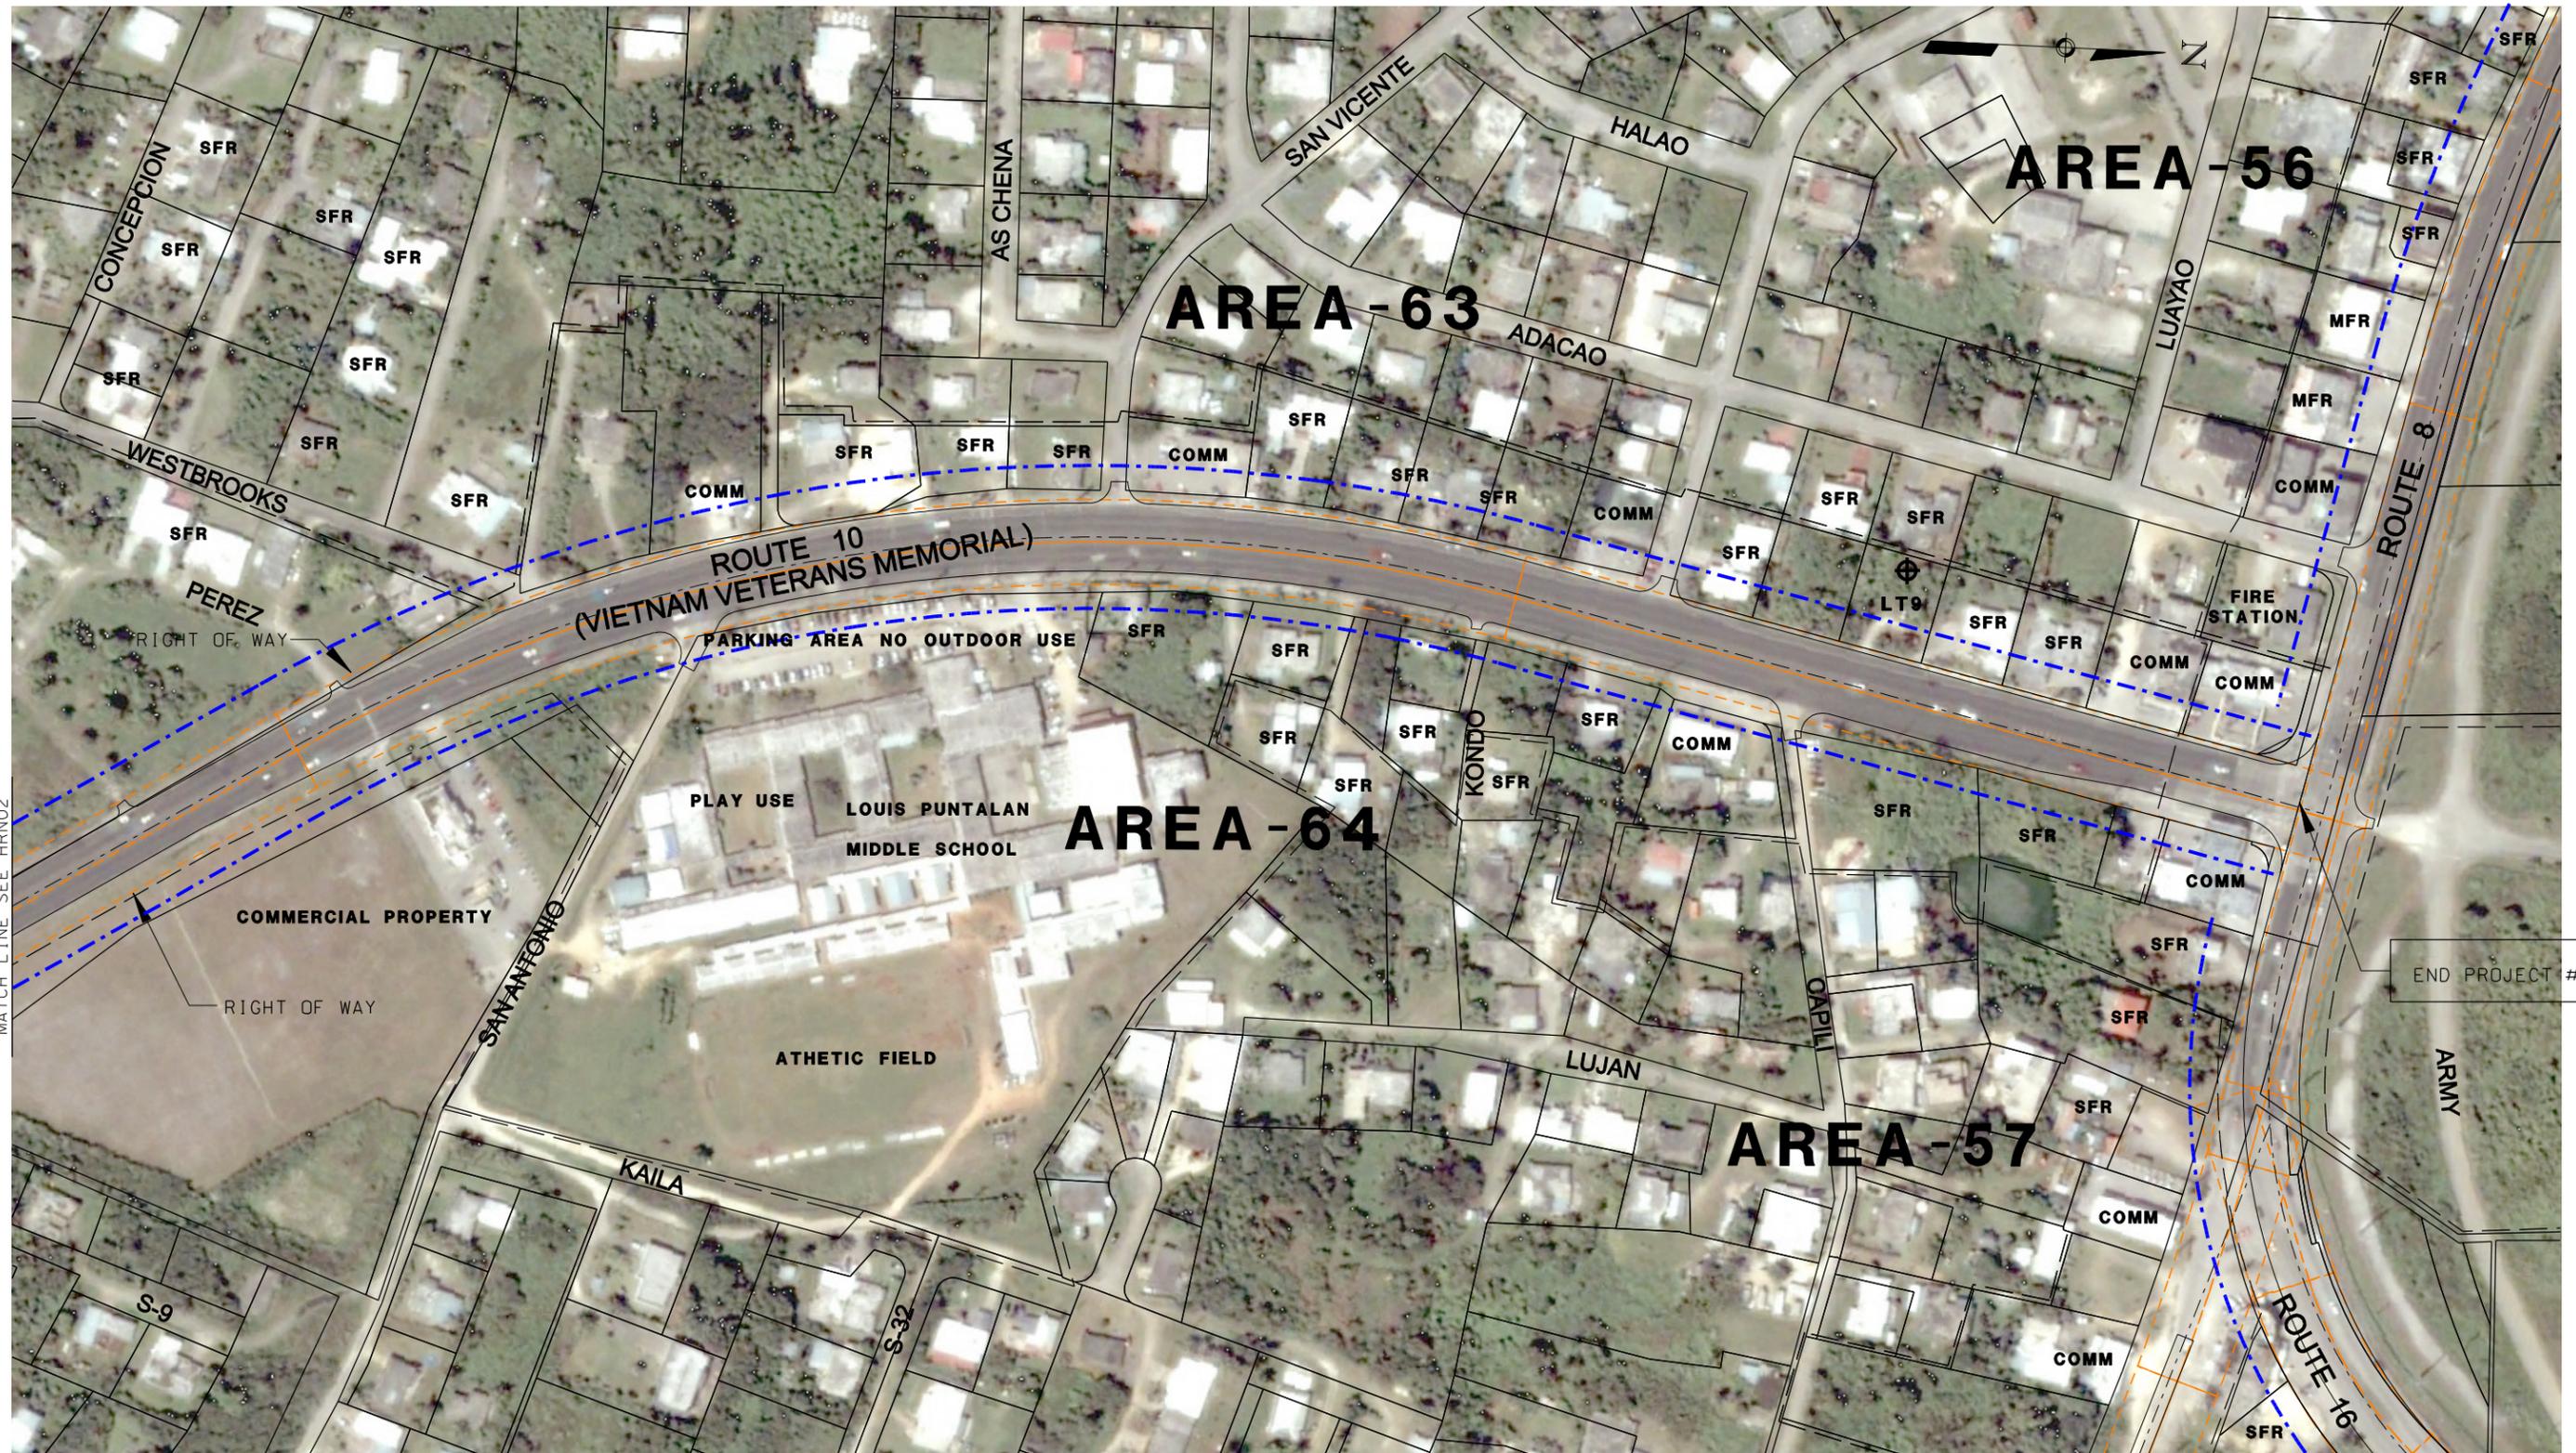
**66 dBA NOISE  
IMPACT CONTOUR LINE  
FOR NON ABATEMENT**
